SERVICE No. 173 BULLETIN

Piper Aircraft Corporation

SUBJECT: Aileron Balance Weight Attachment Bulkhead

MODELS AFFECTED: PA-24 "180" and PA-24 "250"
Serial Numbers 24-1 to 24-973 inclusive and 24-980
(See special note below)

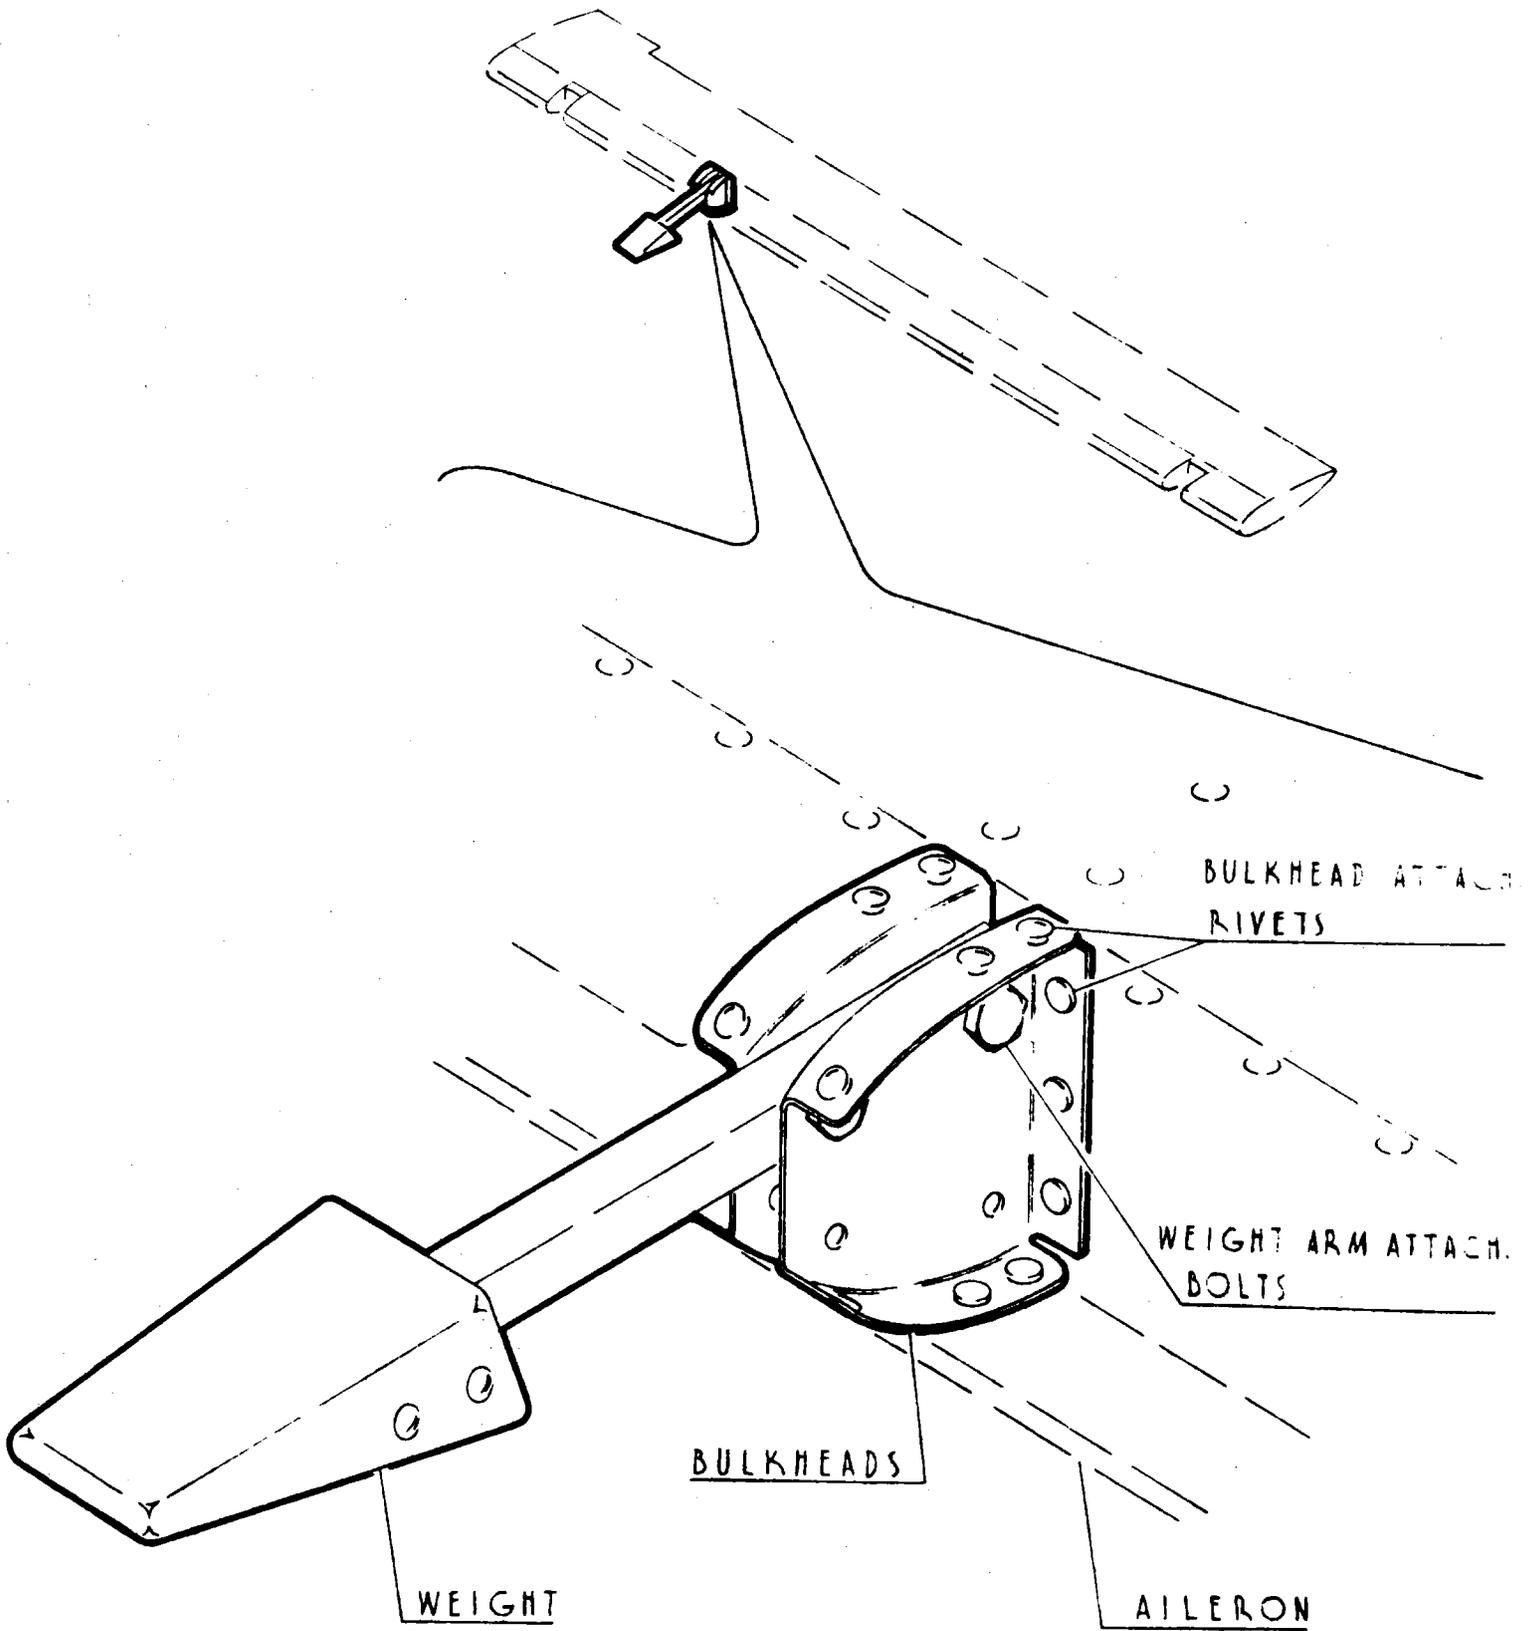
Several reports have been received by the Service Department that cracks have developed in the aileron balance weight attachment bulkheads. These bulkheads are riveted to the front spar of the aileron and are the support to which the balance weight arm is attached. See sketch on the reverse side of this bulletin.

This bulkhead, which has been re-designed to strengthen the area in which cracks have developed in the past, is now being used on current production airplanes.

At the next 100 hour inspection the two bulkheads on both ailerons must be replaced. Service kit, part number 754 233, is available from your nearest Piper distributor or dealer free of charge if the airplane serial number is included on the purchase order.

NOTE: Replace aileron balance weight attachment bulkheads on right aileron only on serial number 24-980.
