VENDOR SERVICE PUBLICATION

SUBJECT: AVCO Lycoming Service Bulletin No. 464A

Bendix Engine Products Division Jacksonville, Fl. 32245-7880
SERVICE BULLETIN	JP- 00278
Engineering Aspects are FAA Approved	Bulletin No. 623A Date 9/1982 Revised 8/1984

Inspection of impulse coupling cam assemblies.

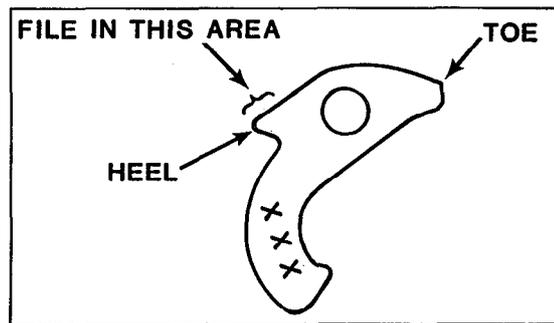
Figure 1.

Some improperly heat treated (soft) flyweights have been reported on impulse couplings currently in service. If this condition exists and is not detected, impulse coupling failure could occur. The flyweights must be inspected in accordance with the instructions in this Service Bulletin and if defective (soft) the impulse coupling or cam assembly must be replaced immediately.

3. Use finger pressure to push inward on the toe (see figure 1) of each flyweight so that the flyweight heel protrudes outward.
4. Using a fine #1, double cut, 1/2 inch wide file, at least 3/32 inch thick, pass the file across the heel of the flyweight attempting to remove material. (See figure 1.) If the flyweight has been properly heat treated the file will "glide" smoothly over the heel of the flyweight, removing no material. If the flyweight is not properly heat treated (soft), the file will not "glide" easily across the surface of the flyweight heel, and material will be removed.

XXX indicates heat treated flyweight by lot number

5. If an improperly heat treated (soft) flyweight is found, immediately remove and replace the cam assembly and/or the impulse coupling assembly following procedures in the magneto overhaul instructions, and paying strict attention to notes and cautions.

11. Any cam assembly with an improperly heat treated (soft) flyweight should be returned to the manufacturer through a currently Authorized Bendix Engine Products Division Distributor.
12. A new method of marking is being implemented to permanently identify heat treated cam assembly flyweights. See figure "1" for location. Pending consumption of current inventory, there will be a mixture of assemblies identified by the following methods.
 1. Original method ---- Yellow paint (Dykem or Lacquer) on the heel of each flyweight.
 2. New method ---- Stamped numbers as indicated in figure "1" on each flyweight.
