Service Letter No. 364A (Supersedes No. 364)

SUBJECT: Detached or Loose Rubatex Blocks in Wing Panels

MODELS AFFECTED: PA-24 and PA-24 "250" Comanches - Serial Nos. 24-1 to 24-2264 inclusive

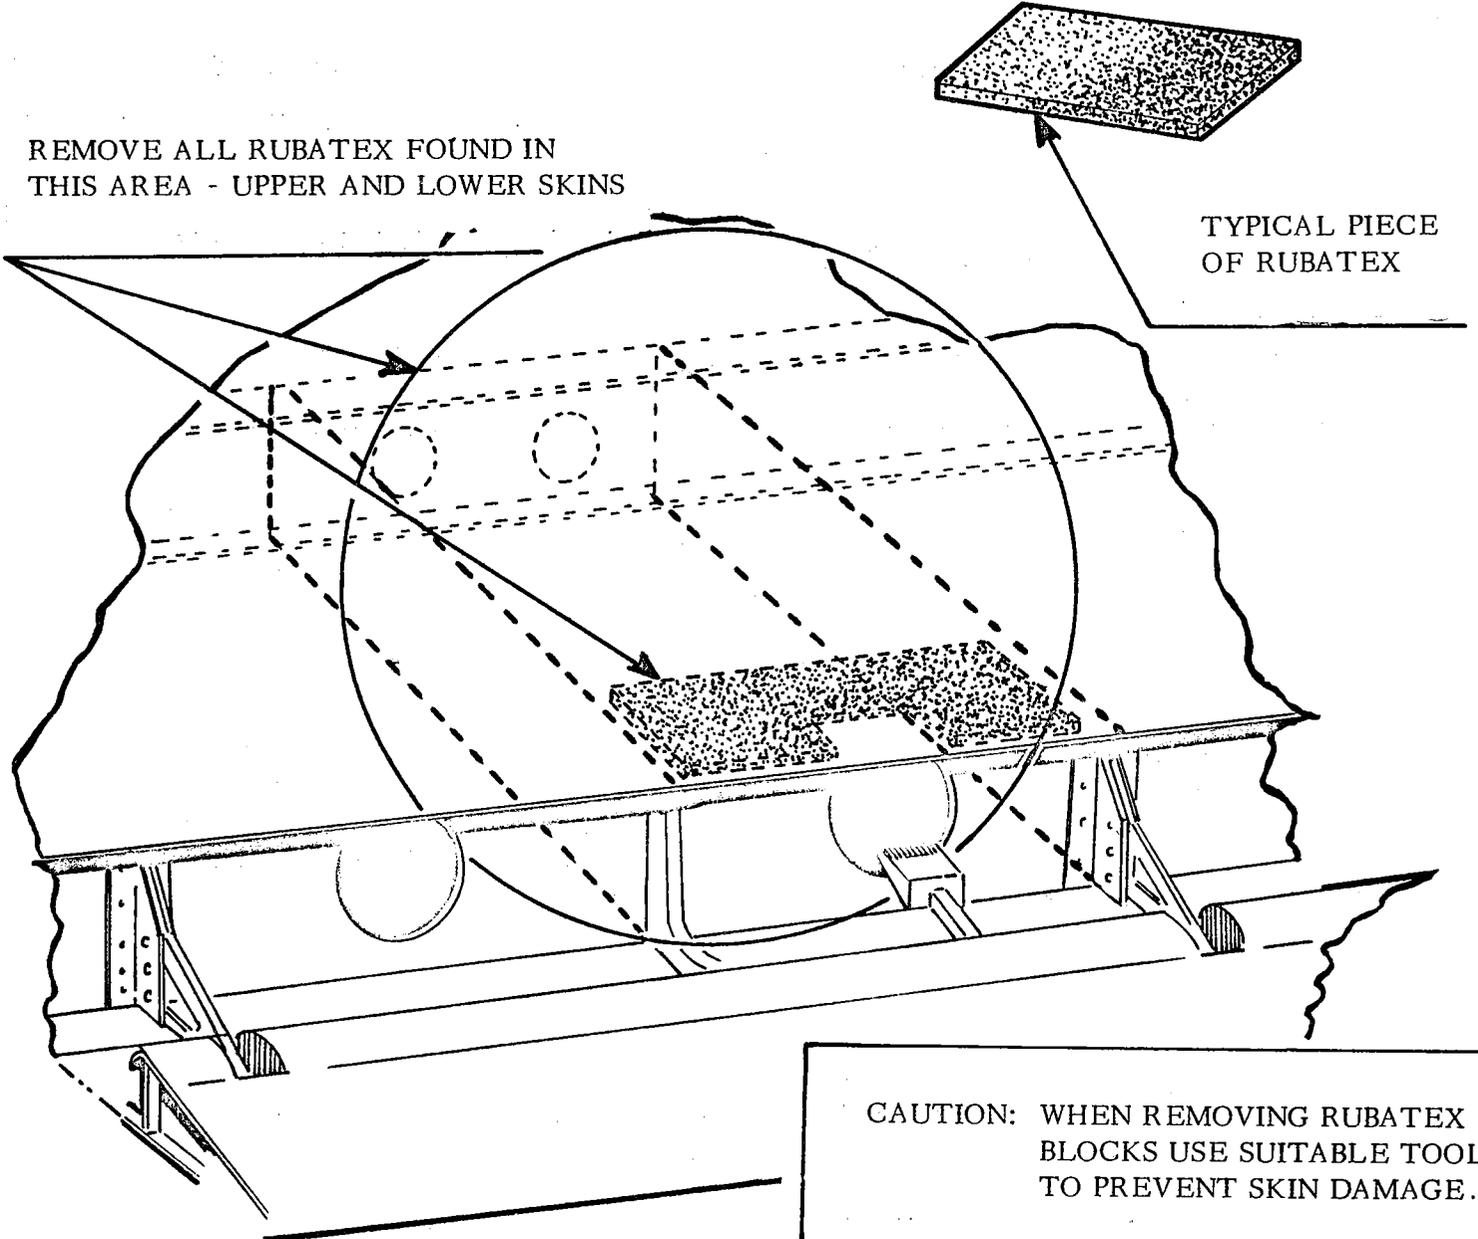
Rubatex blocks were used in a few instances to reduce the tendency of oil canning in the areas of the wing panels, as shown on the sketch on the reverse side of this Service Letter. Prior to but not later than the next 50 hours of operation, this entire area on both wings must be inspected and where these blocks are observed either loose or attached, they are to be removed.

TYPICAL PIECE
OF RUBATEX

REMOVE ALL RUBATEX FOUND IN
THIS AREA - UPPER AND LOWER SKINS

CAUTION: WHEN REMOVING RUBATEX
BLOCKS USE SUITABLE TOOL
TO PREVENT SKIN DAMAGE.
