SERVICE LETTER

No. 665A

Rotator Type Intake Valves -- reference Lycoming Service Instruction No. 1280A dated September 28, 1973, reproduced on reverse side.

Service Instruction No. 1280A
(Supersedes Service Instruction No. 1280)
Engineering Aspects are
FAA (DEER) Approved

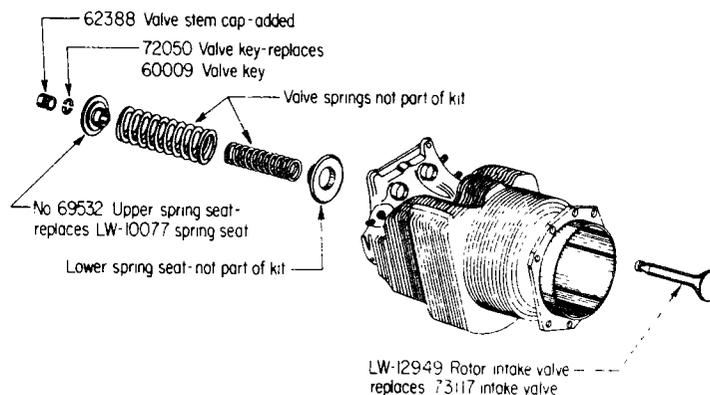
Rotator Intake Valve Components

Kit No. LW-13292, Rotator Valve Replacement for one cylinder consists of:

1 no. LW-12949	Intake Valve (replaces 73117 intake valve)
1 no. 69532	Upper Spring Seat (replaces LW-10077 spring seat)
2 no. 72050	Valve Key (replaces 60009 valve key)
1 no. 62388	Valve Stem Cap (added part)
