Service Letter No. 422

SUBJECT: Rework of Propeller Spinner Assembly

MODELS AFFECTED: PA-30 Twin Comanches, Serial Nos. 30-1 to 30-348 inclusive

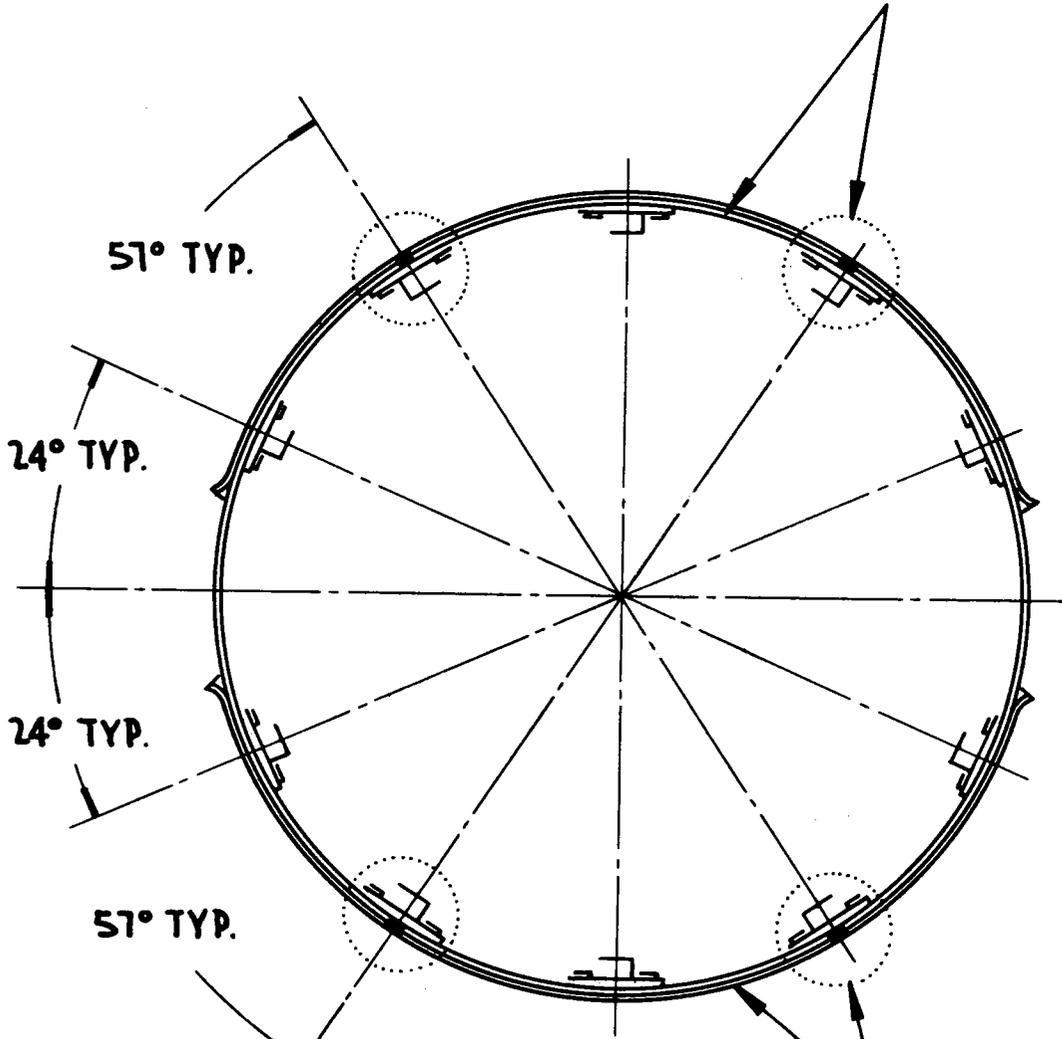
SKETCH A
KIT 756 796
Spinner Attachment

We have had reports which indicate that the propeller spinner attaching screws on the subject aircraft are chafing the spinner. In some cases the screw head had chafed sufficiently to wear through the spinner.

In order to correct this situation we have added four (4) additional screws to each spinner. These screws are installed midway between existing screws. Refer to sketch on the reverse side of this service letter.

.189/.191 HOLE (4 REQ.)
ANCHOR NUT NAS686A3 (4 REQ.)
RIVET AN426AD3-4 (8 REQ.)
(ADD TO 23815 BULKHEAD ASSY.)

.189/.191 HOLE (4 REQ.)
(ADD TO 23818 SPINNER ASSY.)

SCR. AN526-1032128 (4 REQ.)
(AT INST.)
