SERVICE *No.884* BULLETIN

Piper Aircraft Corporation
Vero Beach, Florida, U.S.A.

SUBJECT:

Lock Wiring of V-Band Couplings

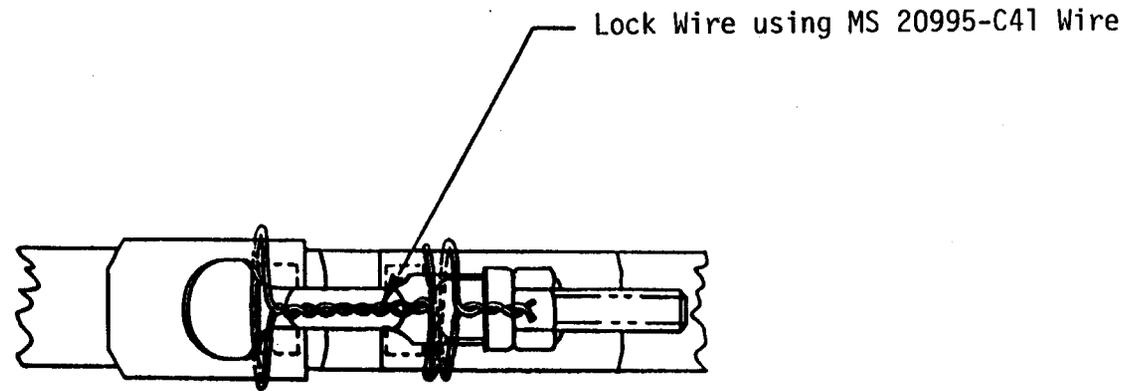
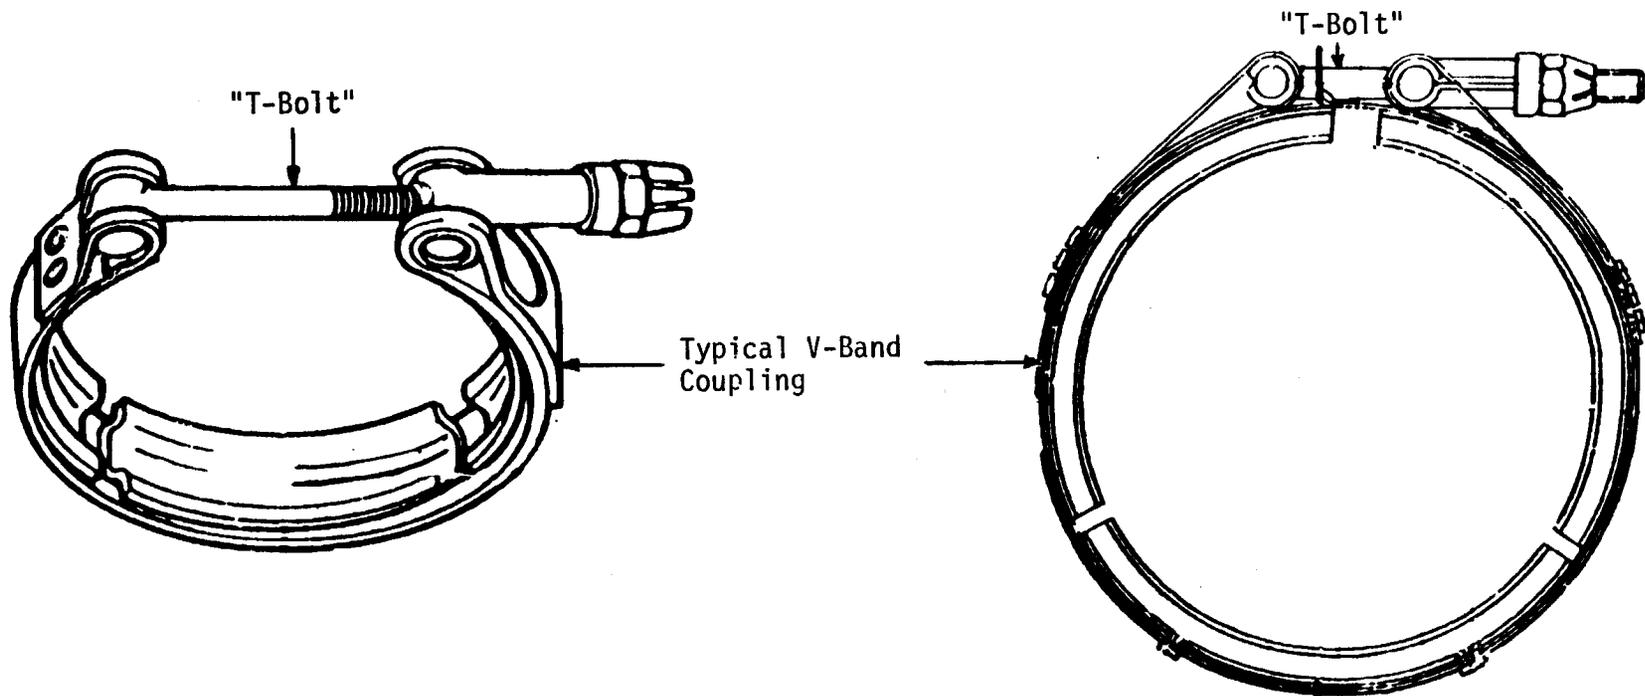
SKETCH "A"

PURPOSE: Reports have been received of broken "T-bolts" in the V-Band Couplings used in the exhaust, bleed air and cabin heat systems on various Piper Airplanes. The failure of a T-bolt can allow the coupling to separate, permitting hot exhaust gases or bleed air to be expelled, creating a fire hazard.

1. Refer to the applicable parts catalog to determine the number and location of V-Band Couplings on the affected aircraft.
2. Inspect all V-Band Couplings for security and integrity of T-bolts and lock wire (if installed). Refer to Sketch "A" attached.
3. If lock wire is damaged or missing, lock wire coupling using MS20995-C41 wire. Refer to Sketch "A".
4. Make an appropriate logbook entry of compliance with this Service Bulletin.
