SERVICE BULLETIN

No. 172

Piper Aircraft Corporation

SUBJECT: Inspection of Control Wheel Sprocket Mounting Hole

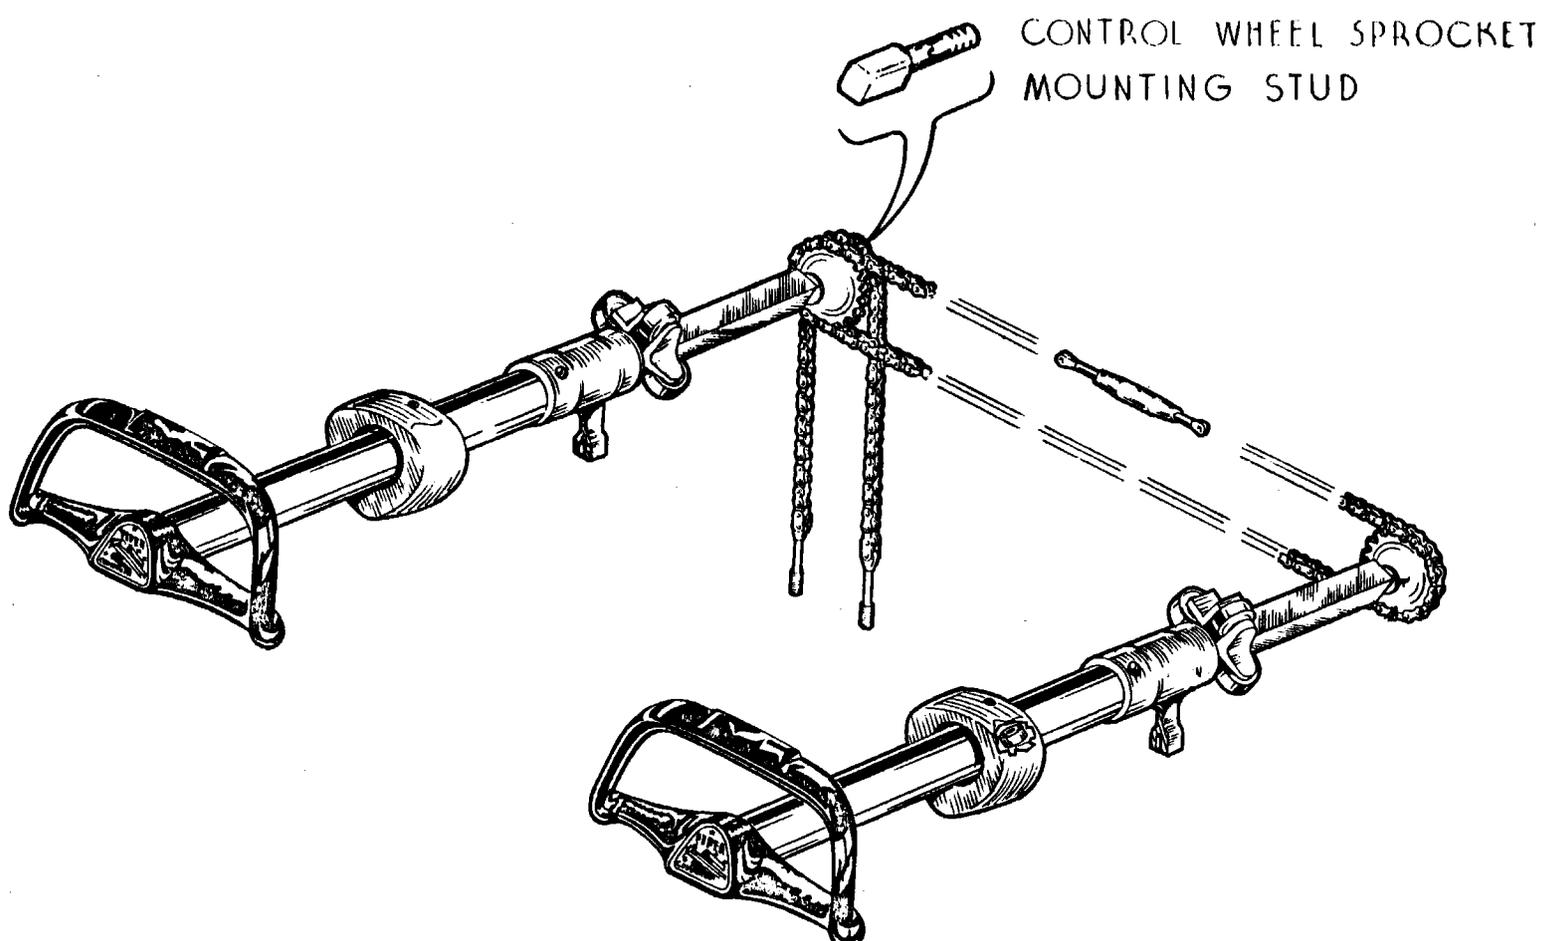
FIG. 1

There is a possibility that the control wheel sprocket mounting stud (See Figure 1 on reverse side of this bulletin), at the extreme forward end of the control wheel shaft, has been subjected to an unusual amount of torque due to the improper installation of the AutoControl servo motor drive pin. This condition must be inspected by June 30, 1959 on airplanes 24-1 to 24-102 inclusive on the right control wheel shaft and on airplanes 24-103 to 24-885 inclusive on the left control wheel shaft if an AutoControl is installed or has been installed at any time.

An inspection procedure for the removal and inspection of the control wheel sprocket mounting stud on the above mentioned airplanes is attached to this bulletin. Inasmuch as special wrench, part number 869 865, is needed to remove the sprocket from the mounting stud, it is suggested that you take your airplane to the nearest Piper distributor, dealer or Certified Service Center to have this inspection performed.

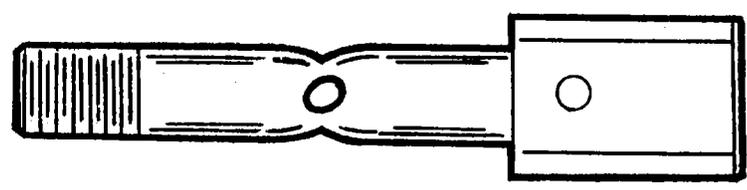
FIG. 2
No 172

14. Slide the bearing bracket and the sprocket from the sprocket stud.
15. Carefully inspect the sprocket stud, part number 20913-00, around the hole where the sprocket was attached and ascertain that the stud is not cracked or twisted and the hole is not elongated. (See Figure 2.)

25. Slide the bearing bracket and the sprocket from the sprocket stud.
26. Carefully inspect the sprocket stud around the hole where the sprocket was attached and ascertain that the stud is not cracked or twisted and the hole is not elongated. (See Figure 2.)

18. Slide the bearing bracket and the sprocket from the sprocket stud.
19. Carefully inspect the sprocket stud, part number 20913-00, around the hole where the sprocket was attached and ascertain that the stud is not cracked or twisted and the hole is not elongated. (See Figure 2.)

29. Slide the bearing bracket and the sprocket from the sprocket stud.
30. Carefully inspect the sprocket stud around the hole where the sprocket was attached and ascertain that the stud is not cracked or twisted and the hole is not elongated. (See Figure 2.)

16. After inspecting the sprocket stud, part number 20913-00, and replacing, if necessary, re-assemble in reverse (1) through (14). If part number 20913-00 or 20975-00 must be replaced, telephone the Service Department, Piper Aircraft Corporation, Lock Haven, Pennsylvania immediately.

27. After inspecting the sprocket stud and a replacement is found necessary, a control wheel square shaft and sprocket stud assembly, part number 20975-00, already assembled will be furnished by the factory. If part number 20913-00 or 20975-00 must be replaced, telephone the Service Department, Piper Aircraft Corporation, Lock Haven, Pennsylvania immediately.

20. After inspecting the sprocket stud, part number 20913-00, and replacing, if necessary, re-assemble in reverse (1) through (18). If part number 20913-00 or 20975-00 must be replaced, telephone the Service Department, Piper Aircraft Corporation, Lock Haven, Pennsylvania immediately.

31. After inspecting the sprocket stud and a replacement is found necessary, a control wheel square shaft and sprocket stud assembly, part number 20975-00, already assembled will be furnished by the factory. If part number 20913-00 or 20975-00 must be replaced, telephone the Service Department at Piper Aircraft Corporation, Lock Haven, Pennsylvania immediately.
