SERVICE

NUMBER 164

BULLETIN

MODEL AFFECTED: PA-24 Comanche

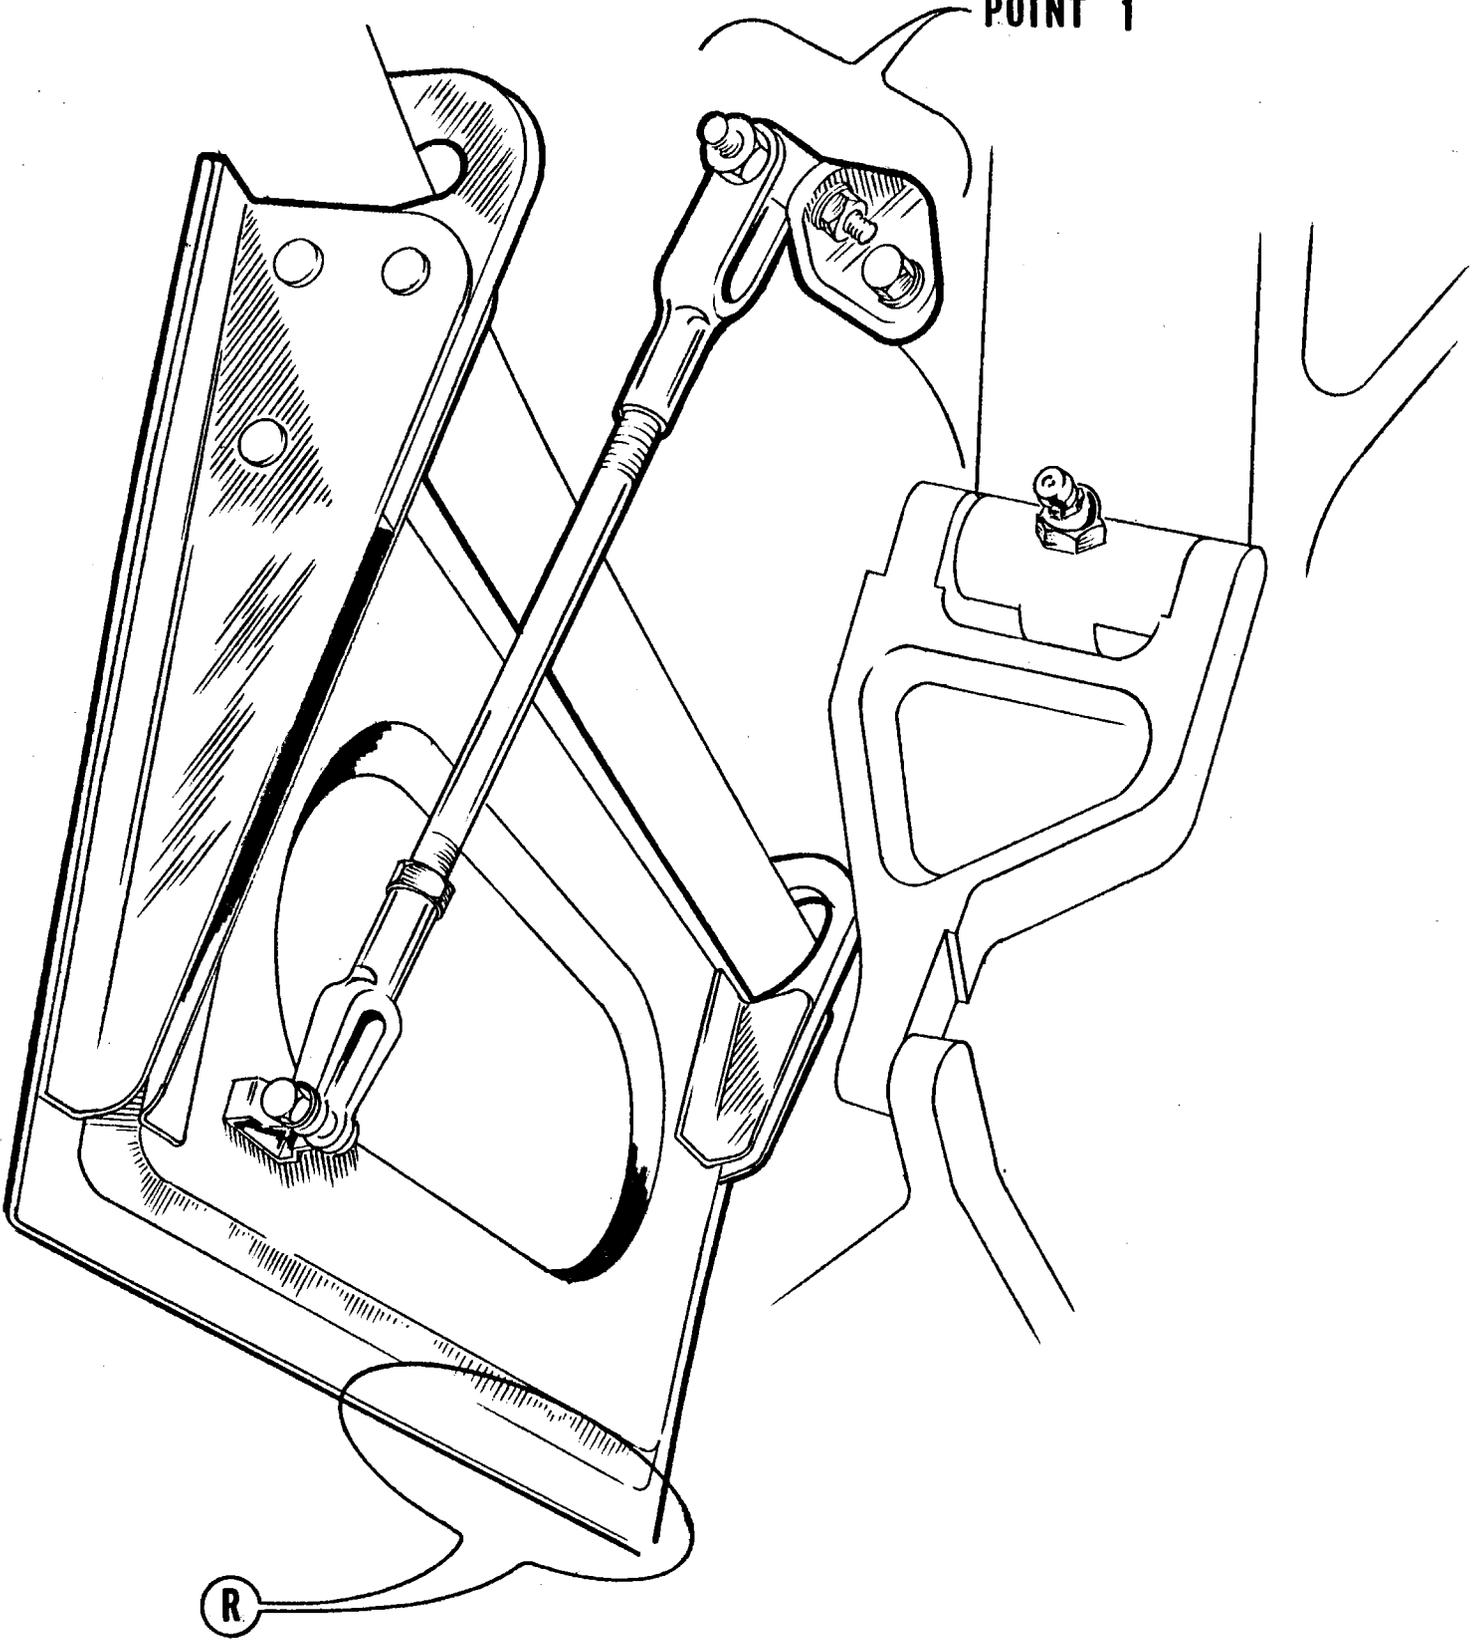
NOSE GEAR DOOR RETRACTION ROD	
SKETCH "A"	Service Bulletin 164
PIPER AIRCRAFT CORPORATION	
LOCK HAVEN, PENNSYLVANIA

To preclude the possibility of damage to the nose gear door, it is recommended that the door retraction rod attachment on serials 24-1 to 24-76 inclusive be inspected and changed, if necessary, per Sketch "A" and instructions attached to this bulletin. The lock nut for the upper rod end fitting for the retraction rod must be removed on aircraft serials 24-1 to 24-106 inclusive.

1. Place aircraft on jacks and tail pedestal. (300 lbs. ballast on pedestal.)
2. Check eye bolt at upper end of retraction rod at point 1.
3. If eye bolt is not installed as shown, remove and reinstall per sketch.
4. Remove upper rod end fitting and lock nut.
5. Replace upper rod end fitting.
- *6. Disconnect lower end of rod from door assembly and back off upper rod end fitting approximately two (2) turns.
- *7. Reinstall lower end of rod to door temporarily and retract landing gear.
- *8. Keep adjusting the rod end fitting until the door closes flush with bottom cowl skin.
- *9. Tighten lock nut on bottom rod end fitting and complete installation of rod end to gear door.

If nose gear door rubs the gear strut when retracting gear, trim rear edge of door with tin snips in area "R".
