Piper Aircraft Corporation

**SUBJECT:** Gascolator Bowl Drain Valve

**MODELS AFFECTED:** PA-24 and PA-24 "250" Comanche Aircraft - Serial Numbers 24-2500 to 24-2700 inclusive

SERVICE BULLETIN #208

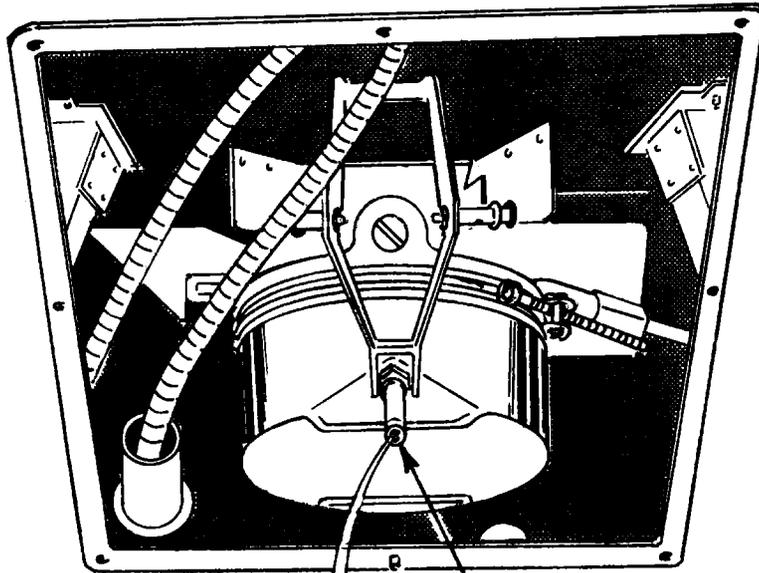
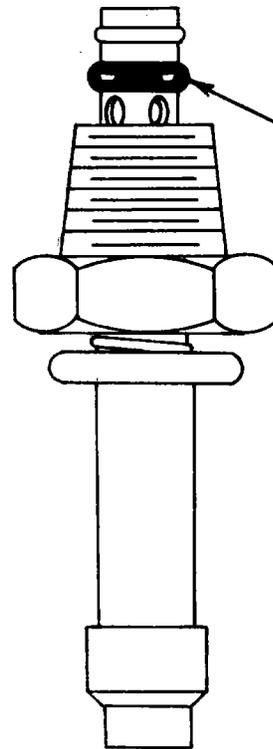
FUEL STRAINER DRAIN VALVE

The failures have occurred as a result of machining the valve. The longitudinal hole drilled through the stem has penetrated the stem too deeply; thus weakening the stem adjacent to the "O" ring. It is requested that the valves installed in the aircraft indicated by the above serial numbers be inspected in the following manner:

1. Remove the belly access panel at the drain valve.
2. Look into the longitudinal hole in the valve stem and note if the cross-drill marks resulting from the cross-drilling of the stem adjacent to the "O" ring are visible.

Refer to the sketch on the reverse side of this Bulletin.

If the cross-drilling marks are observed, the valve may be considered satisfactory and no further action is required.

If the cross-drilling marks are not observed, the valve must be replaced.
