SERVICE LETTER

No. 667A

Piper Aircraft Corporation

Stabilator Attachment Bolts

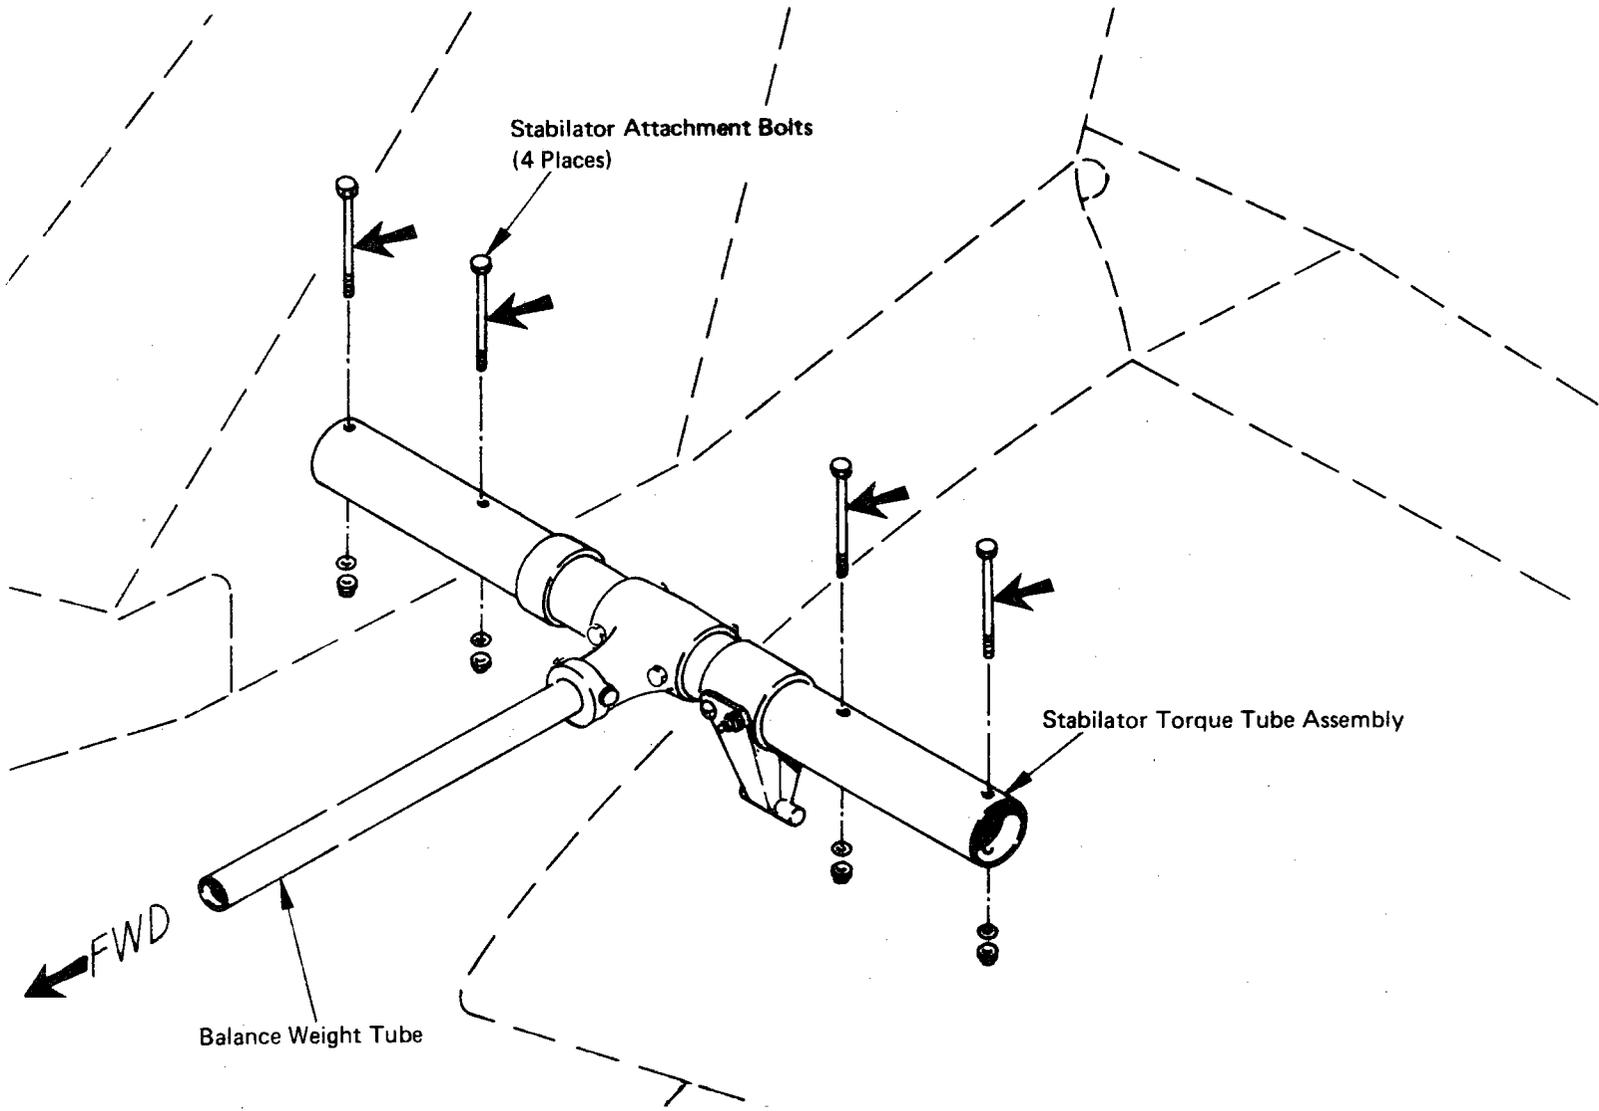
Stabilator Attachment Hardware

It has been determined that the stabilator attachment bolts on the above referenced aircraft may corrode. This situation has occurred primarily on high time aircraft at least five years old and/or operating in areas likely to induce corrosion -- near salt water, etc.

Remove existing stabilator attachment bolts, washers and nuts, indicated on sketch, and install new bolts and attaching hardware.
CAUTION: Remove and replace one bolt at a time. Refer to sketch for correct replacement hardware identification and proper assembly of bolts, washers and nuts.

2. Correct torque value for bolts is as follows:
 - a. PA-24-180/250 and 260 - torque to 30-40 inch lbs.
 - b. PA-23-235/250/250 (Six Place) and PA-24-400 - torque to 60-85 inch lbs.
 - c. PA-30 - Refer to the Twin Comanche Service Manual (Section 4 - paragraph 49) which states that the nuts ("holding the stabilator to the torque tube") should "be tightened just enough to take the play out of the washers."

Bolt AN174-C32A P/N 502 329 (Corrosion Resistant) or Bolt AN174-32A P/N 402 329 (Non-Corrosion Resistant)
 Washer AN960-416L P/N 407 585
 Nut MS20365-428C P/N 404 888

Bolt AN175-C32A P/N 502 342 (Corrosion Resistant) or Bolt AN175-32A P/N 402 342 (Non-Corrosion Resistant)
 Washer AN960-516 P/N 407 566 (PA-23-235/250 and 250 Six Place only)
 Washer AN960-516L P/N 407 586 (PA-24-400 and PA-30 only)
 Nut MS20365-524C P/N 404 889
