Service Letter No. 373

SUBJECT: Installation of Oil Shields on Airborne Mechanisms Dry Vacuum Pumps, Models 113A1 and 113A5

MODELS AFFECTED: PA-22-108 Colts - Serial Nos. 22-8000 to 22-9256 inclusive
PA-24 and PA-24 "250" Comanches - Serial Nos. 24-2176 to 24-2987 inclusive
PA-28 Cherokees - Serial Nos. 28-1 to 28-494 inclusive

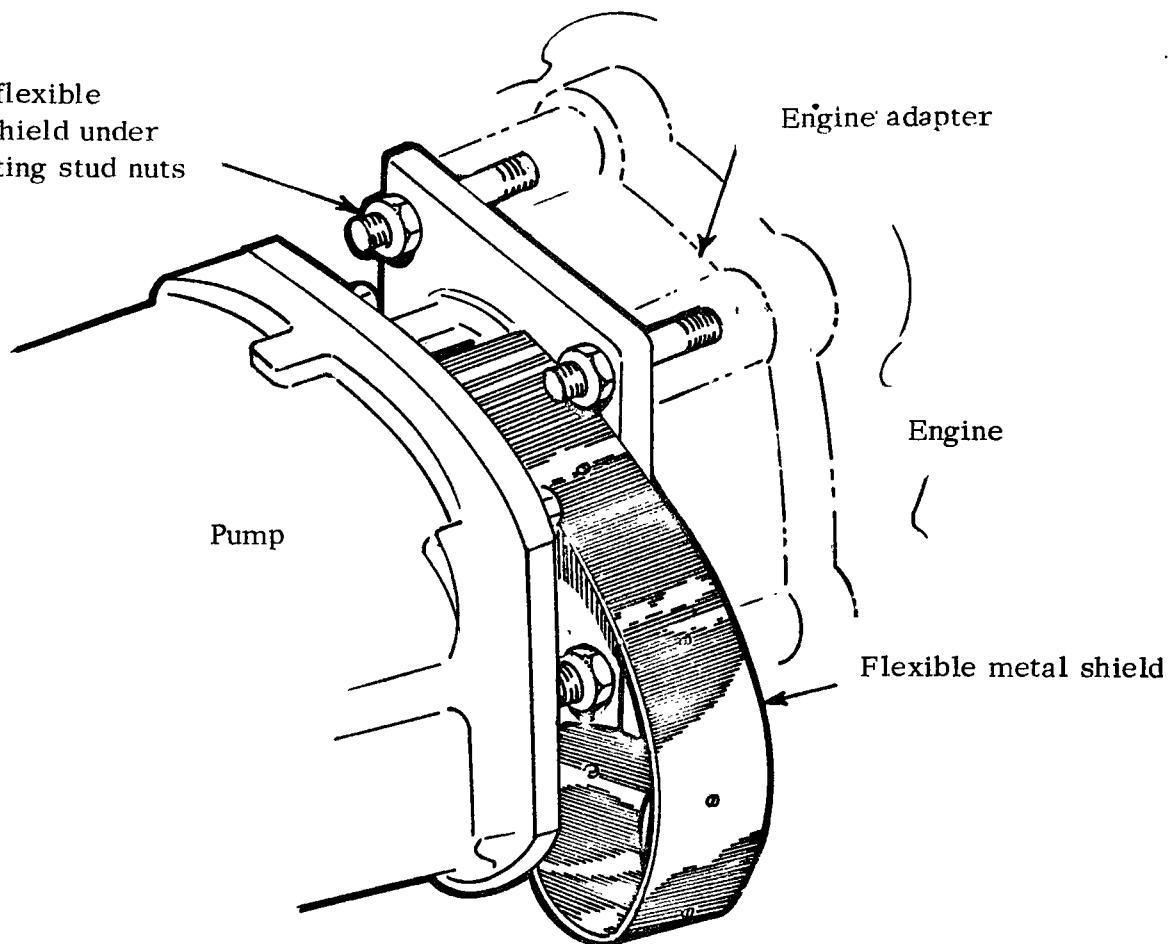
It has been determined that occasionally oil or cleaning solvents have entered the ventholes in the face of the mounting flange of the 113A1 and 113A5 Airborne Mechanisms dry vacuum pump.

A flexible metal shield, part number 756 143, which is easily installed by threading under the pump mounting bolts, has been designed to protect these openings. Removing the pump is not necessary and the shield does not require fastening as the spring tension of the shield will hold it in its proper position, once installed. Installation of this shield is recommended on the subject aircraft equipped with Airborne Mechanisms Dry Vacuum Pumps. See sketch on the reverse side of this letter.

Install flexible
metal shield under
4 mounting stud nuts

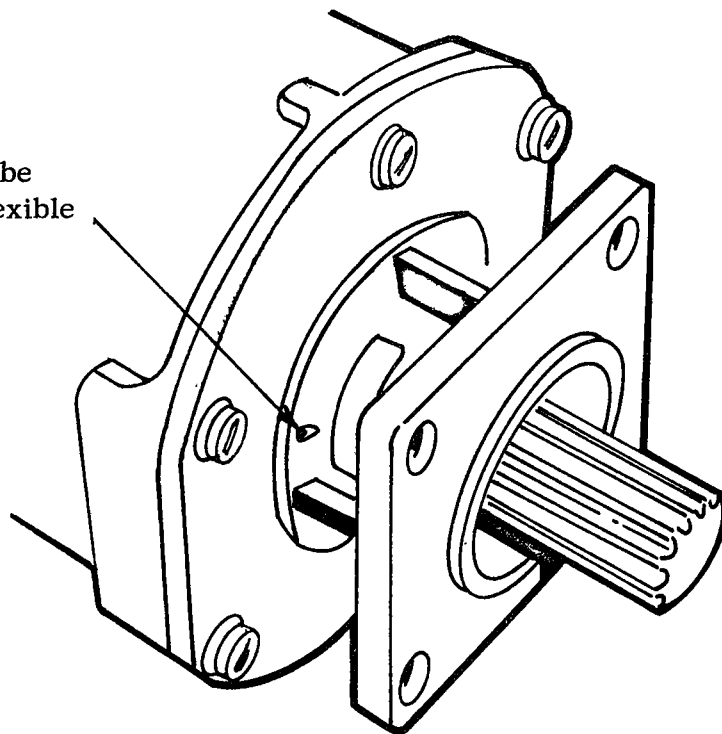
Vent holes to be
covered by flexible
metal shield
