Piper Aircraft Corporation

SERVICE LETTER

No. 648

Battery Ground Inspection and Modification

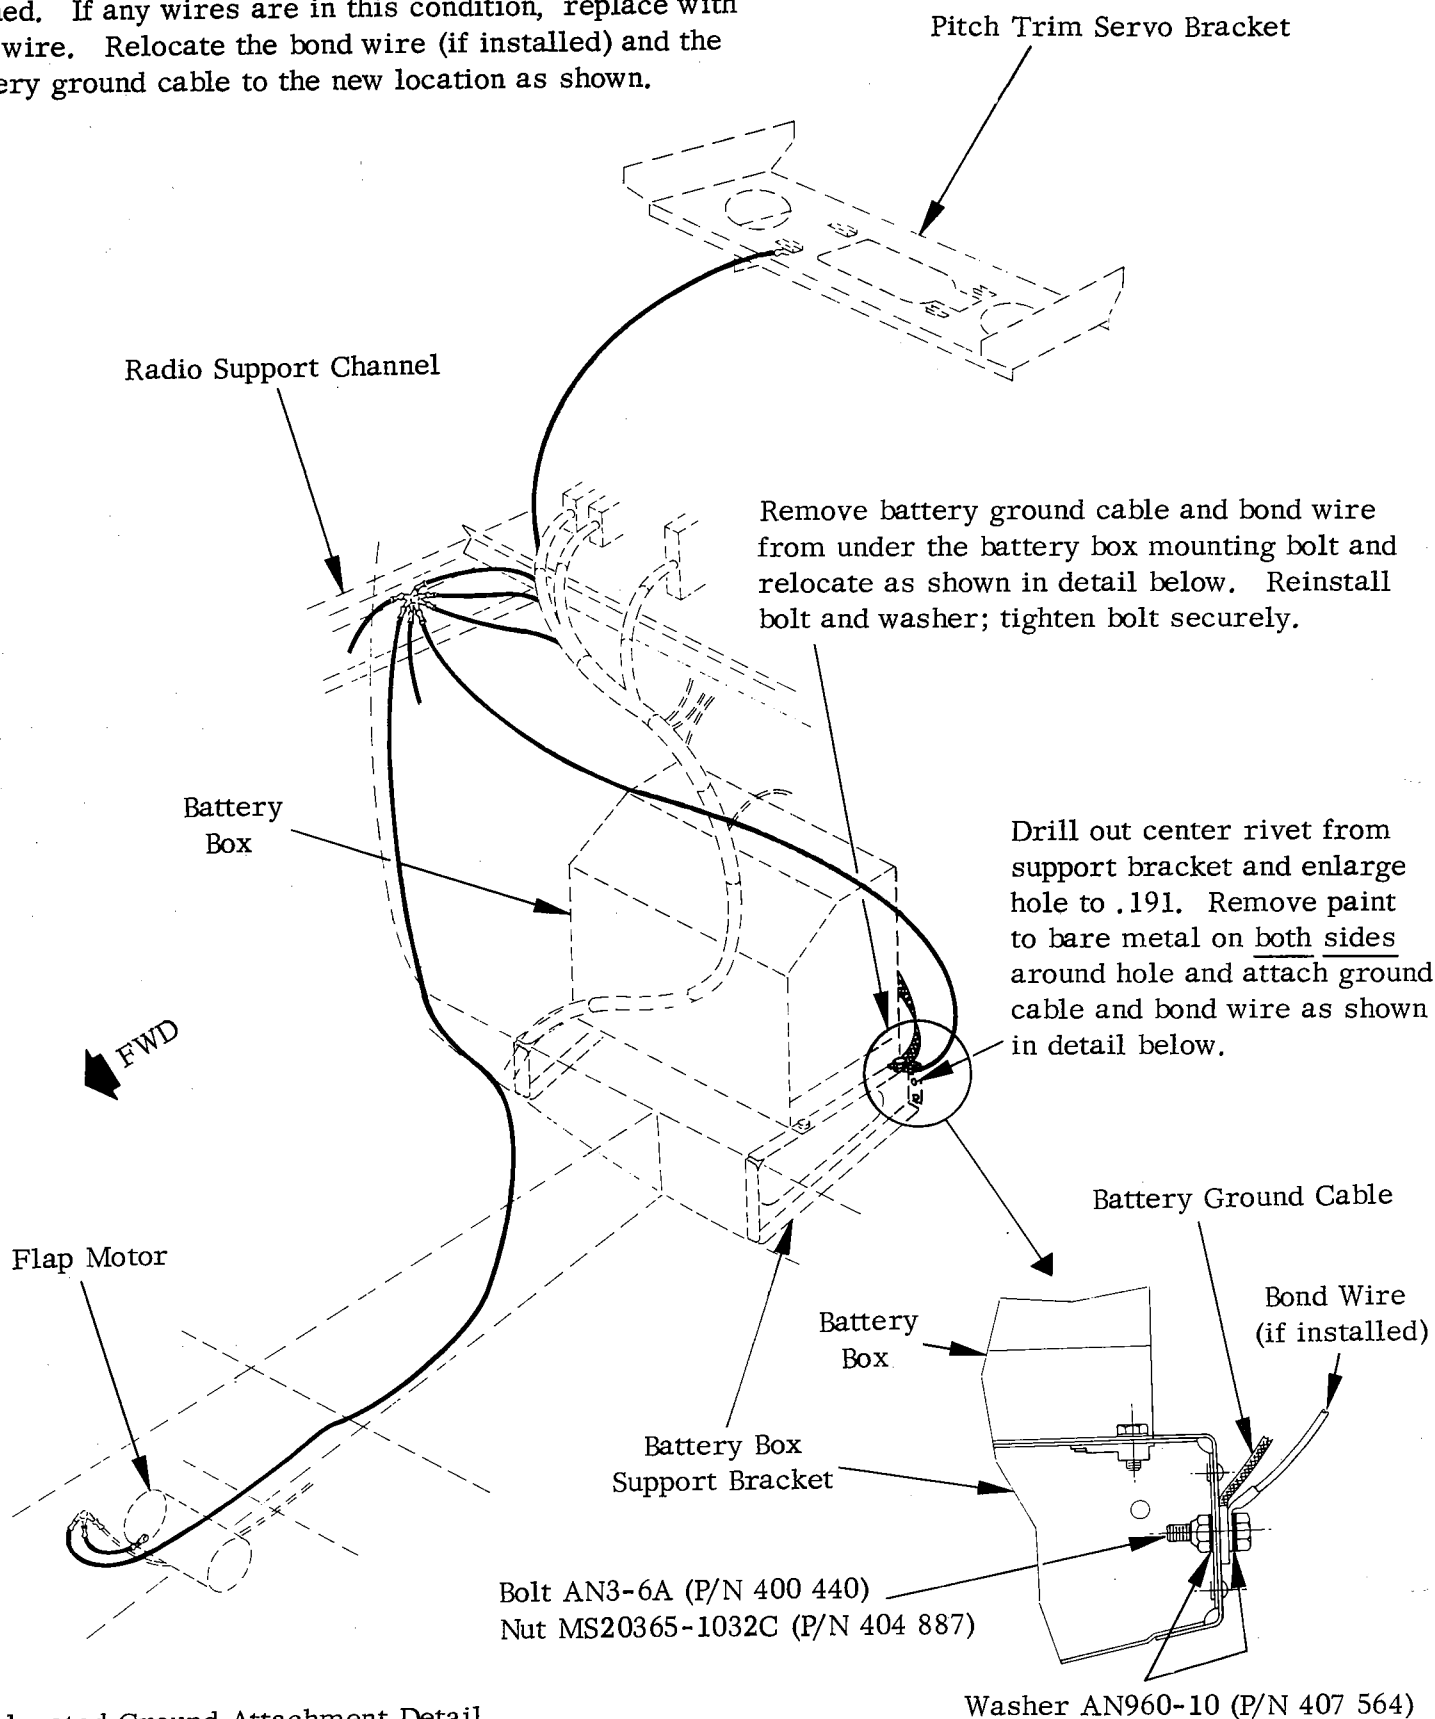
A field report has been received describing damaged electrical wiring in the battery area -- in the form of scorched or burned wires. This condition was attributed to improper attachment security of the battery ground strap and bonding wire (if installed) to the battery box mounting bolt.

Inspect all wires (indicated by solid lines) in the battery area for the possibility of any wires being scorched or burned. If any wires are in this condition, replace with new wire. Relocate the bond wire (if installed) and the battery ground cable to the new location as shown.
