Service Letter No. 347

SUBJECT: Installation of Dry Vacuum Pump Exhaust Tube

MODELS AFFECTED: PA-24 and PA-24-250 Comanches - Serial Nos. 24-2176, 24-2177, 24-2179 to 24-2184 inclusive, 24-2186 to 24-2202 inclusive, 24-2204 to 24-2218 inclusive and 24-2222.

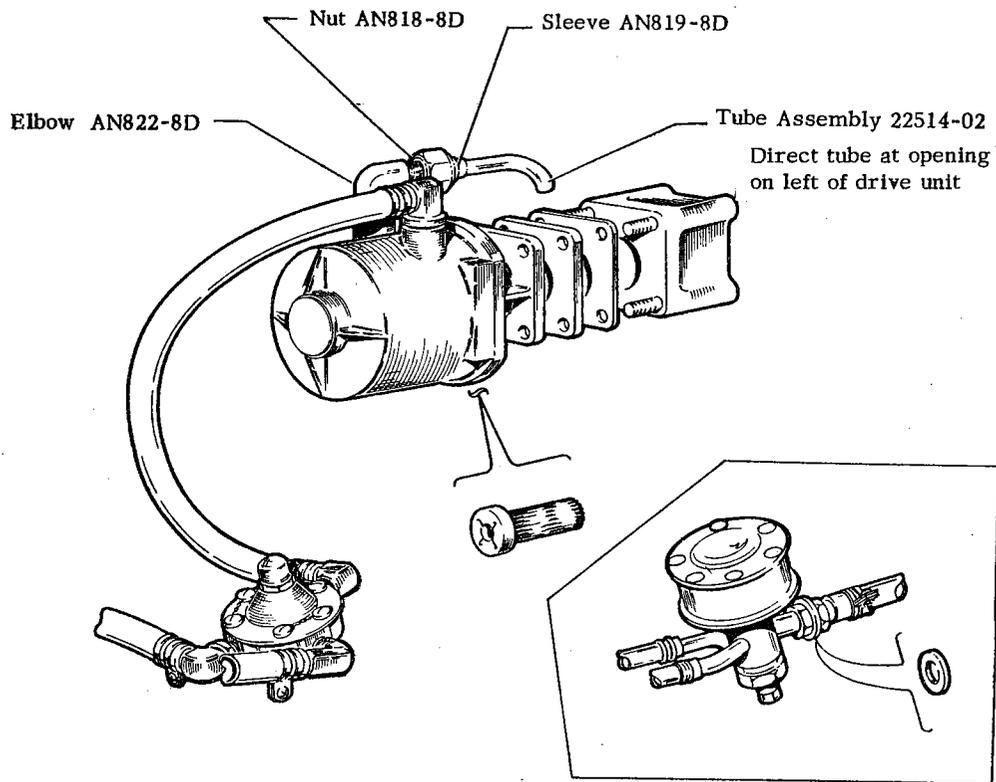
We have been advised that during maintenance operations, where cleaning solvents are used to wash the engine and engine components, these solvents in a few instances have found their way into the vacuum pump via the exhaust vent on top of the pump. The introduction of this fluid to the pump has resulted in its malfunction. In order to prevent this fluid from entering the pump, an exhaust tube shall be installed.

The subject aircraft shall be modified by the installation of Kit No. 754 358. The sketch on the reverse side may be referred to for further details.

NOTE

Remove cap and fitting
supplied with pump and
replace with AN822-8D
elbow and tube assembly
