Service Letter No. 415

SUBJECT: Sealing of the Nose Wheel Well

MODELS AFFECTED: PA-30 Twin Comanches, Serials 30-1 to 30-205 inclusive

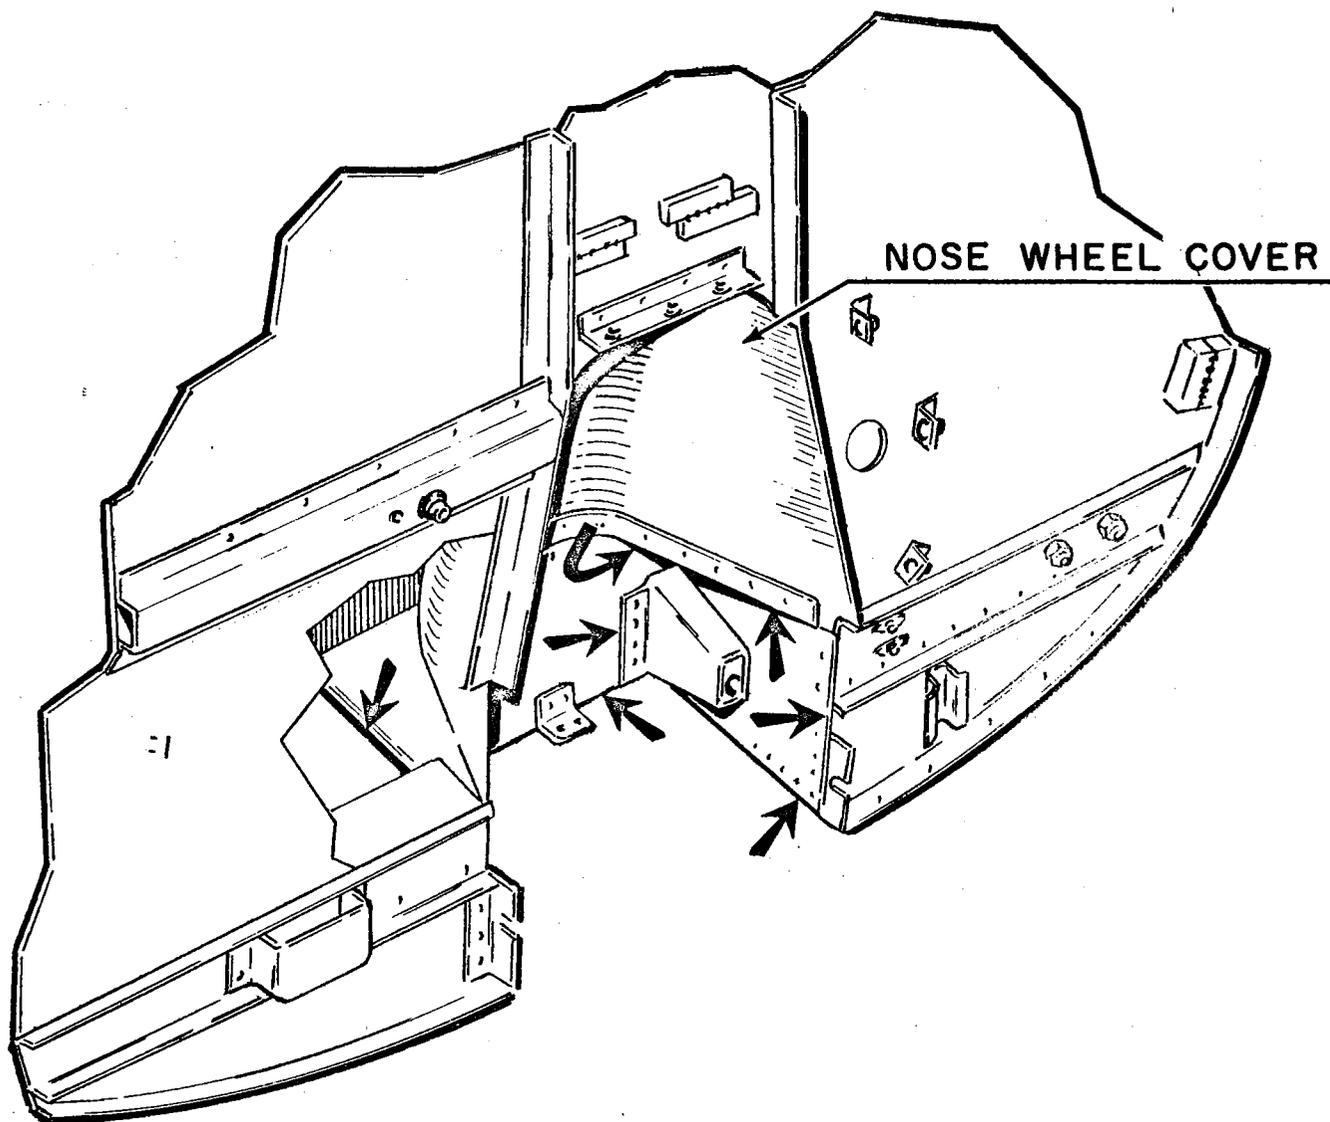
Service letter No. 415

Reports have been received of moisture entering the fuselage area occupied by the circuit breakers causing the circuit breakers to trip.

To eliminate this problem, additional sealing of the seams in the nose wheel well will be necessary in those aircraft indicated by the serial numbers listed above. Permagum Bead #576 and shellac or an equivalent method of sealing should be used. Please refer to sketch on the reverse side of this letter which indicates the areas affected.

➔ SEAL THESE JOINTS WITH PERMAGUM BEAD # 576 & SHELLAC OR EQUIVALENT.
