Piper Aircraft Corporation
Lock Haven, Pennsylvania, U.S.A.

SERVICE BULLETIN

No. 224

SUBJECT: Mitchell Bulletin No. A55 — Modification of Pitch Servo

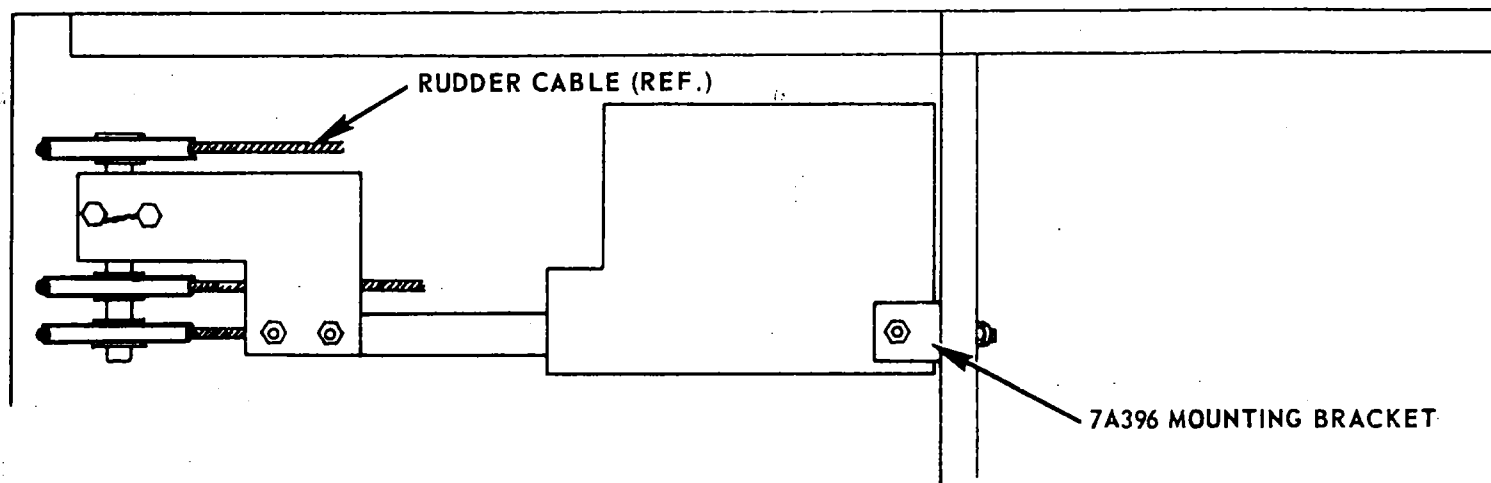
SERVICE BULLETIN
No. 224

There have been several reports of interference occurring between the pitch servo rack assembly and the screw heads of the AN510-10R16 screws that attach the forward end of the servo to the forward mounting bracket. These screw heads should be inspected to be sure they are flush.

Cable must have upward deflection
of 1/16" thru full travel of rack assy.

If the screws are not flush, then the pitch servo spacer block, part number 25422 should be removed and the two (2) holes increased to 1/4" diameter. Any subsequent installation should have the holes in the pitch servo block, part number 25422, drilled to 1/4" before it is installed.

Install this bracket so the upper portion of
the fairlead contacts the top of the cable.
Use shim washers between skin and bracket
to prevent cable deflection of more than 1/8
inch from its normal position.
