SERVICE No. 496 BULLETIN

Piper Aircraft Corporation

Stabilator Balance Weight Tube Replacement.

PA-24-250 Comanche

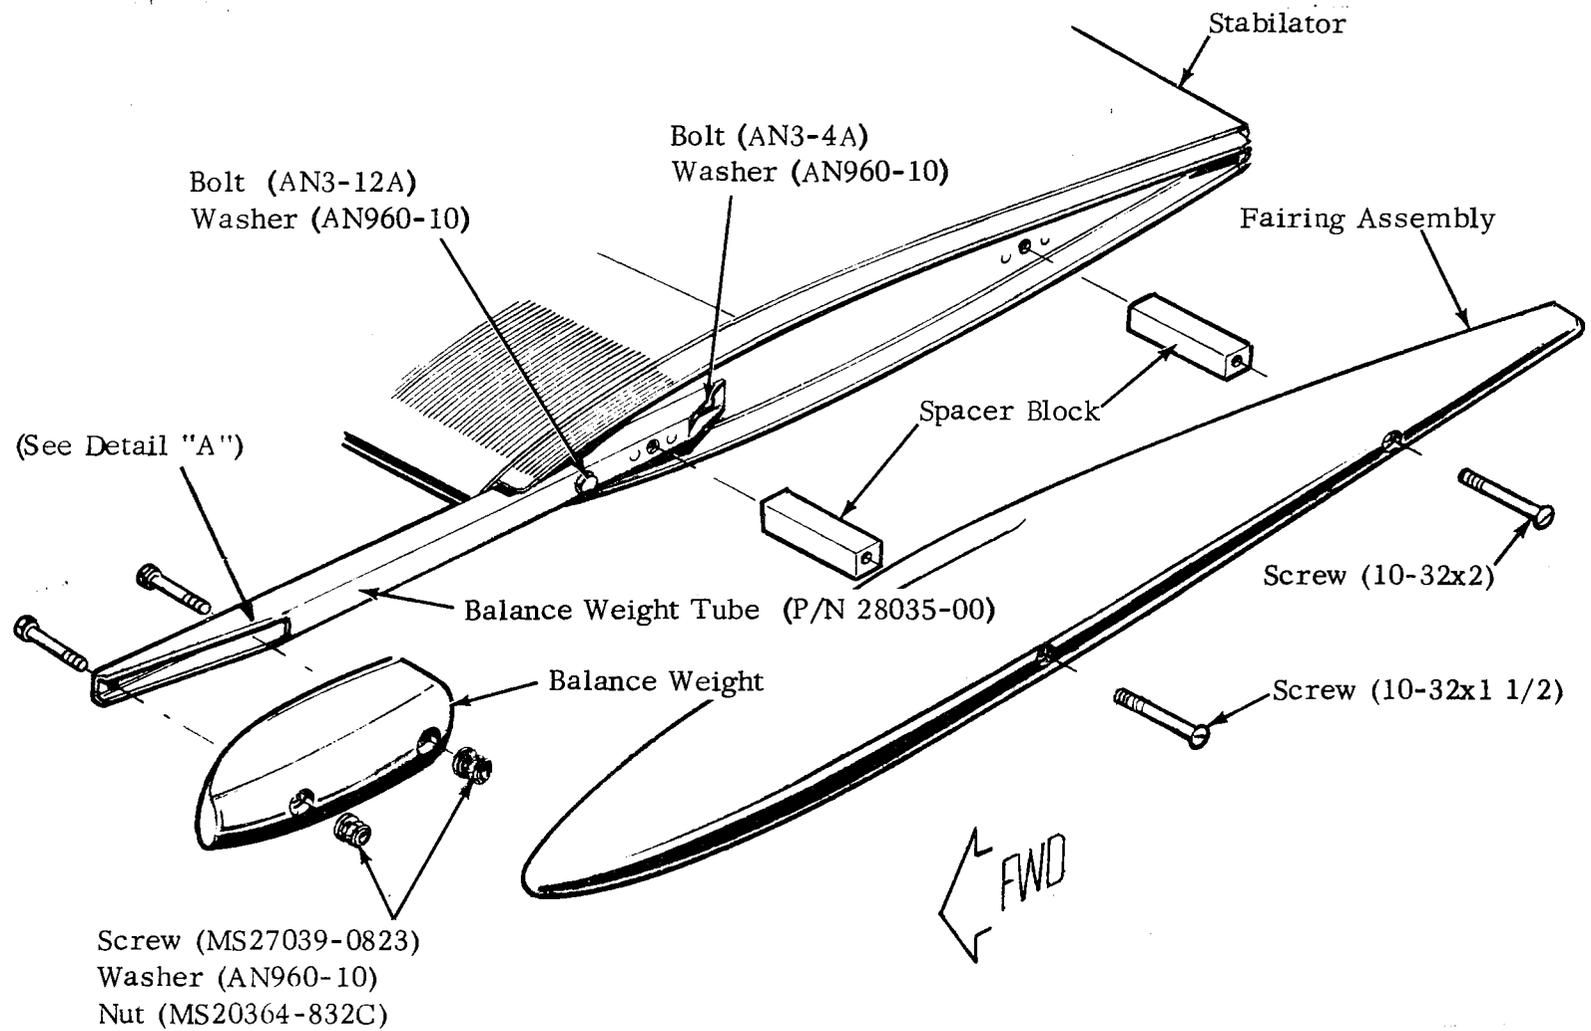
Detail "A" :

Piper Service Letter No. 687 dated June 19, 1974, announced the availability of Stabilator Modification Kit Piper Part Number 760 747 for the above referenced aircraft. Recent factory testing indicates that cracks may develop in the stabilator balance weight tube assembly (part number 28035-00, supplied with the above referenced modification kit) in the corners of the balance weight cutout.

Previous Tube - "squared" corners

New Tube - rounded cutout

1. Remove fairing assembly and balance weight from left and right stabilators.
2. Remove existing balance weight tubes and install new tubes P/N 28035-00.
Torque bolts to 20-25 inch pounds.
3. Reinstall balance weight and torque screws to 7-9 inch pounds.
4. Reinstall fairing assembly.
5. Make appropriate log book entry.
