VSP-33  
December 18, 1981

VENDOR SERVICE PUBLICATION

To: All Piper Distributors and CORPAC's  
Subject: Bendix Service Bulletins 611, 616, 617, 619

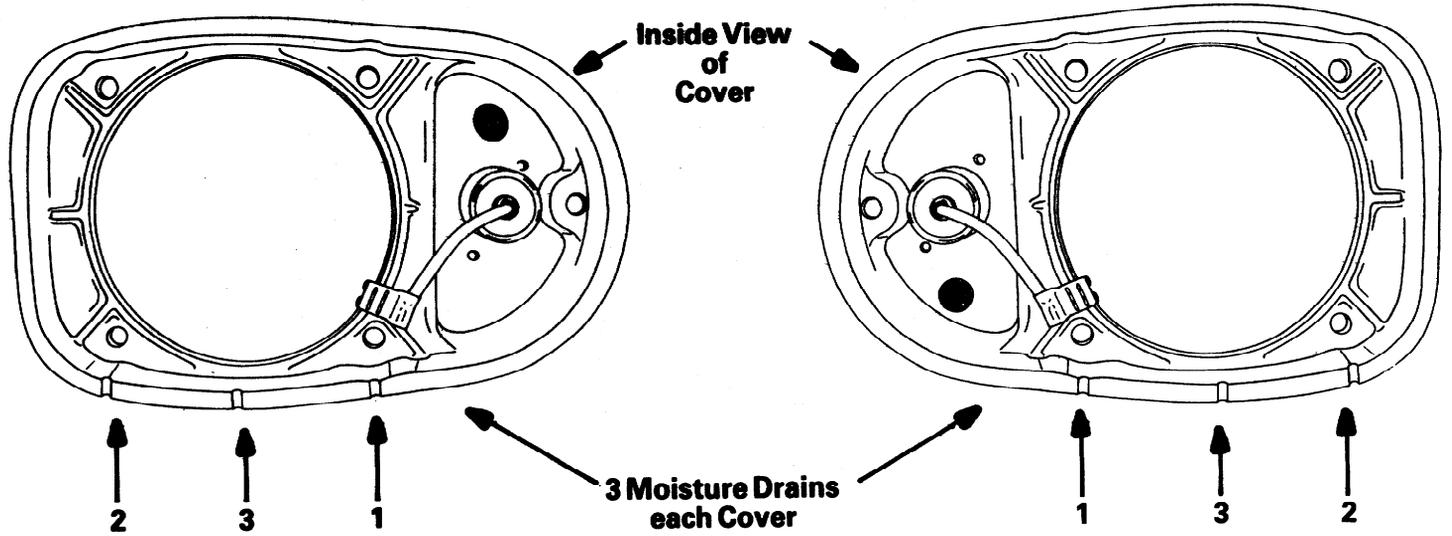
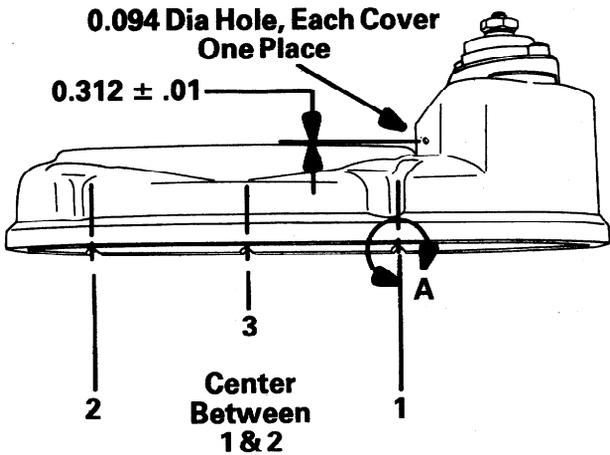
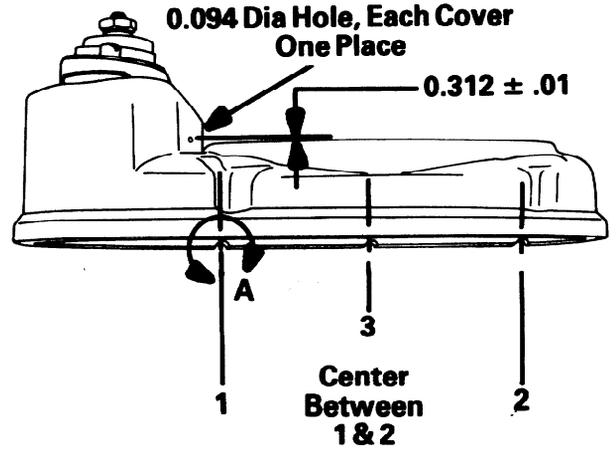
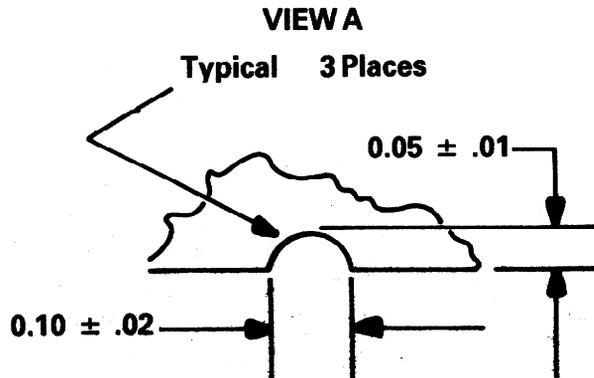
**Figure 1. Location of Drain Holes**

Field reports indicate that some operators of Teledyne Continental Engines of the 470 and 520 series are experiencing water ingestion in the S-1200

Series Magnetos. This moisture contamination may cause ignition difficulties, resulting in possible engine roughness. The addition of moisture drains and sealing of the screen vent in the magneto cover will provide a means for drainage of accumulated moisture and prevent moisture from entering the magneto through the screen vent.

1. Remove the magneto cover by removing the ignition harness adapter plate from each magneto and then removing the magneto cover securing screw. Pull the magneto cover away from the magneto and carefully pull the capacitor, and retard lead, if used, from the breaker flag terminal(s).
2. Using Figure 1 as a guide, lay out the positions for the moisture drains. Positions 1 and 2 are in line with the stud holes in the cover and position 3 is centered between 1 and 2. Using a small round file, create the three hemispherical recesses as detailed in view A, figure 1.

The moisture drains must be on the lower side of each cover when it is reinstalled on its related magneto assembly on the engine.

3. Lay out the position for drilling a 0.094 in.  $\pm$  0.005 in. hole in the center of the ledge area of the covers and drill one hole in each cover using a 3/32" or No. 42 drill, as shown in Figure 1.

Do not allow the drill to penetrate through the cover and hit the housing of the capacitor which is directly in line with the hole being drilled. Mask drill bit for maximum allowable depth (1/4 in.).

4. Remove any burrs left during the filing and drilling operations on the covers and clean the covers of any metal shavings. Apply a thin coat of black enamel to the bare metal exposed during the filing of the moisture drains. Avoid getting paint on the adjacent cover-to-magneto mounting surface.

5. With a putty knife, spatula or similar tool, apply a sufficient amount of sealant to the outside of the vent screen to fill the vent screen recess flush with the adjacent cover surface. Acceptable sealants are listed below:
  - a. Dow Corning Sealant No. 3145
  - b. Permatex No. 1
  - c. Hi-Sol Epoxy Patch, Kit 1C
  - d. G.E. Silicone Sealant (Automotive type)

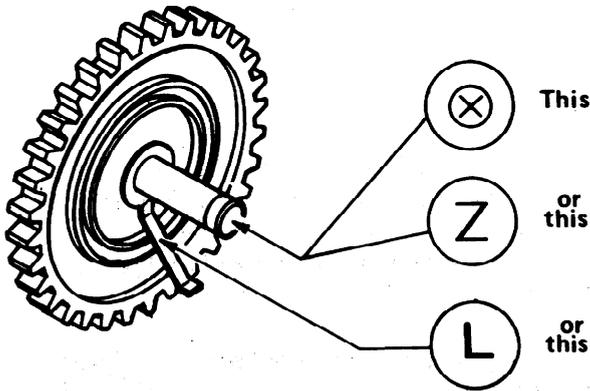
Figure 2. Location of Identification Mark(s)  
on Distributor Gear

Field reports indicate that the distributor gear electrode has been found to be loose on some D-2000/2200 series magnetos. If this condition exists, the distributor gear electrode may contact the distributor block stationary electrodes causing contamination in the distributor in the form of dusty brass particles. This contamination may cause arcing within the distributor resulting in misfiring. This could in turn cause rough engine operation or cylinder or engine damage.

1. Remove cover from magneto and inspect the retaining ring end of the distributor gear axles for the letter "z" or the letters "x" and "o". (The letter "x" may or may not be circled by the letter "o".) If the letter "z" or the letters "x" and "o" together are laser etched on the end of the axles, the gears are serviceable and the cover can be reinstalled. Identify the magneto per

3. Inspect the block for serviceability and replace any block found to be unserviceable.
4. Clean and inspect each gear. If the gear is part of an insulated gear kit (identifiable by the presence of a nylon insulating washer on the gear axle between the gear and the block) inspect for the presence of the letter "L" on the electrode (see figure 2). If "L" is stamped on the electrode, the gear is serviceable and can be reinstalled. If "L" is not present, the gear must be replaced with serviceable gear, P/N 10-682014 for 4 or 8 cylinder magnetos or P/N 10-682016 for 6 cylinder magnetos.

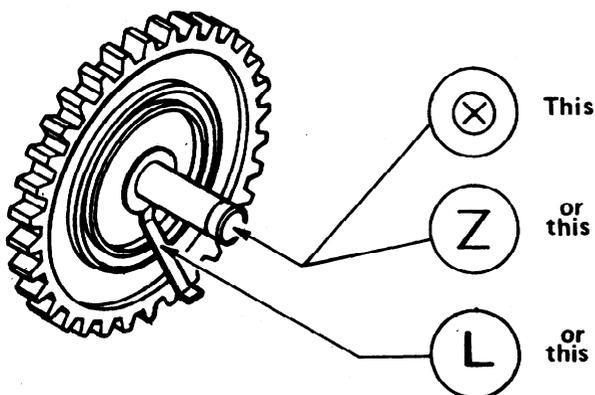
Figure 2. Location of Identification Mark(s) on Distributor Gear

contact the distributor block stationary electrodes causing contamination in the distributor in the form of dusty brass particles. This contamination may cause arcing within the distributor resulting in mis-firing. This could in turn cause rough engine operation or cylinder or engine damage. In order to preclude the possibility of service difficulties, the distributor gears of all affected D-3000 and D-3200 magnetos must be replaced.

The distributor gear electrode has come loose in service on some D-3200 Series Magnetos. If this condition exists, the distributor gear electrode may

5. Reassemble the distributor block with new serviceable gears. Serviceable gears are identified by the presence of the letter "z" or the letters "x" and "o" together, laser etched on the retaining ring end of the gear axle, or the letter "L" stamped on the electrode (see figure 2).
