SERVICE LETTER

No. 650

Piper Aircraft Corporation

Inspection of Landing Gear Retraction and Flap Control
Transmission Assemblies

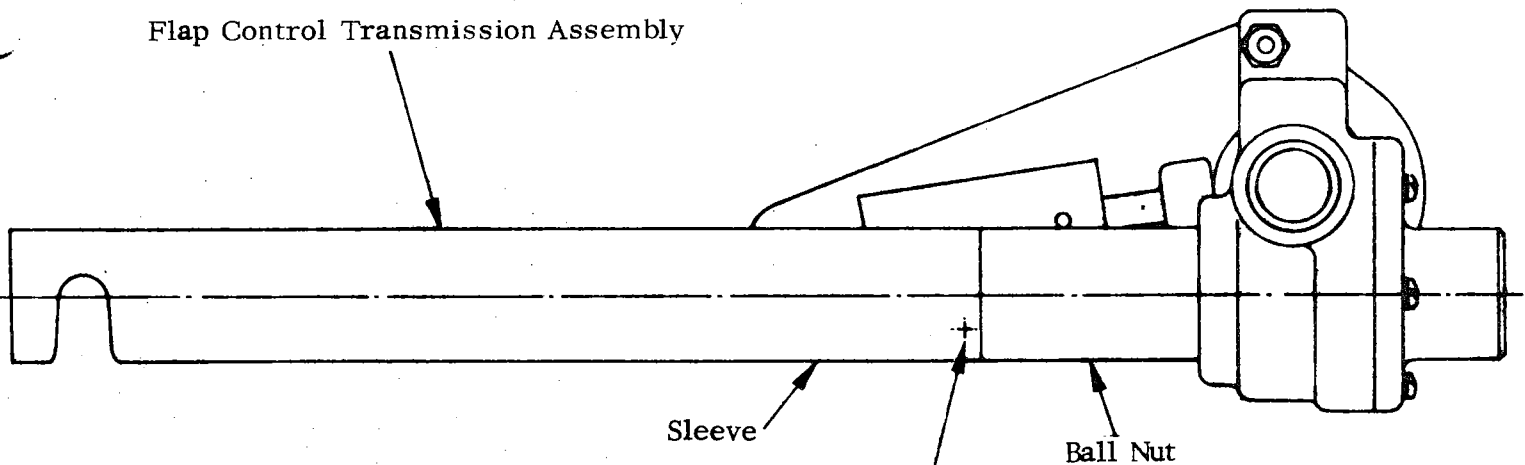
Flap Control Transmission Assembly

Sleeve must be staked at three points
(on circumference of sleeve) to prevent
separation of threaded joint.

1. Refer to the appropriate Service Manual and gain access to the flap control transmission (if installed) and the landing gear retraction transmission.
2. Inspect transmissions to determine if sleeve has been properly staked as shown on above sketch.
3. If the transmission sleeves have been properly staked, no further action is required.
4. If either of the transmission sleeves have not been staked, it will be necessary to remove the transmission from the airplane and stake as shown (sleeve must be tight against ball nut before staking). Use a center punch and carefully stake to a depth of .030 to .040 inches. Refer to the appropriate Service Manual for proper Removal and Installation Procedures.

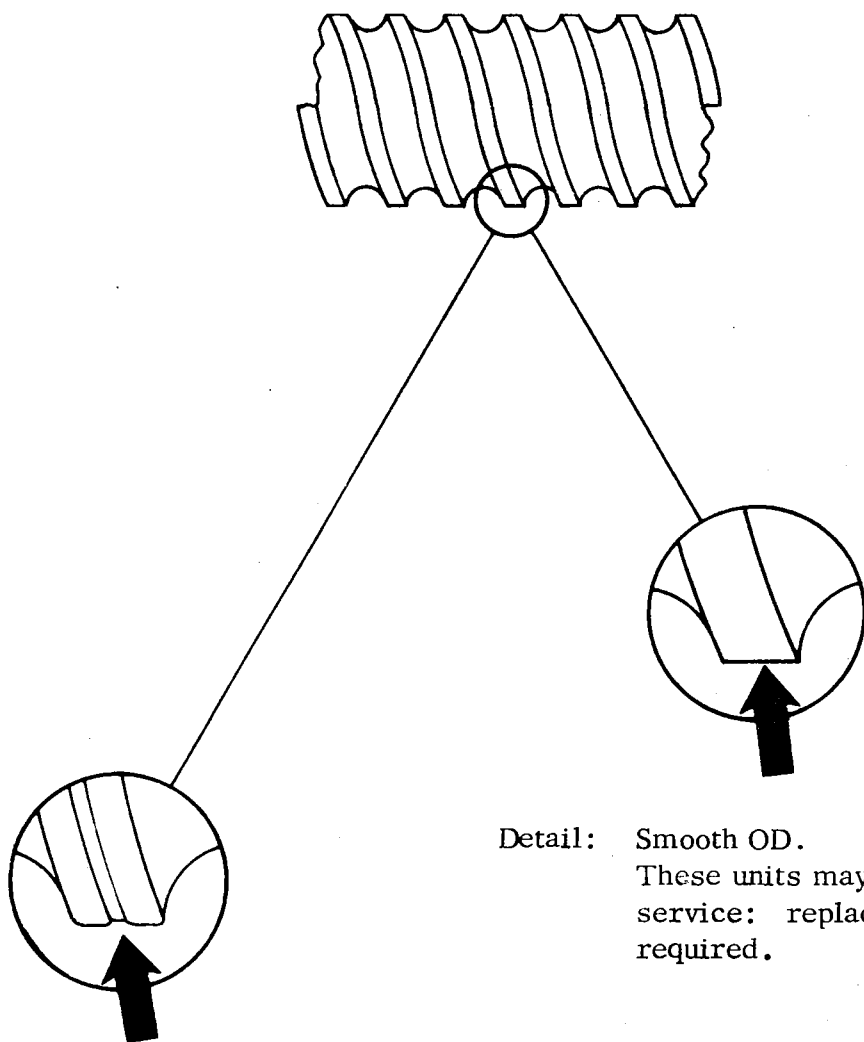
- REFERENCE SERVICE LETTER NO. 650: Purpose II
Identification of Transmission Ball Screw;
Transmission serial numbers 919 thru 1068 inclusive.

Detail: Smooth OD.
These units may remain in
service: replacement not
required.

Detail: Grooved OD.
These units must be replaced.

1. Expose the threaded ball screw portion of the transmission assembly to view.
2. With a magnifying glass, inspect the threads as specified on the sketch on the reverse side of this communication.
3. Refer to the "detailed" call-outs on the sketch to determine whether the transmission assembly must be replaced.
4. Refer to the balance of Piper Service Letter No. 650 for replacement material identification data.
