Service Letter Number 426

SUBJECT: Crankshaft Propeller Flange Inspection, per Lycoming Service Bulletin No. 300 and

DATE: November 2, 1964

SUBJECT: Crankshaft Propeller Flange Inspection

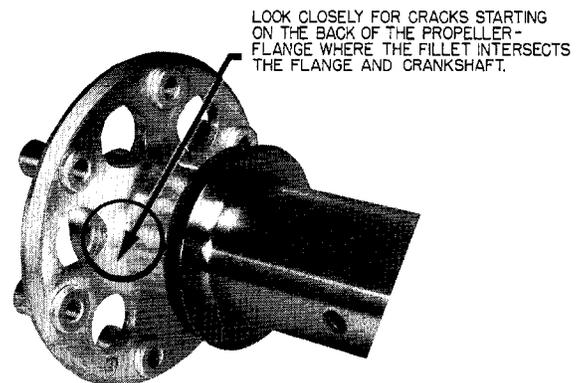
a. Remove the propeller and starter ring gear from the mounting flange of the engine and examine the entire area of the crankshaft flange from the crankshaft seal forward for evidence of cracks. Use a magnifying glass of approximately 10 power and adequate lighting for this purpose or portable magnetic particle test equipment. Pay particular attention to the flange area and fillet radius on rear face of propeller flange. See accompanying illustrations for possible location of where cracks might appear and type of structural damage which can occur. Because of machining marks, the factory does not recommend using dye penetrant for this inspection. Further flight with a cracked propeller flange is not permissible.

Figure 1. Rear View of Propeller Mounting Flange Showing Area of Lightening Holes.

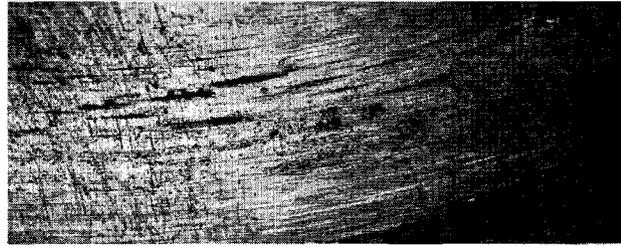
a. During magnetic particle inspection, particular care should be taken to examine the propeller flange area in the large fillet radius tangent to the crankshaft in addition to the normal flange and shaft areas for possible cracks or other evidence which indicates bending.

Figure 2. 10X magnified view showing appearance of area cracked due to abnormal loading imposed on the propeller flange during periods of unauthorized maneuvers.

b. Report immediately to the factory any crankshafts which fail to meet inspection standards in this area.

c. Crankshafts which conform to inspection standards at first overhaul can be returned to service.
