VSP-37
July 7, 1982

VENDOR SERVICE PUBLICATION

Subject: Bendix Service Bulletins 615, 620, 621

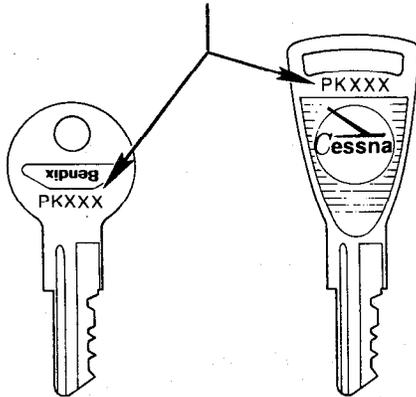
Figure 1

NOTE: The key PK number is located on the key as indicated in figure 1.

Key PK number stamped in this area.

Have to remove black rubber from top of key to expose the PK number.

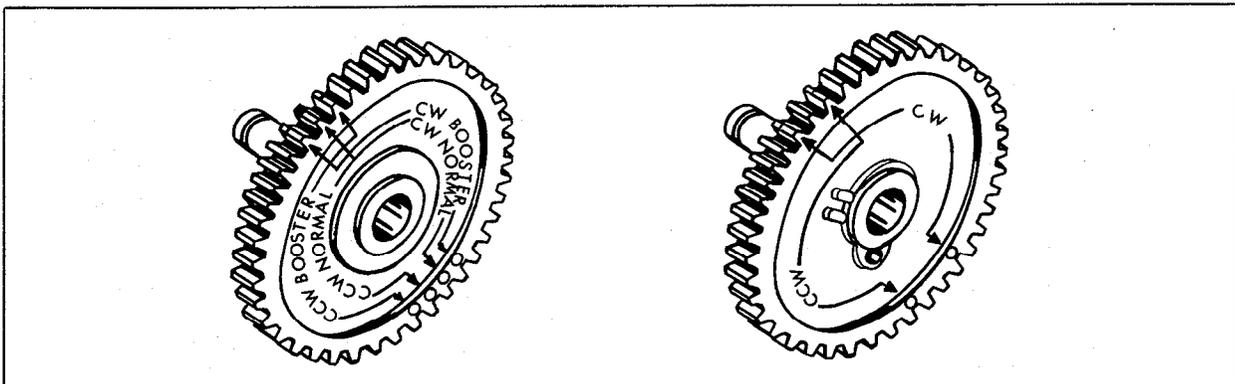
Figure 1. 10-157197 Distributor Gears with Different Timing Marks

2. If old distributor gear, P/N 10-157197, which incorporated two different molded timing identification marks was used (see figure 1), proceed as follows:

- a. Remove paint from booster timing positions with suitable solvent.
- b. Locate normal timing tooth between CW and CCW booster chamfered teeth and paint this tooth and the applicable inner timing mark with red Dykem or red lacquer in accordance with figure 2 or figure 4 for appropriate gear.

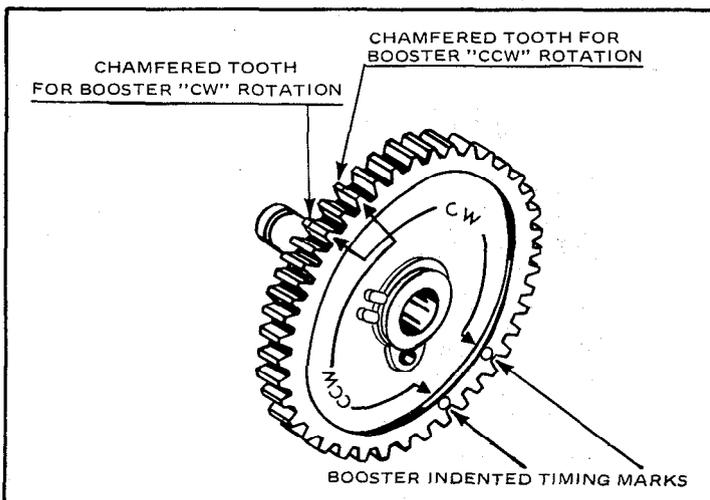
Figure 3. Timing Marks on Present Production Distributor Gear Kit Assembly 10-357586

3. If present production distributor gear as supplied in kit P/N 10-357586 is used (see figure 3) proceed as follows:
 - a. Remove paint from booster timing positions with suitable solvent.
 - b. Locate normal timing tooth between CW and CCW booster chamfered teeth and paint this tooth and the applicable inner timing mark with red Dykem or red lacquer in accordance with figure 4.

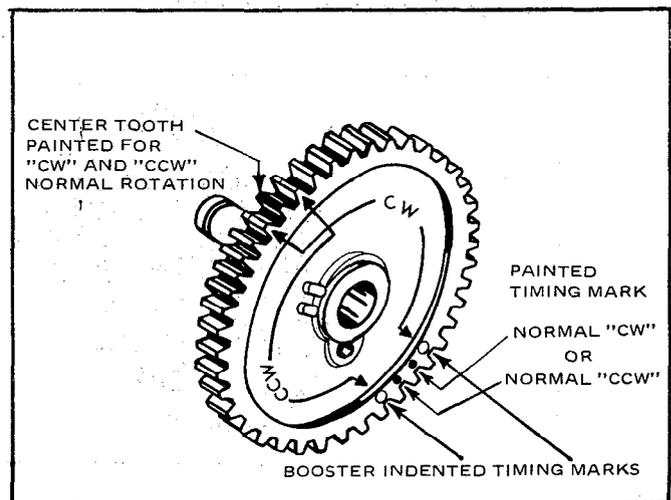
Figure 4. Present Production Distributor Gear Assembly with Additional Timing Marks Painted

The molded timing marks incorporated in new present production nylon spare part gears, as supplied in kit, P/N 10-357586, are for the booster timing position. Before installation of a new gear kit, the applicable normal timing mark and center tooth must be marked with red

Dykem or red lacquer as illustrated in figure 4.

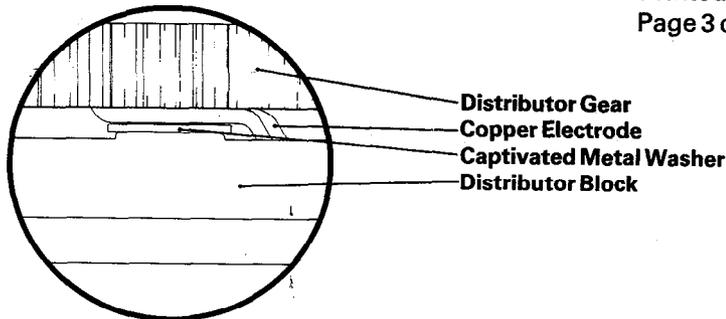
1. Remove the top timing plug.
2. Using a concentrated light beam (a pen light or equivalent) look into the timing hole at the area between the distributor gear and the distributor block parts for existing washer configuration.
3. Current configuration should be as shown in figure 3.
4. Rework magneto whenever configuration is as shown in figure 2.
5. An acceptable configuration is shown in figure 1.

Original Gear Make Up
(Not incorporating insulating or plain steel skid washer.)
Figure 1

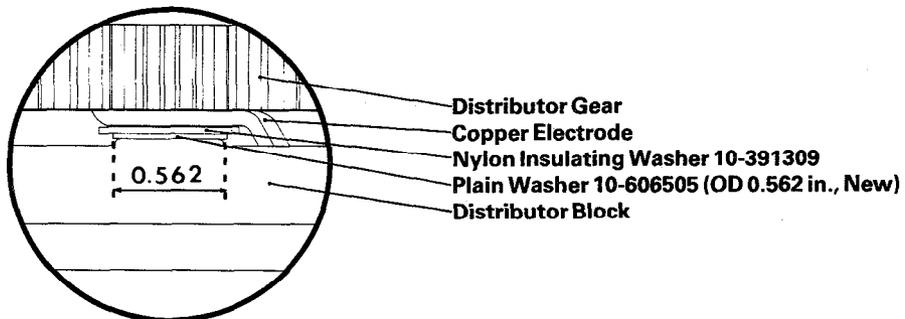
Current Insulated Configuration
(Incorporating 10-357586 Kit parts with correct washer.)
Figure 3
