Service Letter No. 447

March 26, 1965

SUBJECT: Inspection of Landing Gear Transmission Retract Spring

MODELS AFFECTED: All PA-24 Comanche Series and PA-30 Twin Comanche Series Aircraft

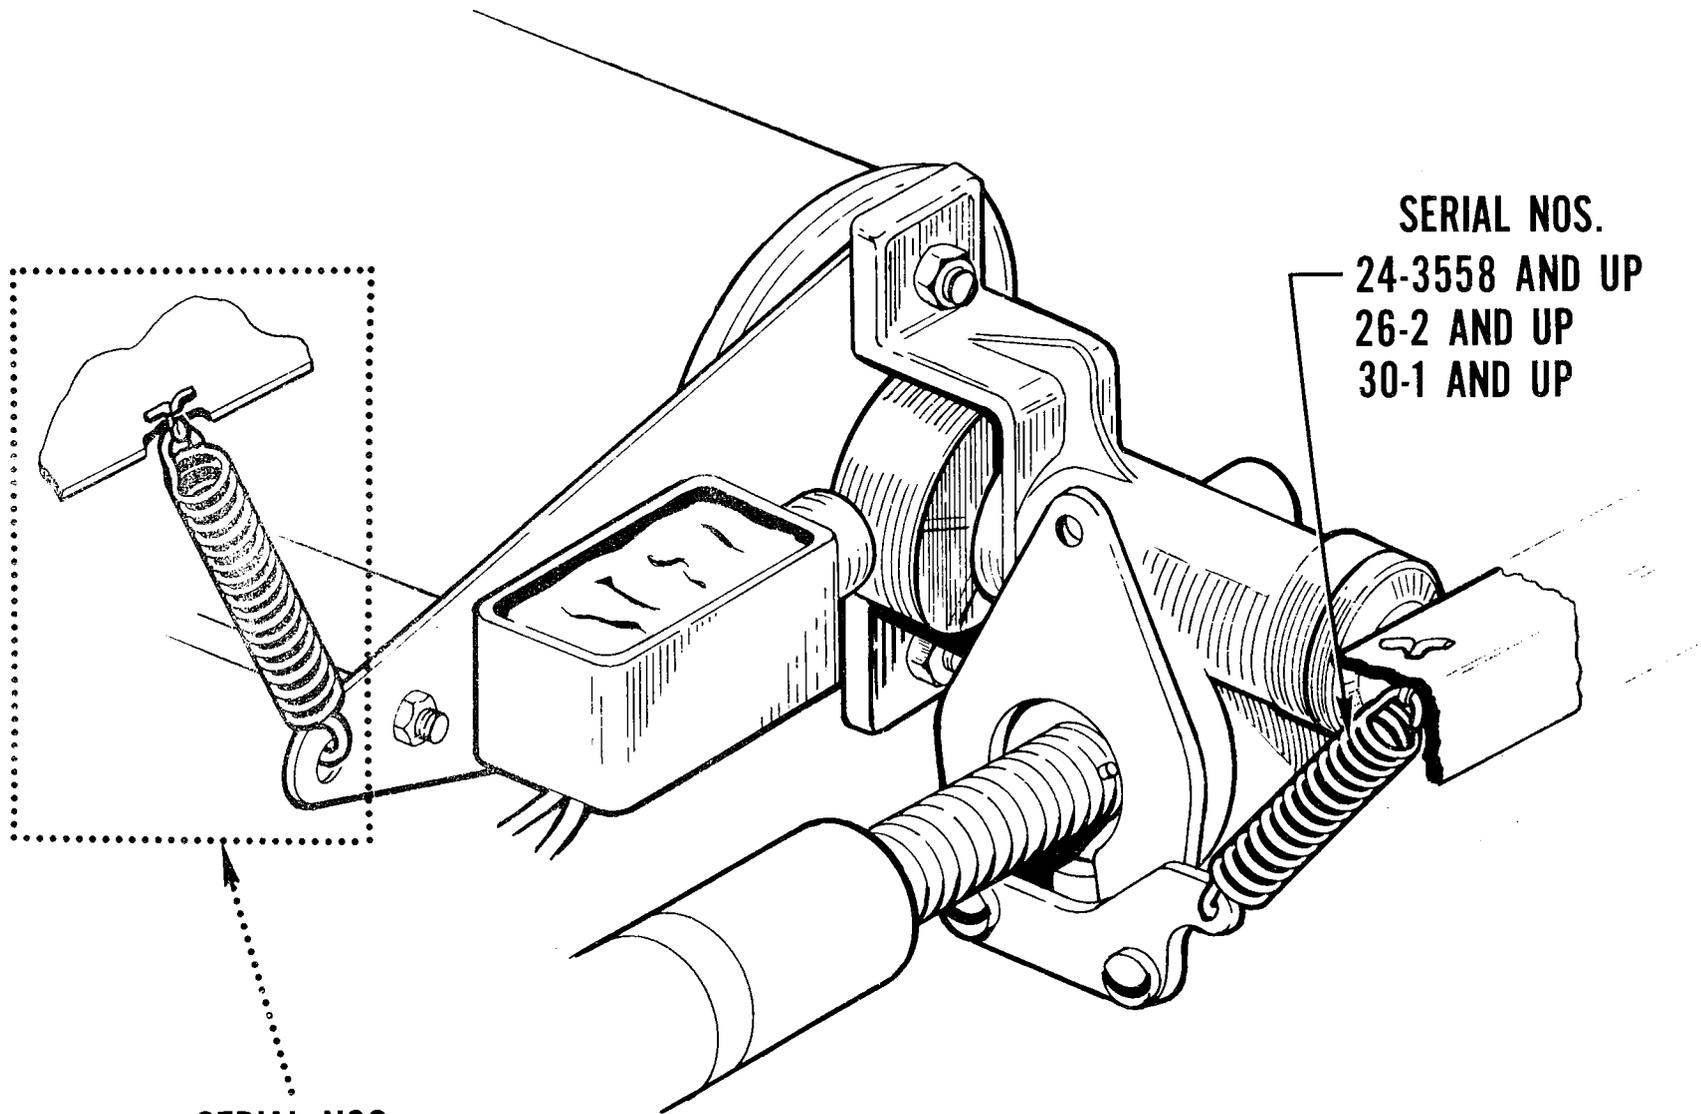
The subject spring is located in the landing gear transmission well and raises the landing gear transmission jack screw to prevent the jack screw from dropping down and interfering with the landing gear mechanism during manual extension of the gear. See sketch on the reverse side of this Service Letter.

SERIAL NOS.
24-3558 AND UP
26-2 AND UP
30-1 AND UP

SERIAL NOS.
24-1 TO 24-3557 INCL.

It is requested that this spring be inspected during routine inspections and, if broken, missing, or not functioning properly, a new spring must be installed.
