SERVICE LETTER

No. 599

Piper Aircraft Corporation

Subject: Wing Panel Exhaust Corrosion Protection

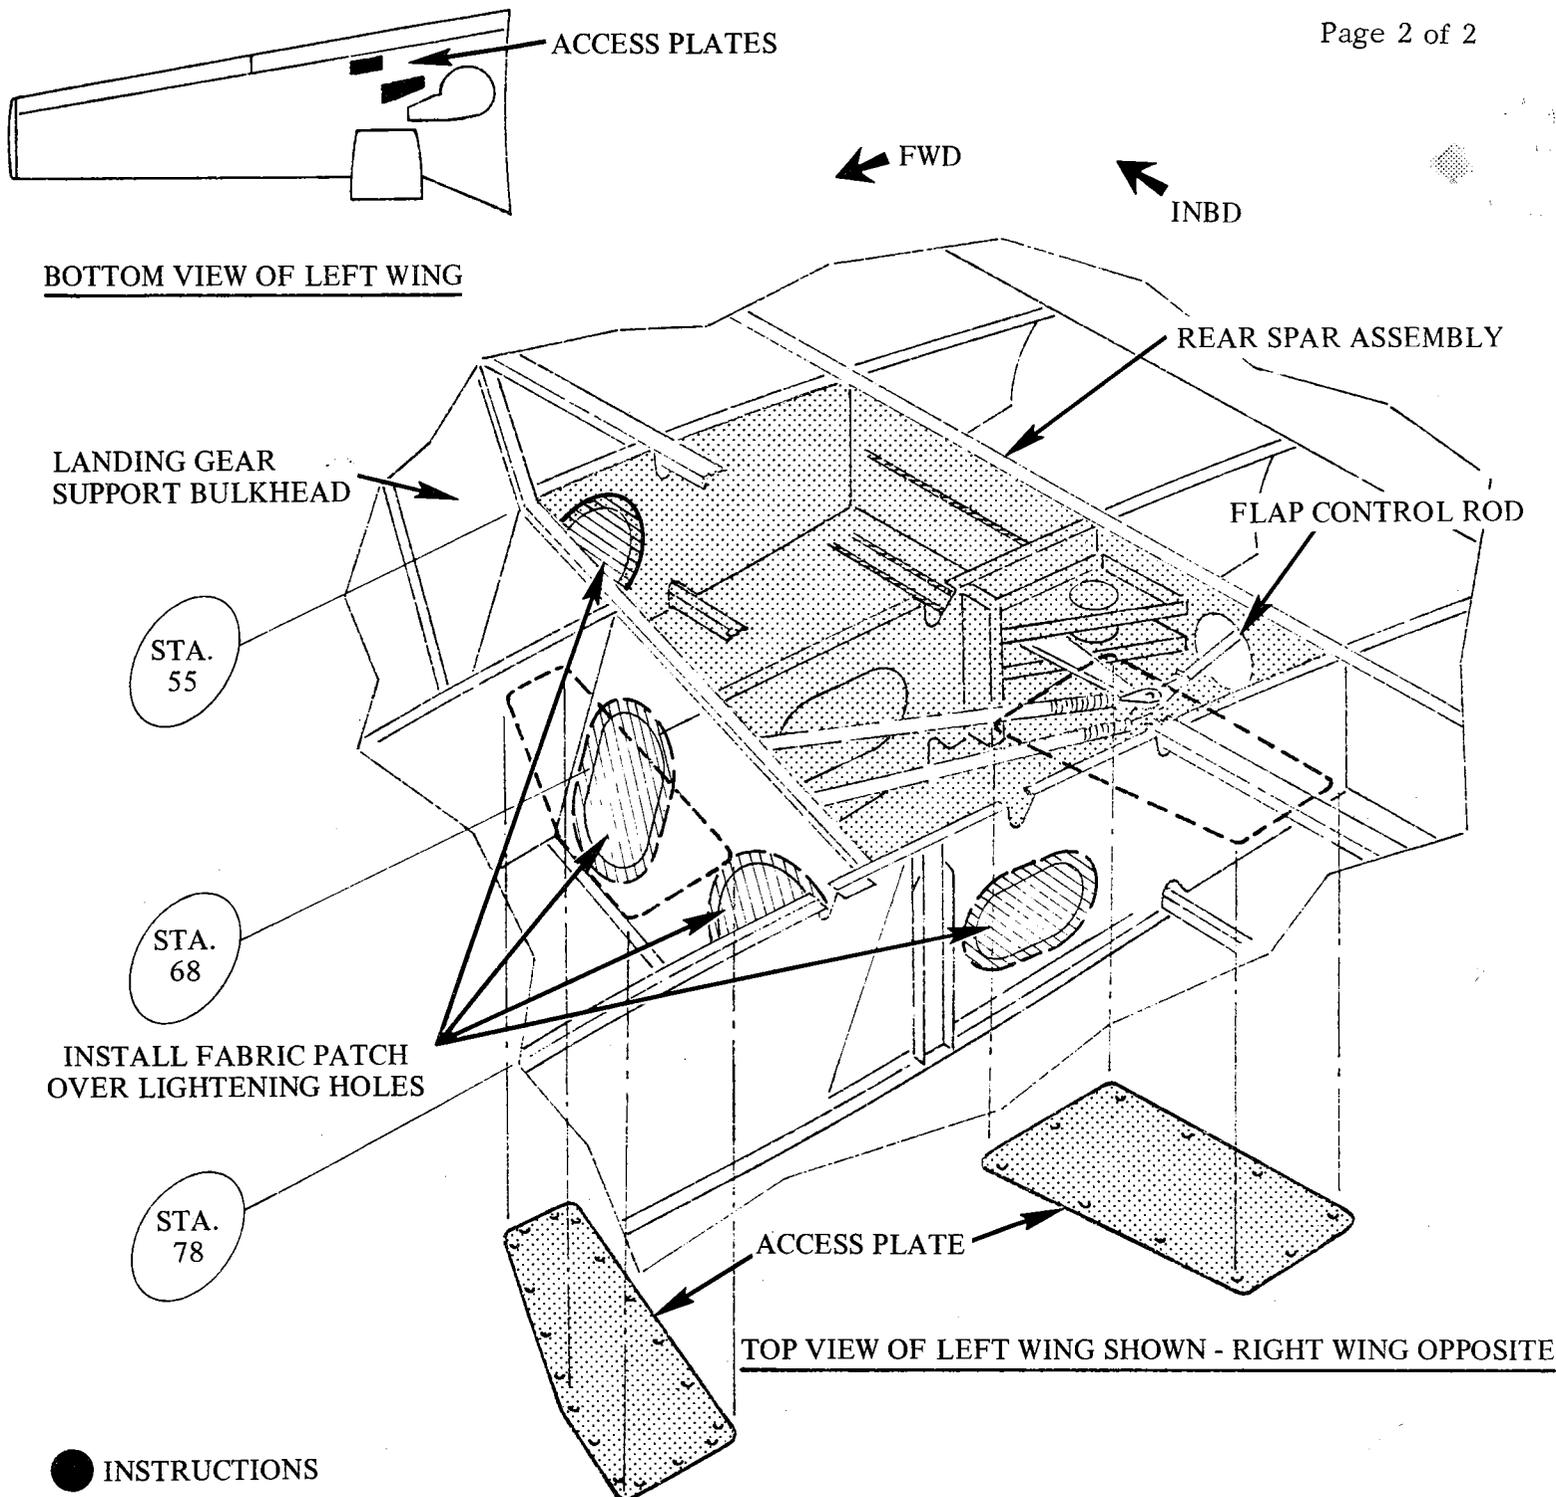
Purpose: Recent product condition reports received from the field describe exhaust corrosion appearing in the right and left wing panel cavity, between wing stations nos. 55 and 78, aft of the landing gear support bulkhead and in front of the rear spar assembly (the sketch on the reverse side of this service letter depicts the location).

1. Remove the two access plates located on the underside of the left and right wing panels as shown.
2. Thoroughly clean all internal surfaces of the left and right wing structure between wing stations 55 and 78, aft of the landing gear support bulkhead to the rear spar assembly removing oil, dirt, exhaust deposits and corrosion. Also clean the internal surfaces of the top and bottom skins and the two access plates. Cleaning procedures should be accomplished in accordance with applicable F.A.A. Regulations contained in AC43.13-1.

3. Seal lightening holes on ribs and bulkhead (refer to sketch) with patches of pre-doped fabric 6-3/8" diameter (Part No. 81232-59). Attach with 3M # EC-847 cement or equivalent.

4. Protect control cables, springs, flap bellcrank and flap control rod from paint buildup by applying tape.
5. Paint all internal area that was cleaned per Step 2 (denoted by shaded area on sketch) with Juneau White Acrylic Lacquer (6 oz. aerosol cans may be secured from Piper Aircraft Corporation under Part No. 754 757).

6. Remove masking tape from parts that were covered.
7. Apply a 1/8" bead of 3M Black Sealant # 1126 around the edge of the forward access plate and install. Apply Permagum Bead # 576 around the edge of the aft access plate, shellac the bead and install plate.
