PIPER

SERVICE LETTER

No. 574

Subject: Revision to Emergency Gear Check List

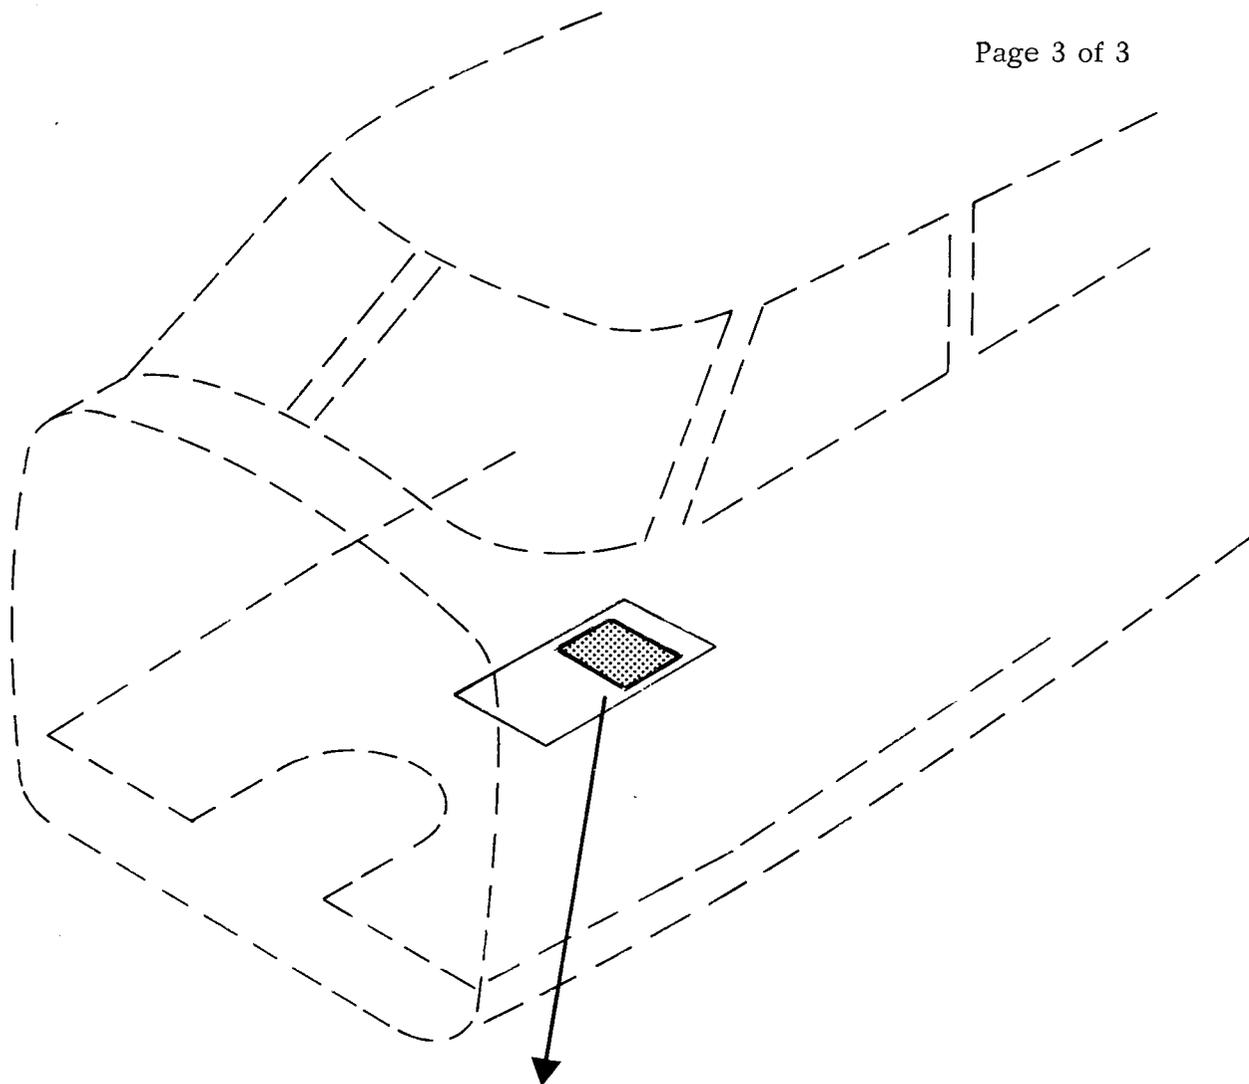
— WARNING —

BEFORE PROCEEDING WITH
EMERGENCY EXTENSION: CHECK

GEAR CIRCUIT BREAKERS ARE IN.
2. MASTER SWITCH IS ON.
3. INSTRUMENT LIGHTS ARE OFF (DAYTIME).

INSTRUCTIONS FOR EMERGENCY EXTENSION
OF LANDING GEAR

1. REDUCE POWER - AIRSPEED NOT TO EXCEED 100 M.P.H.

● INSTRUCTIONS

Remove the emergency gear extension access door and obliterate the words "MASTER AND" from the placard on the underside of the door with red paint.
