SERVICE *No. 246* BULLETIN

Subject: Modification of Oxygen Cylinder Rear Retaining Strap
Piper Part Number 758 109

Models Affected: PA-30 Twin Comanches (NOTE: Applicable only to
aircraft that have had an oxygen system installed at
the factory or aircraft that have had Piper Oxygen
Installation Kit 757 100 installed.)

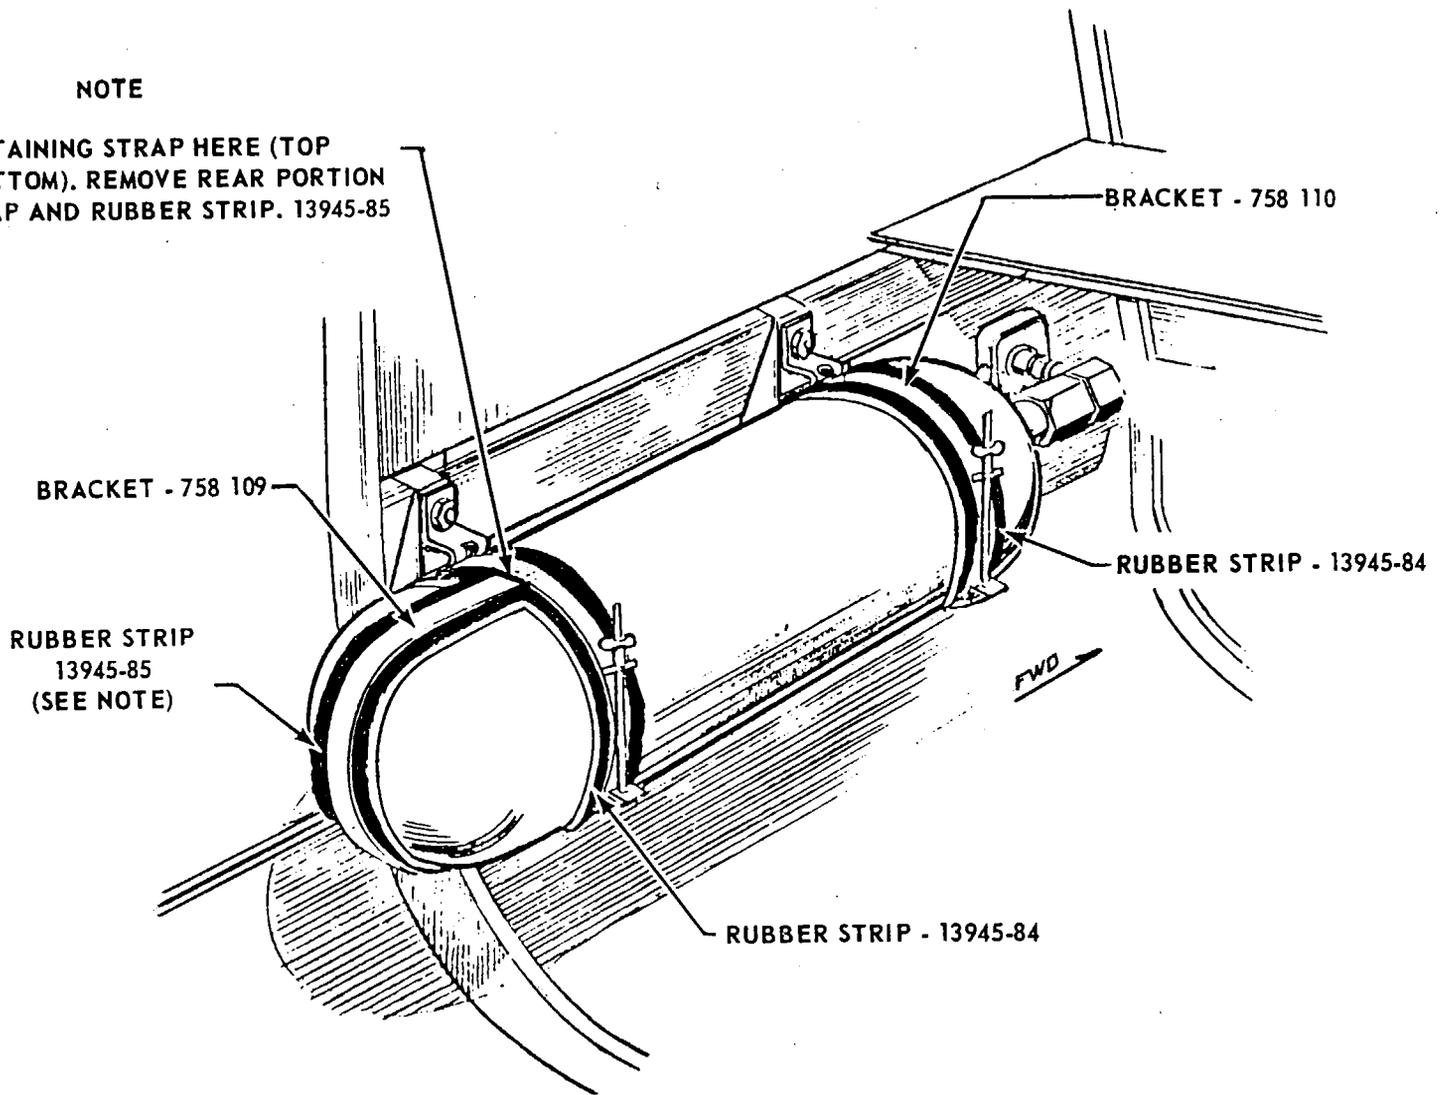
246f1

Reason For Bulletin: Modification of the oxygen cylinder rear retaining strap
part number 758 109 to preclude the possibility of the
strap rubbing the rudder control cable.

Modification Instructions: See sketch on reverse side of this bulletin.

RETAINING STRAP HERE (TOP AND BOTTOM). REMOVE REAR PORTION STRAP AND RUBBER STRIP. 13945-85
