SERVICE No. 192 BULLETIN

Piper Aircraft Corporation

SUBJECT: Throttle Limit Switch Bracket

MODELS AFFECTED: PA-24 and PA-24-250 Comanches
Serial Nos. 24-1 to 24-2148 inclusive

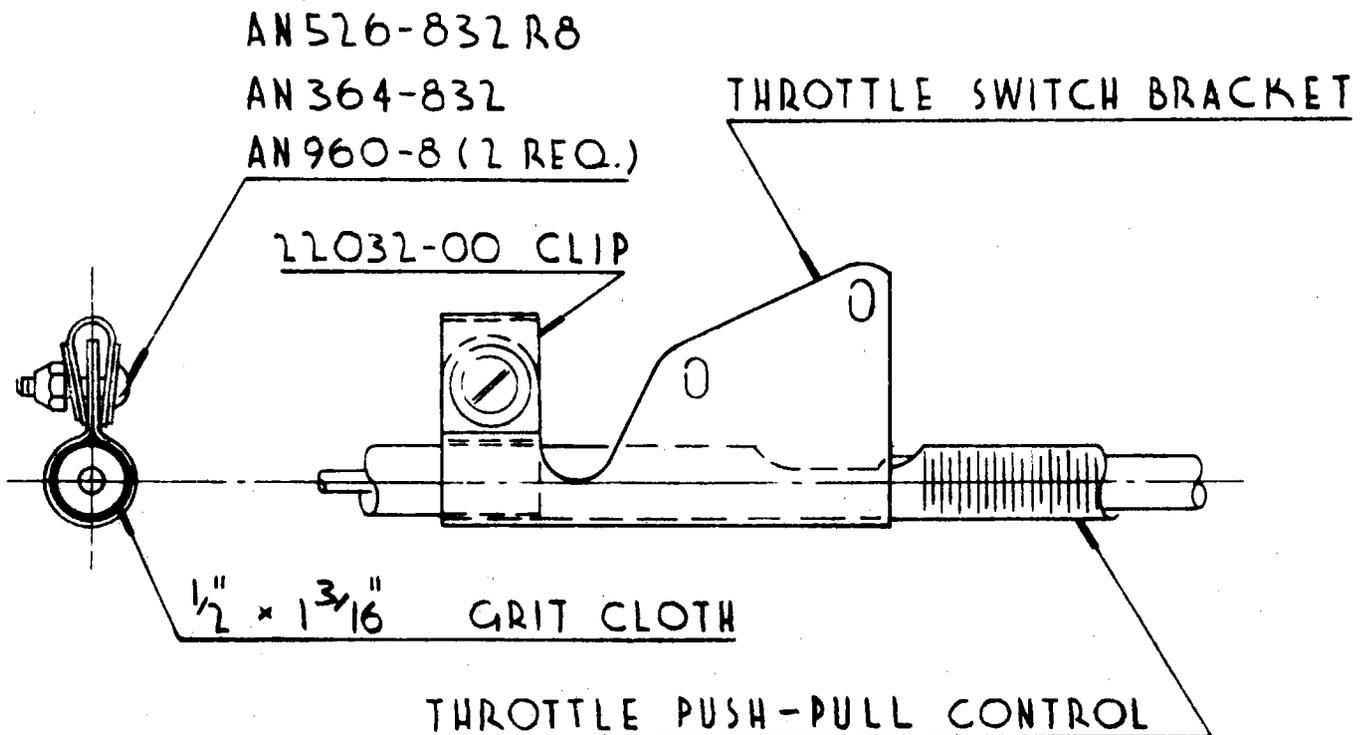
REVISED INSTALLATION
OF
THROTTLE LIMIT SWITCH BRACKET 21246-00

The Service Department has been advised that a movement of the throttle switch bracket during operating conditions has been noted. The movement of this bracket will vary the timing of the landing gear warning horn. To insure a more positive installation of the throttle switch, a piece of grit cloth and a clip shall be installed as per the sketch on the reverse side of this bulletin.
