Service Letter No. 461

SUBJECT: Inspection of Propeller Blades

MODELS AFFECTED: All PA-30 Twin Comanche Aircraft

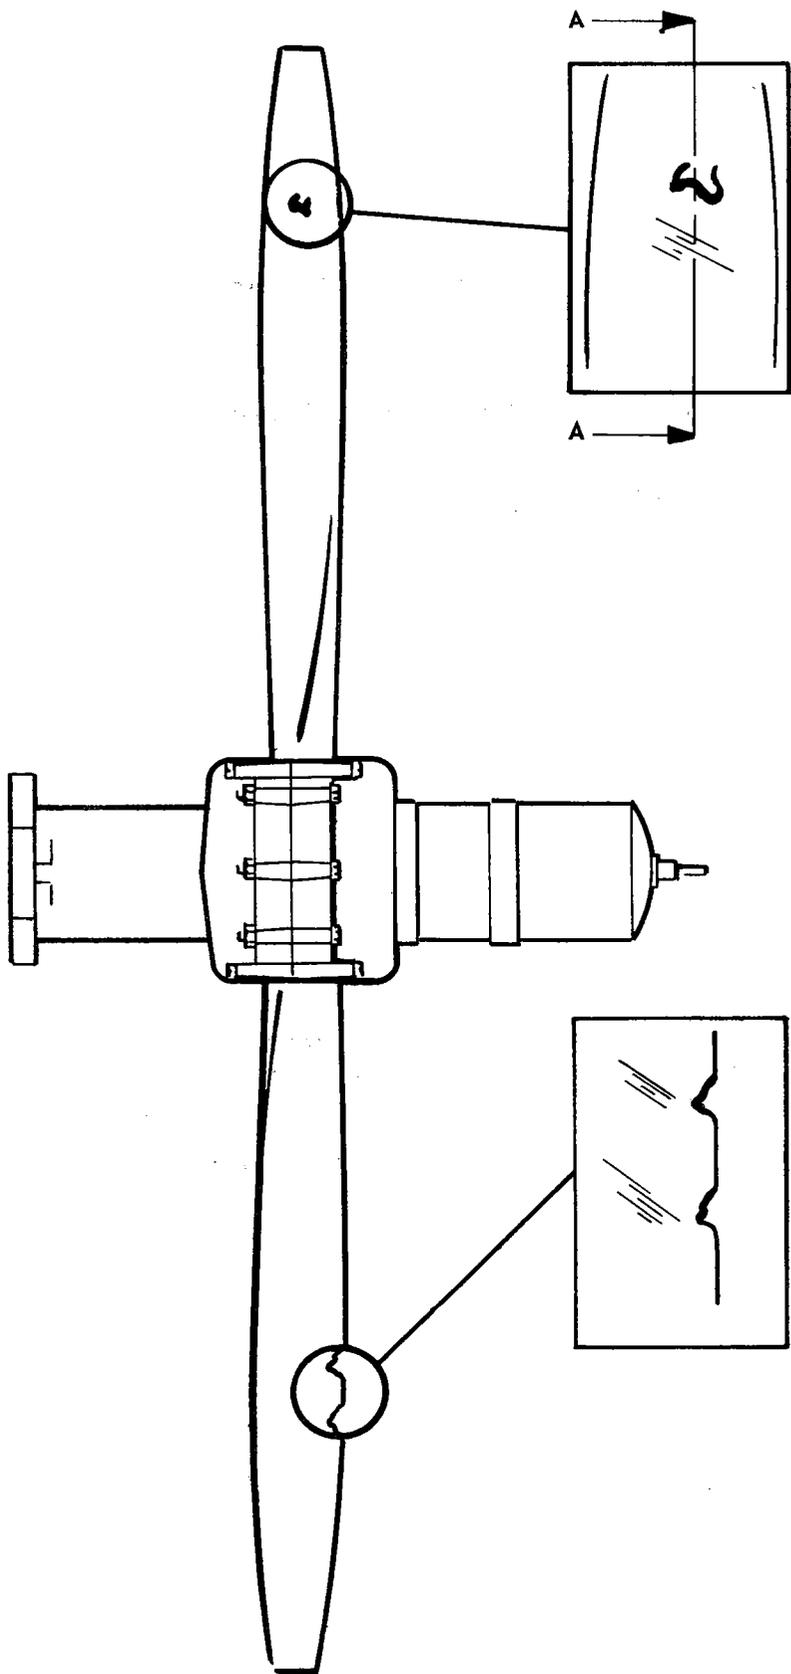
It is imperative that during the daily pre-flight inspection, propeller blades be examined for evidence of scratches, nicks or cracks, and if any are noted, they must be remedied immediately to preclude the possibility of propeller blade failure.

Exaggerated view of nick in face of blade.

Exaggerated view of nicks in leading edge.

Nicks in leading edges of blades should be filed out and all edges rounded, as cracks sometimes start from such places. Use fine emery cloth for finishing. C. A. Manual No. 18 may also be used as a reference for corrective measures. Severe damage should be referred to the Hartzell Propeller Company, Piqua, Ohio, or approved propeller repair stations for correction.

SECTION AA-
Nick in face of blade removed by file and crocus cloth as recommended.

Recommended method for removing nicks by raffle file and crocus cloth. Blend deepest portion of nick into leading edge alignment with smooth curves.
