SERVICE BULLETIN

No. 362

Piper Aircraft Corporation

V_{ne} Airspeed Limit

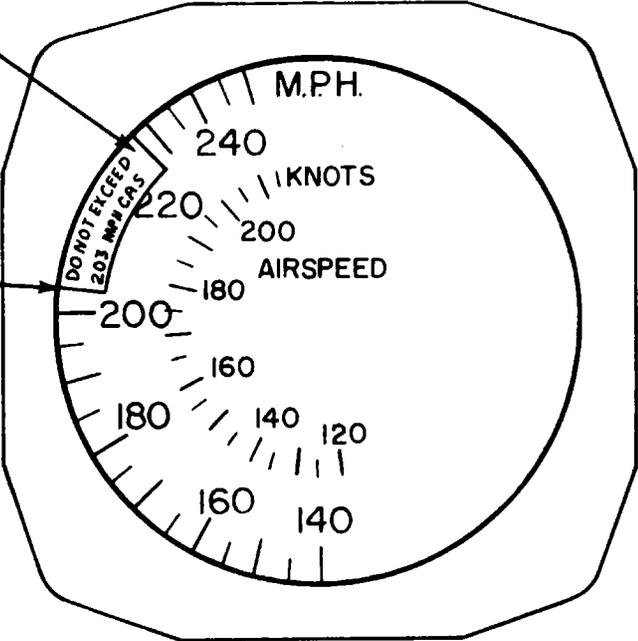
Locate this edge of Placard at 203 M.P.H.

Install Placard SK-2285 on the face of the Airspeed Indicator as shown.
