# SERVICE BULLETIN

No. 464A

Piper Aircraft Corporation

Subject: Inspection of Stabilator Torque Tube Bearing Block Attachment Fitting Rivets.

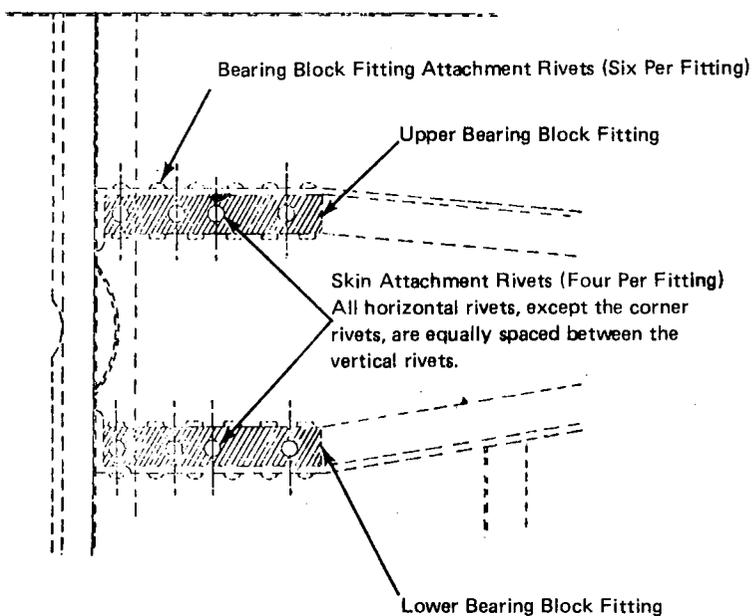
VIEW A-A: CORRECT RIVET ALIGNMENT

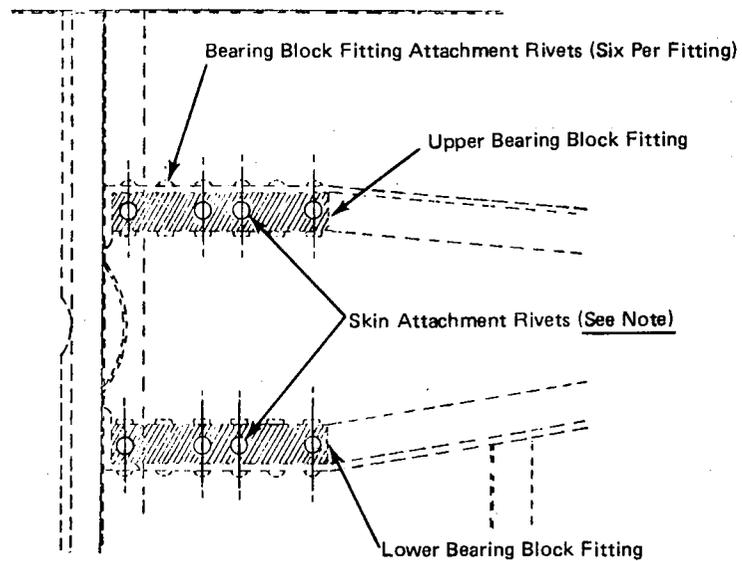
A study was conducted to determine the significance of the above described condition. It was subsequently determined that the rear corner rivet in the bearing block fitting (which is most susceptible to drill penetration) is redundant to the structural integrity of the fitting assembly, and also that one additional rivet located in the bearing block could be removed without reducing the strength of the assembly below an acceptable value. However, if more than two rivets per fitting (described above) have been penetrated during the drilling operation, it will be necessary to install one (1) each per fitting Piper Kit Number 760 835, Hi Shear Rivet Replacement, and install bolts (per kit instructions) in place of the existing rivets in those bearing blocks which contain more than two rivets penetrated during drilling.

VIEW A-A: RIVET ALIGNMENT which may have resulted in rivet penetration:

**NOTE:** All horizontal rivets, except the corner rivets, are incorrectly installed in this view as they are aligned with the vertical rivets. If more than two rivet alignments are evident in each fitting, it will be necessary to install Kit 760 835.

1. One (1) each PER FITTING (i.e., each kit contains sufficient material to modify one only Stabilator Torque Tube Bearing Block Fitting), Piper Kit Number 760 835, Hi Shear Rivet Replacement, if required per Instructions number 3, above.
2. Two (2) each per aircraft Cover Plate, Part Number 28216-02, if installation of Kit 760 835 is required per Instructions number 3, above.
