# SERVICE LETTER

No. 541

Subject: Fuselage Nose Cone Drain Holes

Models Affected: PA-30 Twin Comanche

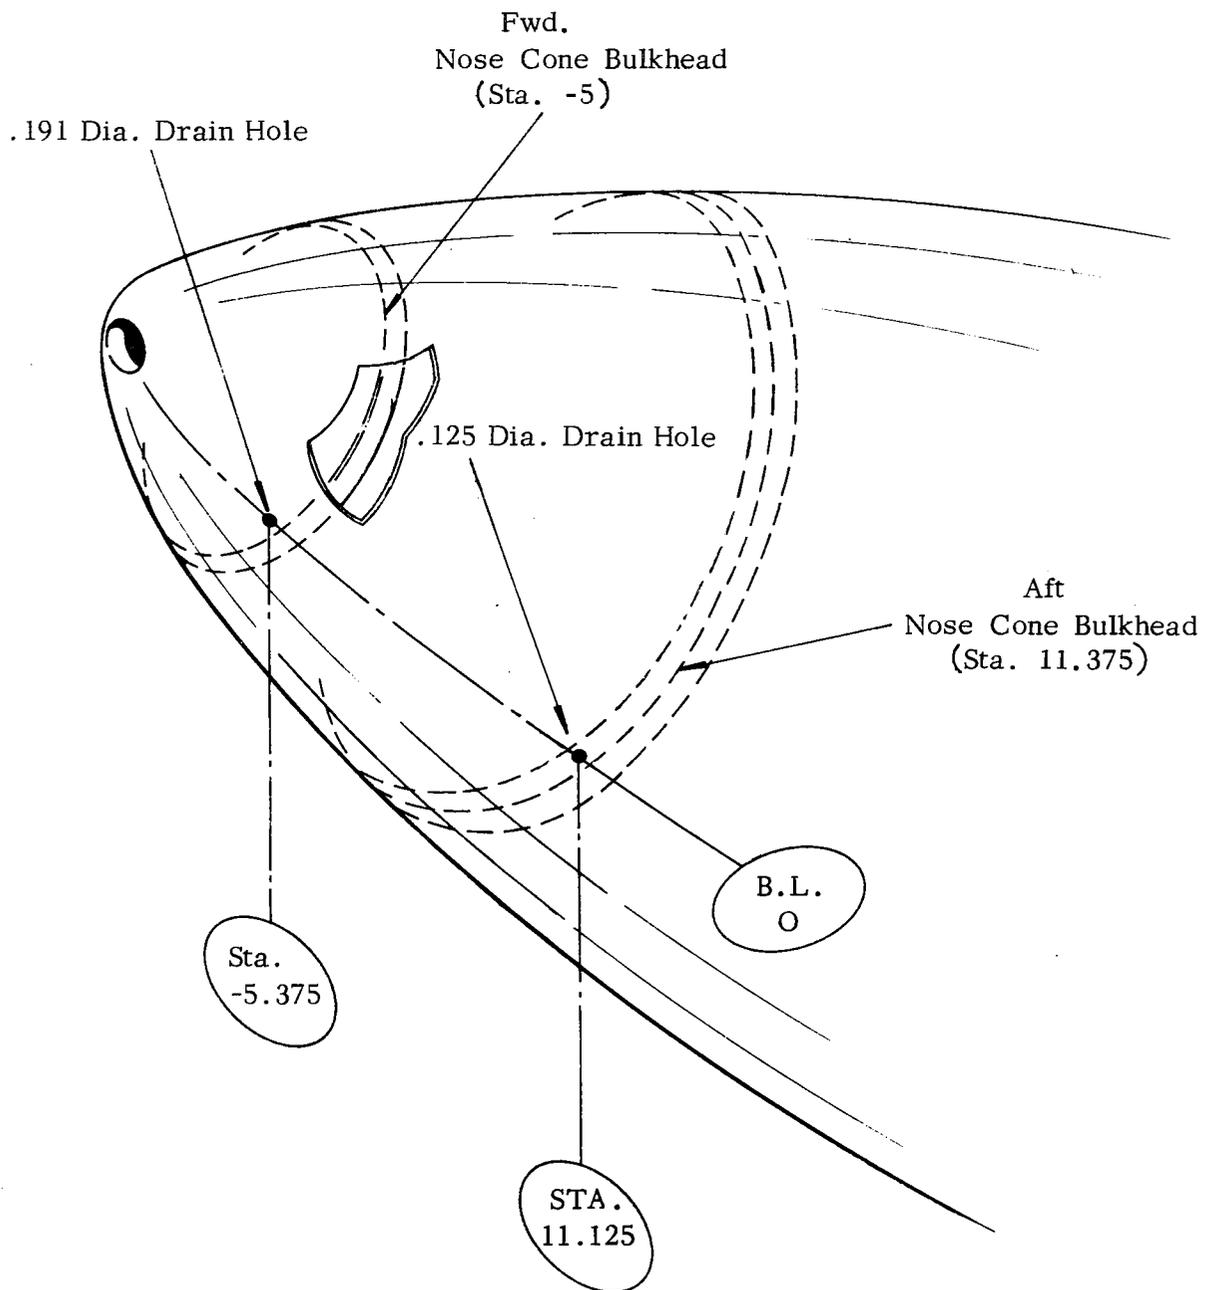
FUSELAGE NOSE CONE

Purpose: To inspect the fuselage nose cone section of the above referenced aircraft to ascertain that drain holes are present in the fuselage nose cone, as indicated by the sketch on the reverse side of this letter.

Instructions: If the above referenced inspection reveals that drain holes do not exist at stations 11.125 and -5.375, add drain hole(s) per sketch on reverse side of this letter.
