Service Letter No. 379

SUBJECT: Landing Gear Safety Switch Harness

MODELS AFFECTED: PA-24 and PA-24 "250" Comanches
Serial Numbers 24-1 to 24-3284 incl.

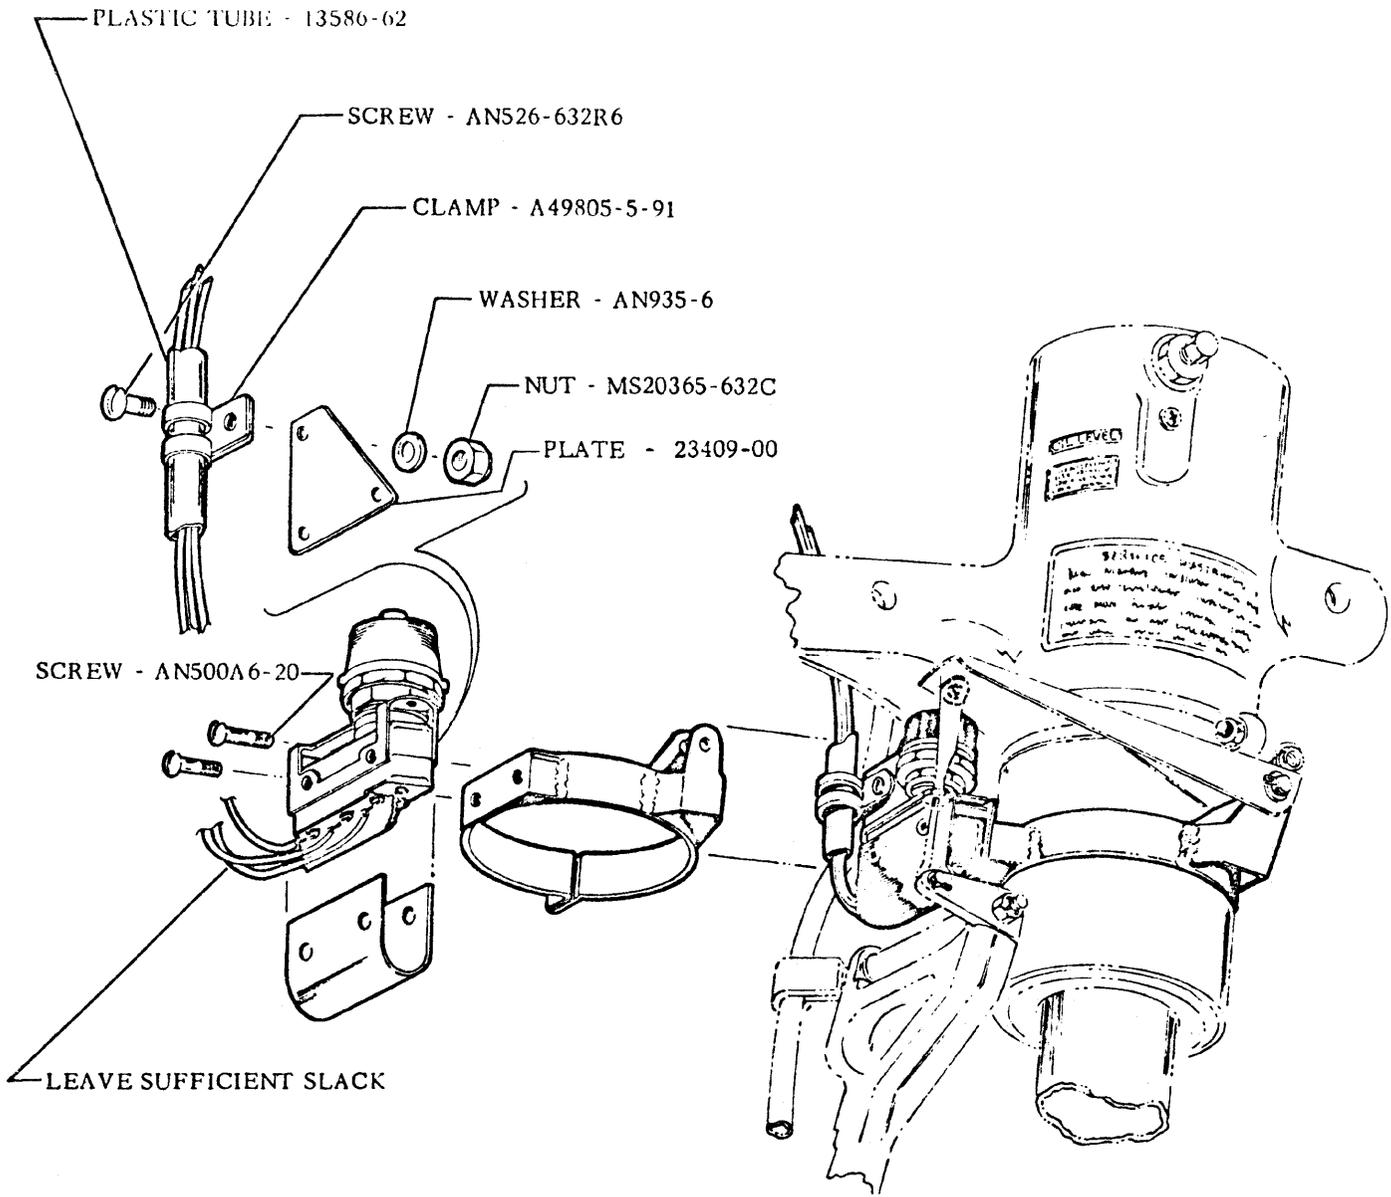
SERVICE LETTER NO. 379

We have been advised that over extended periods of operation, there is a possibility of a wire or wires in the landing gear safety switch harness becoming broken at the switch. This condition would cause malfunction of the safety switch.

A kit, consisting of a bracket, clamp, plastic sleeve and necessary hardware, is available for use in the subject aircraft. It is recommended that this kit be installed in the referenced aircraft as it will support the wire harness of the safety switch. See sketch on the reverse side of this Service Letter.

Until such time as this kit is installed, an inspection of the safety switch and related wire harness should be performed at each 100 hours of operation to ascertain this condition does not exist.

The part number of this kit is 754 475, unit price \$1.08, and is available through your Piper distributor or dealer.
