SERVICE No. 179 BULLETIN

Piper Aircraft Corporation

SUBJECT: Refitting of Door Window

MODELS AFFECTED: PA-24 and PA-24 "250"
Serial Nos. 24-2 to 24-264 incl., 24-266 to 24-544 incl. and
24-546 to 24-988 incl.

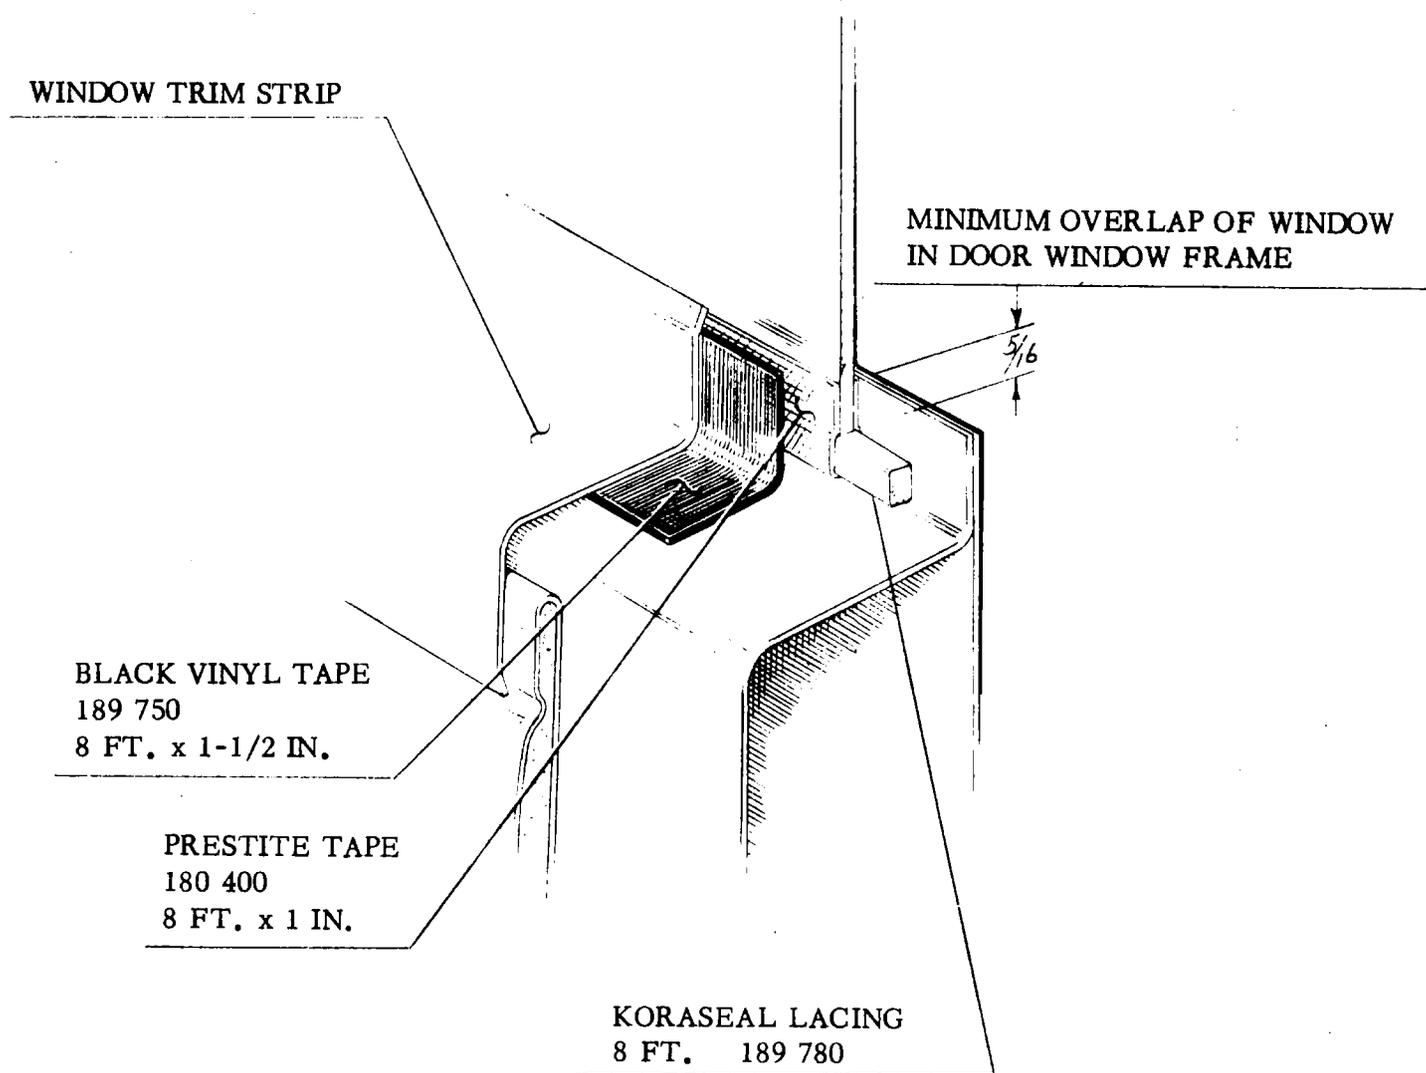
SERVICE BULLETIN № 179

The door windows on the Comanche, referred to by the above serial numbers, must be removed and refitted to insure a tighter fit within the door window frame.

NOTE: Individual windows may vary in overall dimension. A full length of Koraseal may not be required to obtain 5/16" overlap of window in frame, others may require a little more.

The glass, when refitted, must extend into the door frame at least 5/16". This distance must be maintained around the entire window and is measured at the outside window frame. In the event that this measurement cannot be obtained, the Service Department should be advised.

1. Remove window trim mouldings.
2. Remove Vinyl and Presstite tapes holding window to door frame and remove window.
3. With the window removed, attach a length of Koraseal lacing to the edge of the window. The narrowest face of the Koraseal should be used against the window edge. Using a new strip of Presstite tape, center the glass in this tape to permit an equal amount of tape to extend onto both sides of the glass. The Koraseal will now remain in place. Install window with a new length of Vinyl tape over Presstite tape and install window moulding.

4. See sketch on reverse side of this bulletin for part numbers and quantity of material required per airplane.
