# SERVICE LETTER

No. 751

Piper Aircraft Corporation

Fin Front Spar Modification.

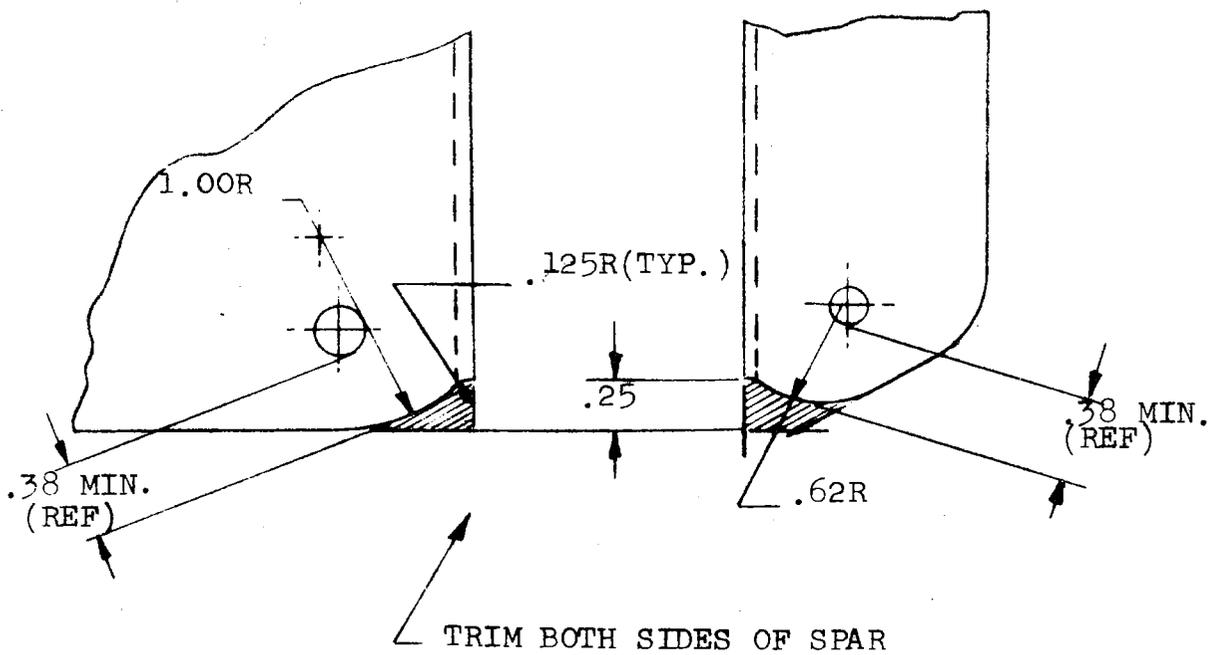
**FIGURE 2**

Currently, it is necessary to physically remove the fin to gain visual access to the channel relief holes, as the fin front spar extends over the relief holes by approximately 1/2 to 2/3 of the relief hole diameter.

To eliminate removal of the fin and to enable an easy visual inspection, the fin front spar may be modified in accordance with the sketch/instruction sheet contained on the reverse side of this release.

Refer to "Spar Trimming Detail" on reverse side of this release.

SPAR TRIMMING DETAIL
