Piper Aircraft Corporation

SUBJECT: Replacement or Modification of Muffler Shrouds

MODELS AFFECTED: PA-24 and PA-24 "250" Comanches - Serial Numbers 24-2588 to 24-2875 incl., 24-2877 to 24-2928 incl., 24-2930 to 24-2948 incl., 24-2950 to 24-2966 incl., 24-2968 to 24-2989 incl., 24-2991 to 24-3032 incl., 24-3034 to 24-3094 incl., 24-3096 to 24-3113 incl., 24-3115 to 24-3129 incl., 24-3131 to 24-3149 incl., 24-3151 to 24-3154 incl., 24-3156 to 24-3172 incl., 24-3174 to 24-3190 incl., 24-3192, 24-3195, 24-3197, 24-3199 to 24-3202 incl., 24-3205 to 24-3221 incl., 24-3223 to 24-3232 incl., 24-3235 to 24-3240 incl., 24-3242, 24-3243, 24-3245, 24-3246, 24-3247, 24-3249 to 24-3253 incl., 24-3255, 24-3256, 24-3259 to 24-3264 incl., 24-3266, 24-3267, 24-3269, 24-3271, 24-3272, 24-3275, 24-3281, 24-3284 and all of the referenced aircraft prior to Serial No. 24-2588 in which mufflers, part number 22594-00 and part number 22594-02 PA-24, and part number 22593-00 and part number 23159-00 PA-24 "250", have been installed as service replacements.

SERVICE BULLETIN NO. 210

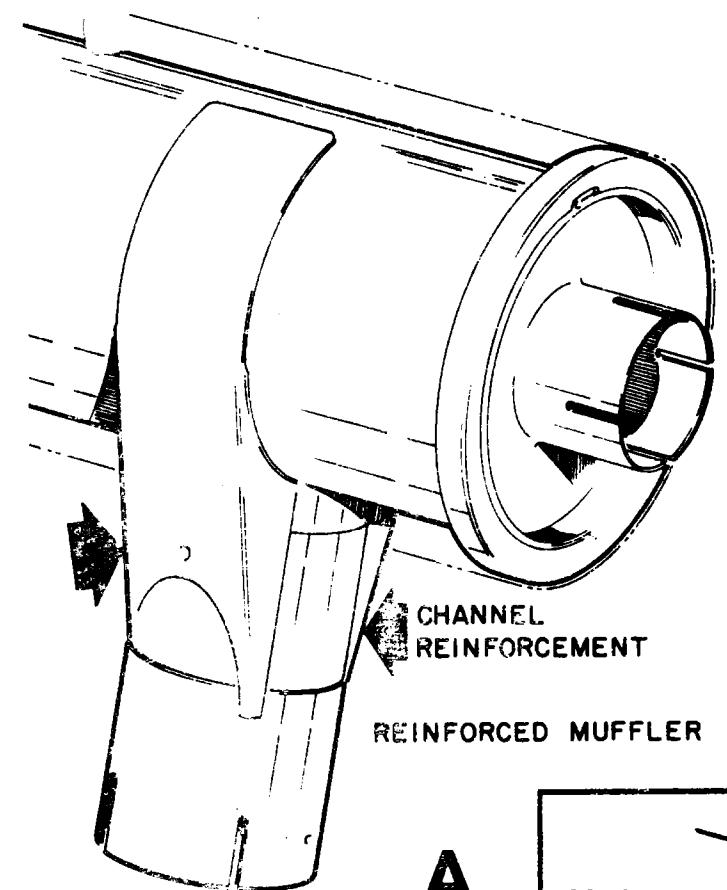
A

Comanche mufflers have been manufactured incorporating two different styles of tailpipe reinforcement brackets. However, this Service Bulletin requires modification of one style only; those with the channel-shaped reinforcement. See Sketch "A" for further identification. Both styles of muffler have been sold as service replacements. It will therefore be necessary to inspect aircraft, Serial Nos. 24-1 to 24-2587 inclusive if the original muffler has been replaced, to determine if compliance with this Bulletin is required.

CHANNEL
REINFORCEMENT
REINFORCED MUFFLER

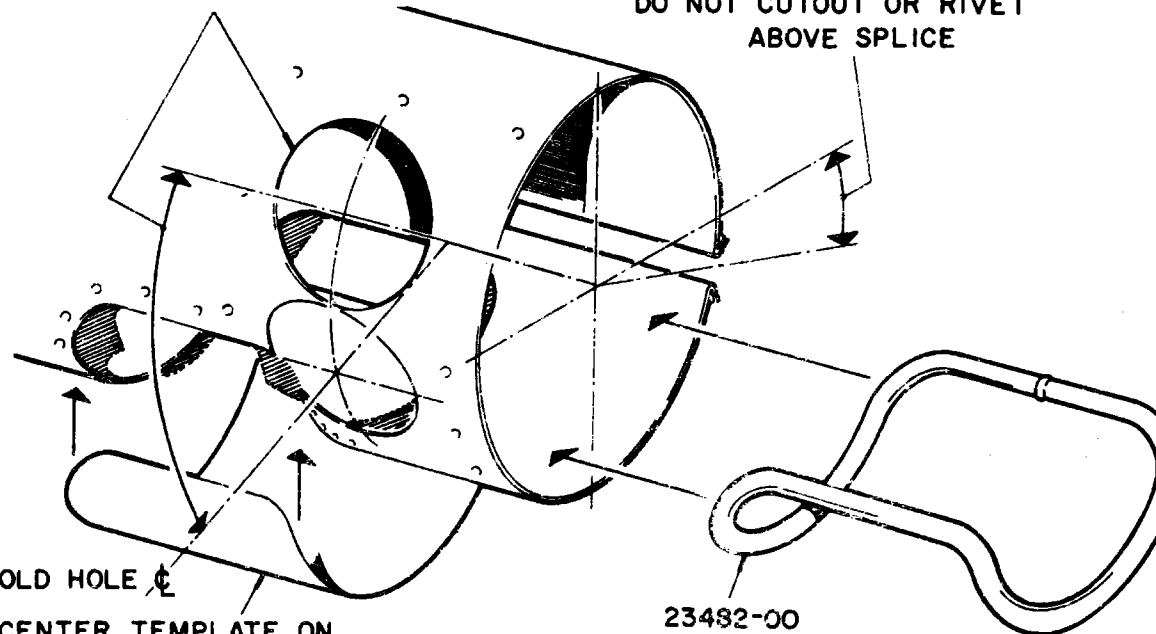
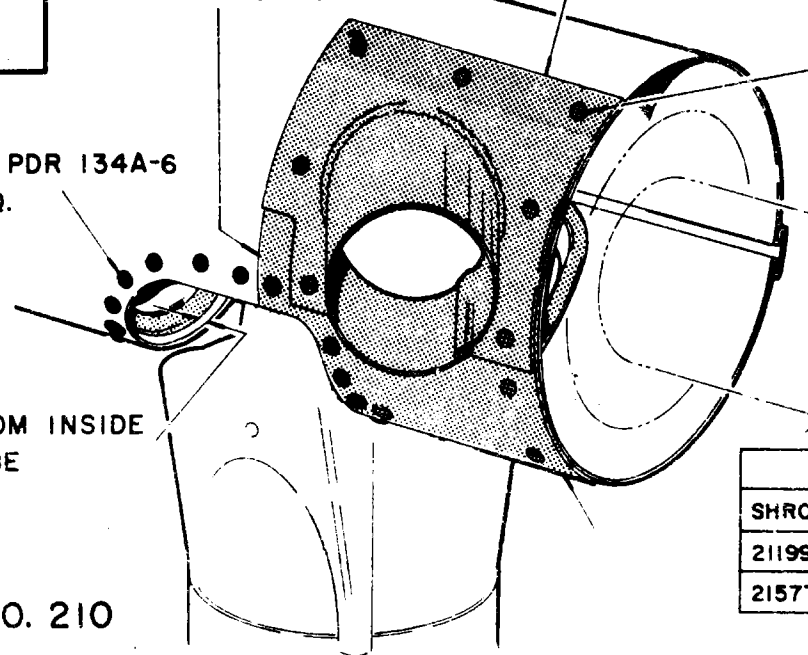
B

Service reports have been received advising of cracks located in the muffler housing near the tailpipe reinforcement strap. The muffler heater shroud has therefore been redesigned to remove the affected area from the heater system. This has been accomplished by increasing the shroud opening around the tailpipe, making the area more accessible for inspection.

8. Cut the new opening in the aluminum shroud, taking care not to cut past the splice. (See Note Sketch "B.")
 9. Install the muffler housing reinforcement tube, part number 23482-00, on the inside of the aluminum heater shroud. (See Sketch "B.")

10. Relocate the cold air inlet take-off assembly as shown on the take-off relocation table and install cover plate, part number 23498-00, over old hole. Trim cover plate as required. (See Sketch "B.")

RELOCAT 2" DIA. TAKE-OFF HOLE
SEE TAKE-OFF RELOCATION TABLE

ON SHROUDS WITH SPLICE AT 45°
DO NOT CUTOUT OR RIVET
ABOVE SPLICE

OLD HOLE
CENTER TEMPLATE ON
OLD EXHAUST STACK HOLE
USING ATTACHED TEMPLATE

CUTOUT APPROX. $\frac{1}{8}$ " FROM INSIDE
OF REINF. TUBE
