SERVICE LETTER

No. 718

Subject: Bendix Magneto Bulletin No. 566 -- reference attached Avco Lycoming Service Bulletin No. 373, dated March 22, 1974.

SUBJECT: S-1200 Distributor Block and Gear Change

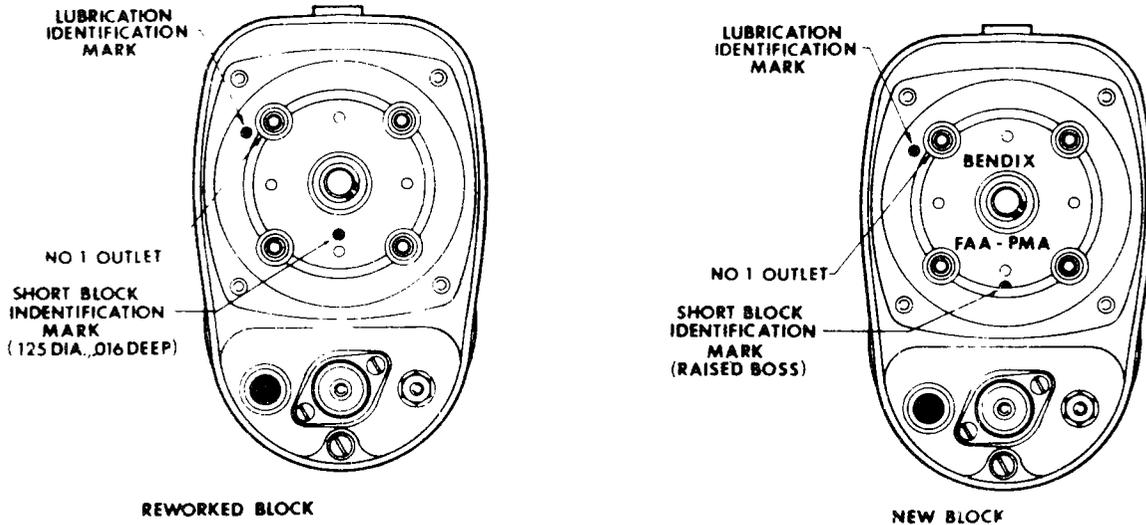
Figure 2

The addition of the washers make it necessary to shorten the gear end of the bushing and block. New production blocks incorporating the change are identified by a raised

boss between the high tension towers at the six o'clock position and molded in letters as shown in figure 2. Reworked blocks are identified by a drill point indentation in the same location. New and reworked blocks both have different part numbers from the current (old) block. See Table 1.

7. Identify reworked blocks by drilling a flat bottomed hole .125" diameter and .016" deep in the six o'clock position as shown in figure 2.
