SERVICE LETTER

No. 623

Piper Aircraft Corporation

Subject: Inspection of Rajay Alternate Air Valve Bracket

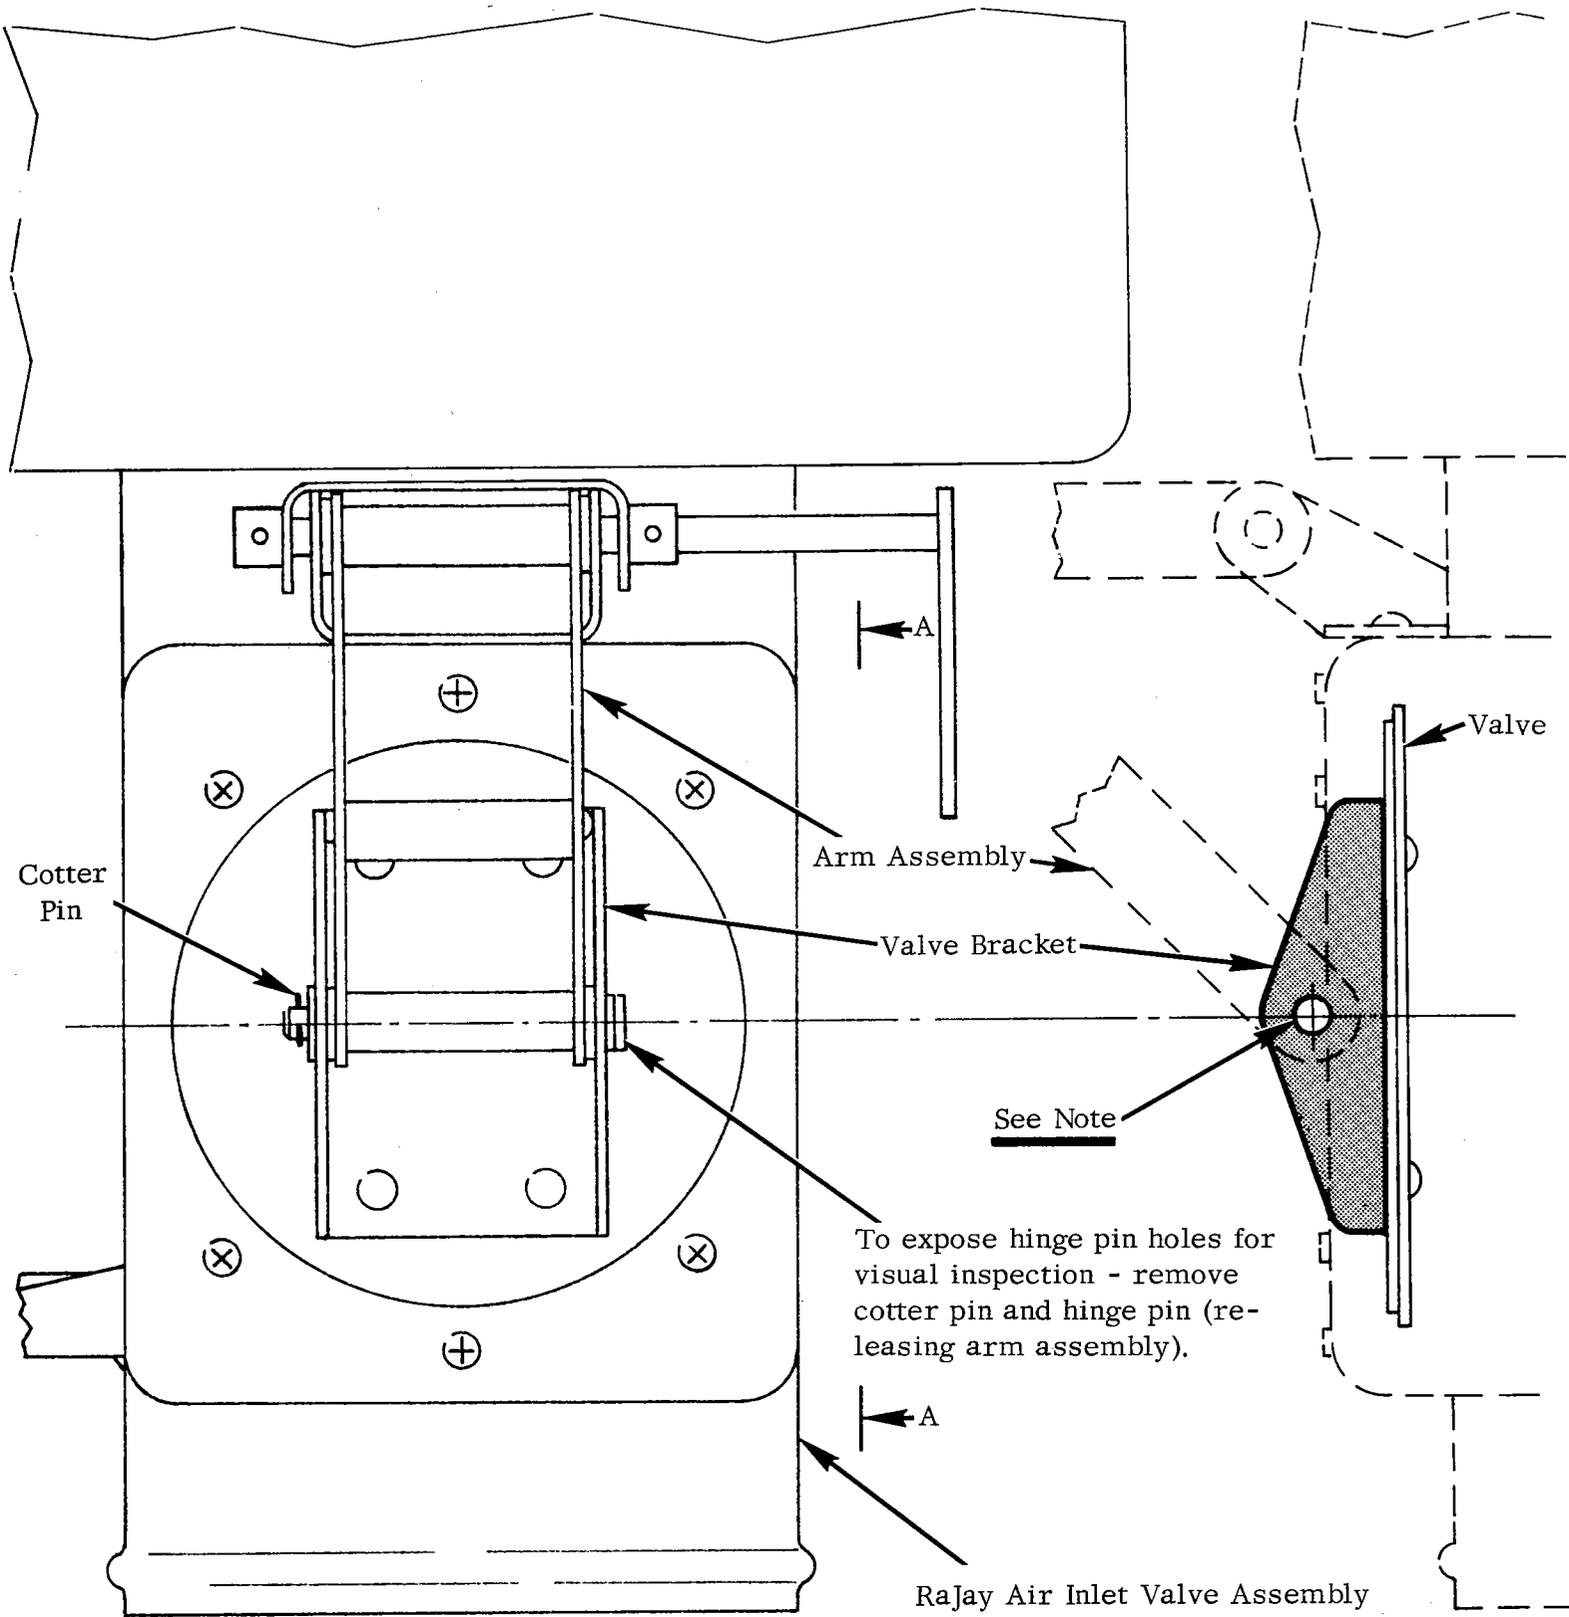
A-A

A survey of field reports recently received indicates that the alternate air inlet valve brackets with brass reinforced hinge pin holes are also subject to wear.

NOTE - Inspect Rajay Alternate Air Inlet Valve Bracket hinge pin holes (2) for wear elongation exceeding 1/16 inch. Replace if required with new alternate air inlet valve and bracket assembly Rajay Part No. RJ0605-5/-71.

1. Gain access to the engine air inlet filter assembly in accordance with PA-30/39 Service Manual Section VIIIA, paragraph VIIIA 27 through 31 inclusive.
2. Inspect alternate air inlet valve bracket hinge pin holes for excessive wear, as evidenced by hole elongation exceeding 1/16 inch. Should elongation exceed 1/16 inch, replace alternate air inlet valve and bracket assembly.
