# SERVICE BULLETIN

No. 315

Subject:  $V_{ne}$  Airspeed Limit

Models Affected: PA-30 Twin Comanche

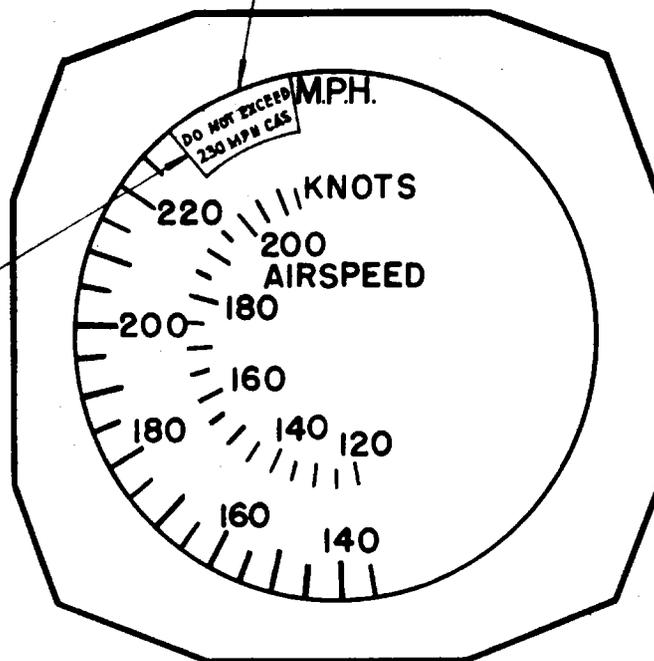
Purpose: To revise the existing  $V_{ne}$  Airspeed Limit of 245 mph C.A.S. to a  $V_{ne}$  Airspeed Limit of 230 mph C.A.S.; reference FAA Airworthiness Directive dated July 2, 1970.

Install Placard SK-2202 on the face of the Airspeed Indicator as shown.

Locate this edge of Placard SK-2202 at 230 M.P.H.
