SERVICE BULLETIN

No. 202

Piper Aircraft Corporation

SUBJECT: Inspection of Comanche Exhaust System

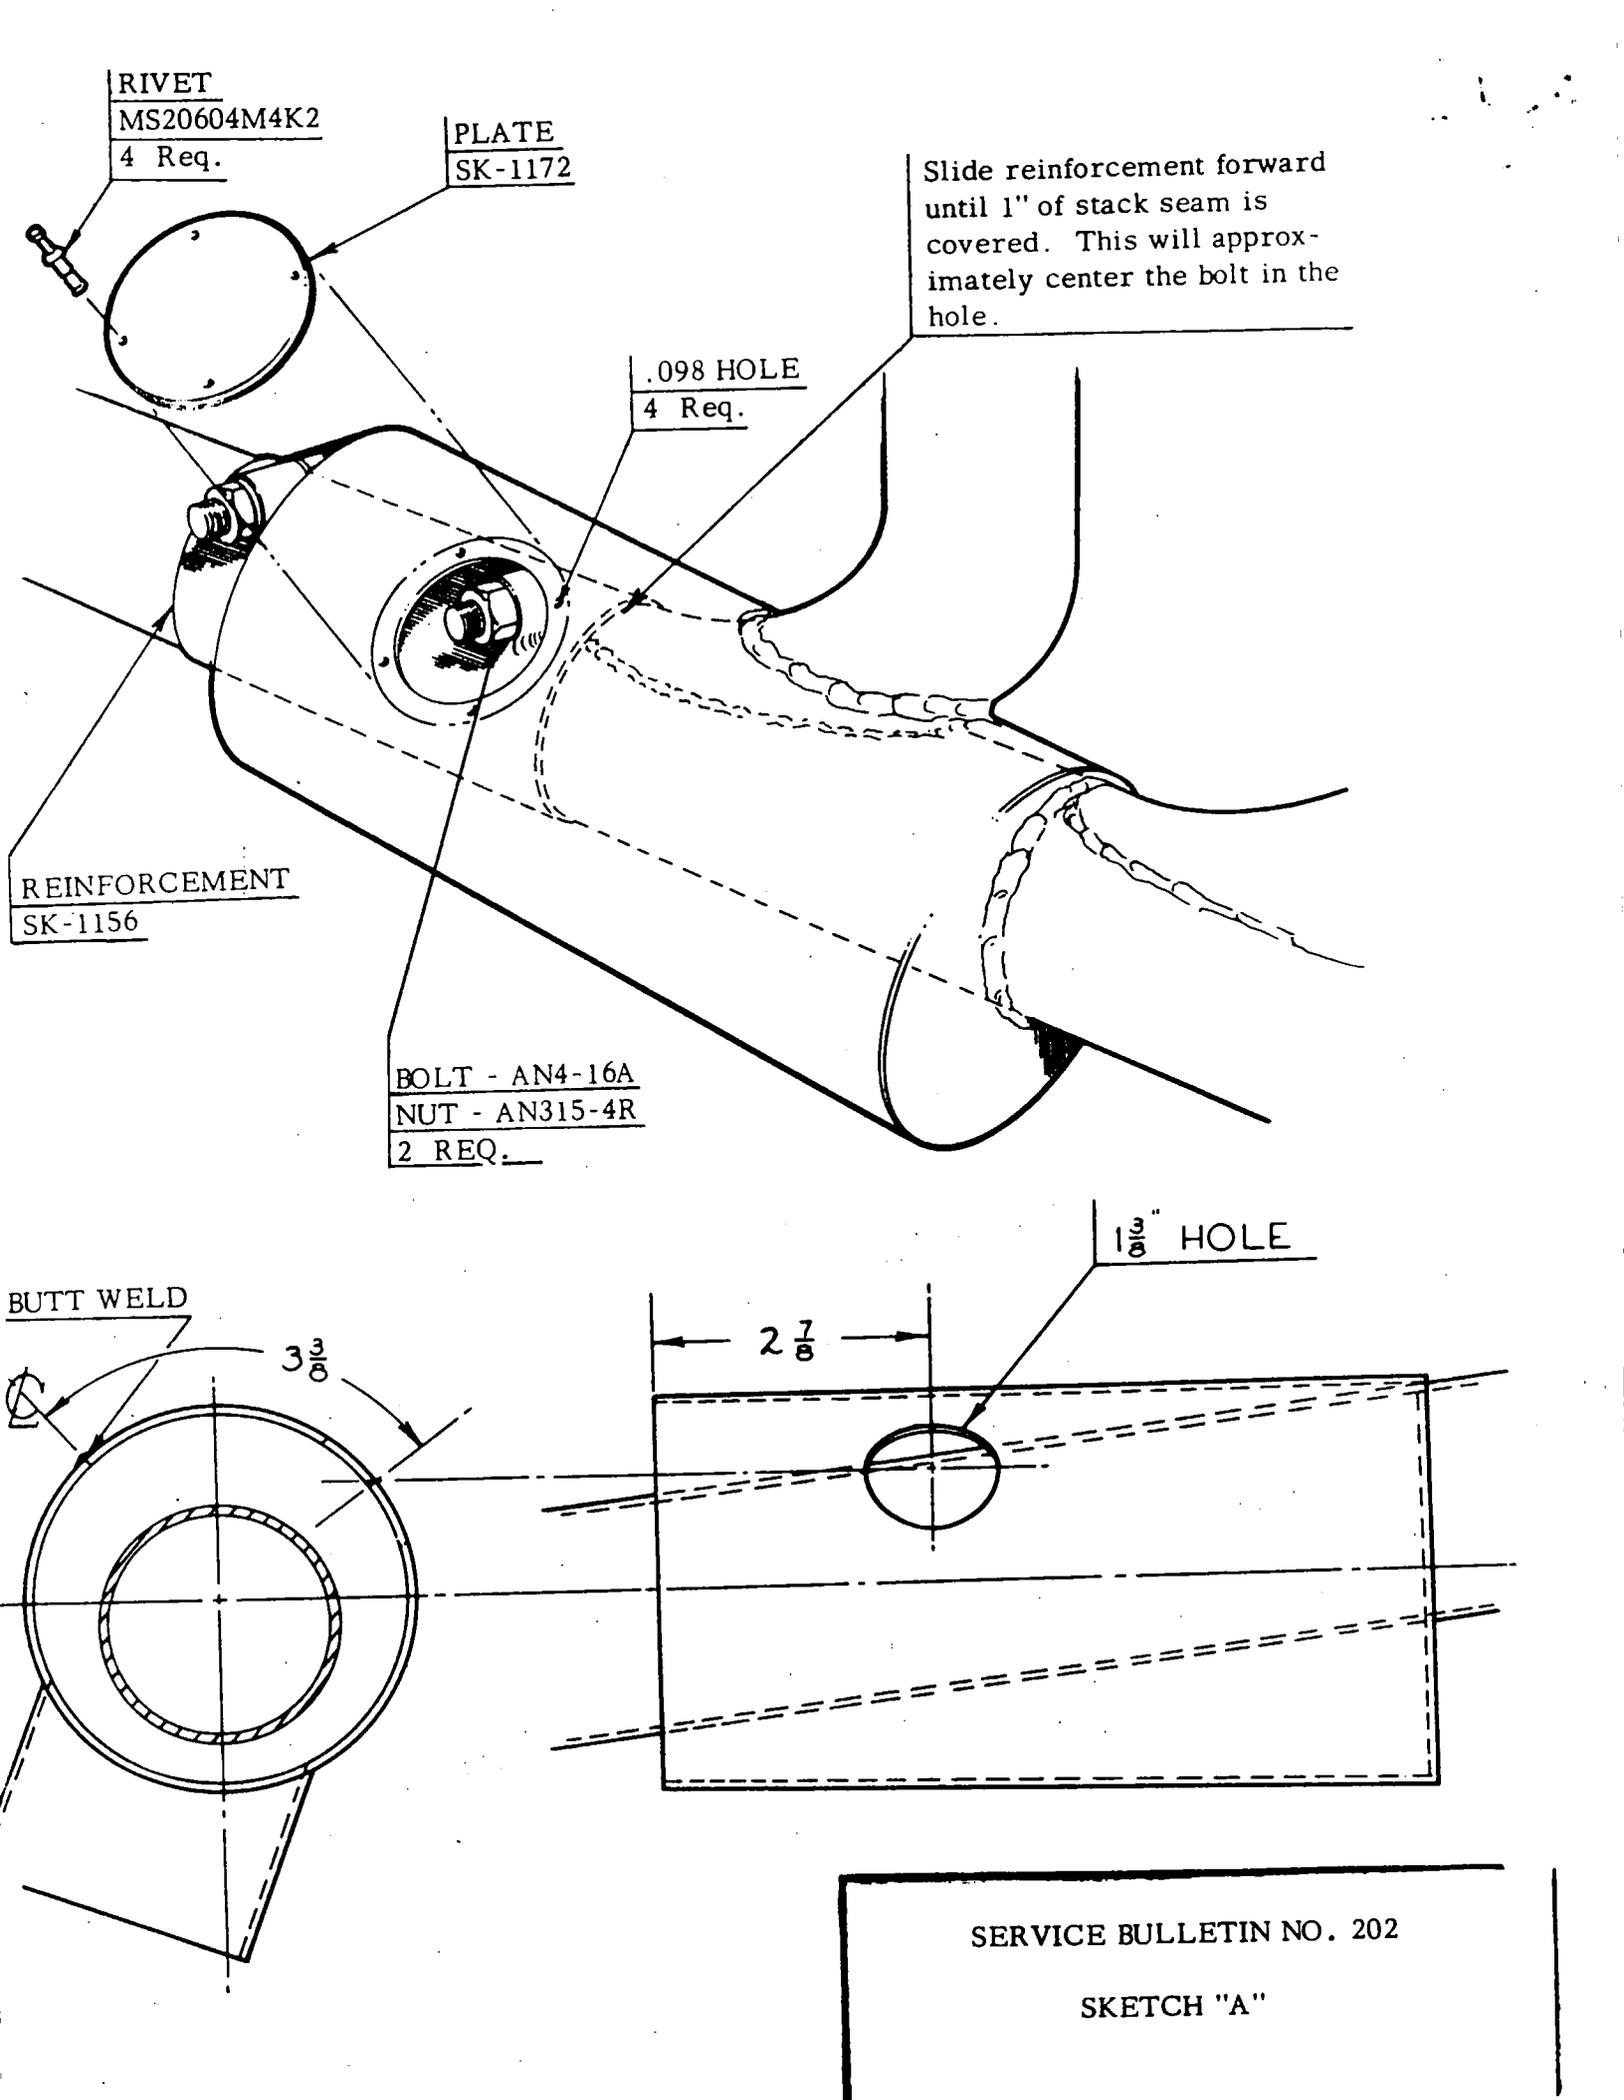
SKETCH "A"

Field service reports indicate that cracks have been appearing in the engine exhaust stack assembly, right side - Part number 21664-03. It is requested these stacks be inspected for cracks or other indications of deterioration in the following manner:

1. Remove or loosen the shroud assembly.
2. Inspect the exhaust stack assembly for any indication of cracks or deterioration. A thorough examination of the area where the rear cylinder exhaust stack is welded to the exhaust stack assembly should be made. This assembly must be replaced immediately if this condition is noted.
3. Exhaust stacks that have a reinforcing plate welded to the stack in the area where Kit No. 754 396 is to be installed will not be affected by this Bulletin.
4. Stacks that do not have the reinforcement plate but are found to be in satisfactory condition shall be inspected each 50 hours of operation until reinforced with Kit No. 754 396. Installation of Kit No. 754 396 must be accomplished prior to but not later than the next 100 hour inspection. Refer to sketch on the reverse side and attached instruction sheet.

Slide reinforcement forward
until 1" of stack seam is
covered. This will approx-
imately center the bolt in the
hole.

3. Locate, mark and drill holes in stationary part of air shroud as per Sketch "A".
4. Make sure all metal filings are cleaned out of shroud before reassembly of air shroud.

5. Install reinforcement on exhaust stack. Slide reinforcement forward until bolt is centered in hole cut in air shroud. This should move the reinforcement far enough forward to cover 1" of exhaust stack weld.

8. After final torque check install repair plate Part No. SK-1172 as per Sketch "A".
