Service Letter No. 411

SUBJECT: Drain Holes in PA-30 Cowling

MODELS AFFECTED: PA-30 Twin Comanches, Serials 30-1 to 30-85 inclusive

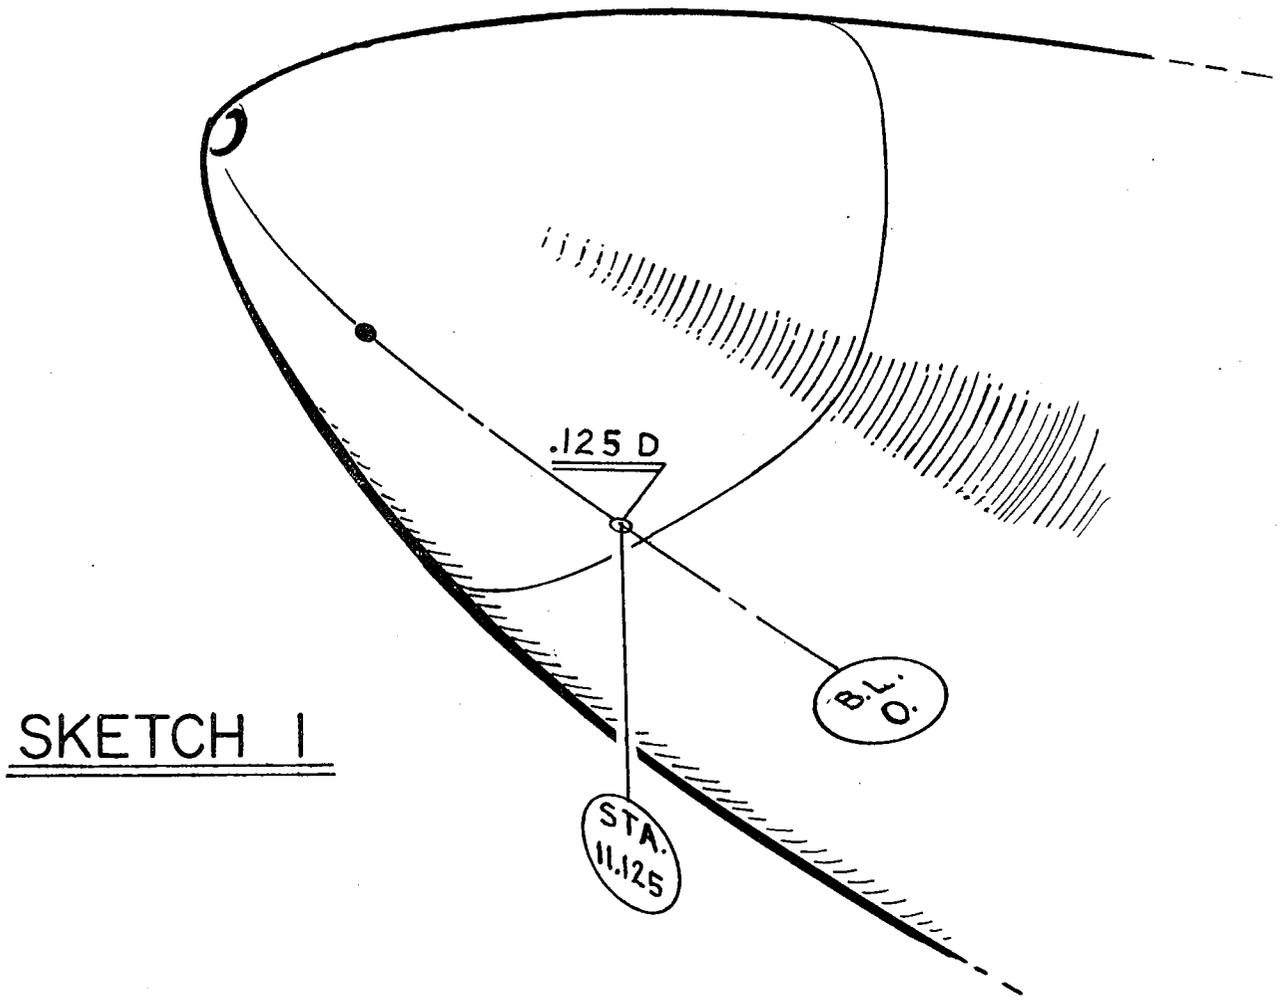
Fuselage Nose Cone

Reports from the field have indicated that accumulation of moisture is possible in the fiberglass nose cone, the bottom engine cowls and the air filter boxes of the PA-30.

1. Add a .125 drain hole at Station 11.125 and B.L.O. in bottom of fiberglass nose cone, part number 23755-00.
2. Add two .125 drain holes in bottom of each engine bottom cowl, part number 23867-05, right, and part number 23867-06, left, at Stations 32.25 and 33.687, 8-3/4" inboard from the cowl centerline.
3. Add a .125 drain hole in each air filter box assembly, part number 23883-00, per sketch attached to this letter.
