Service Letter No. 435

SUBJECT: Relocation of Nose Wheel Steering Tube Boot

MODELS AFFECTED: All PA-24 "250" Comanches

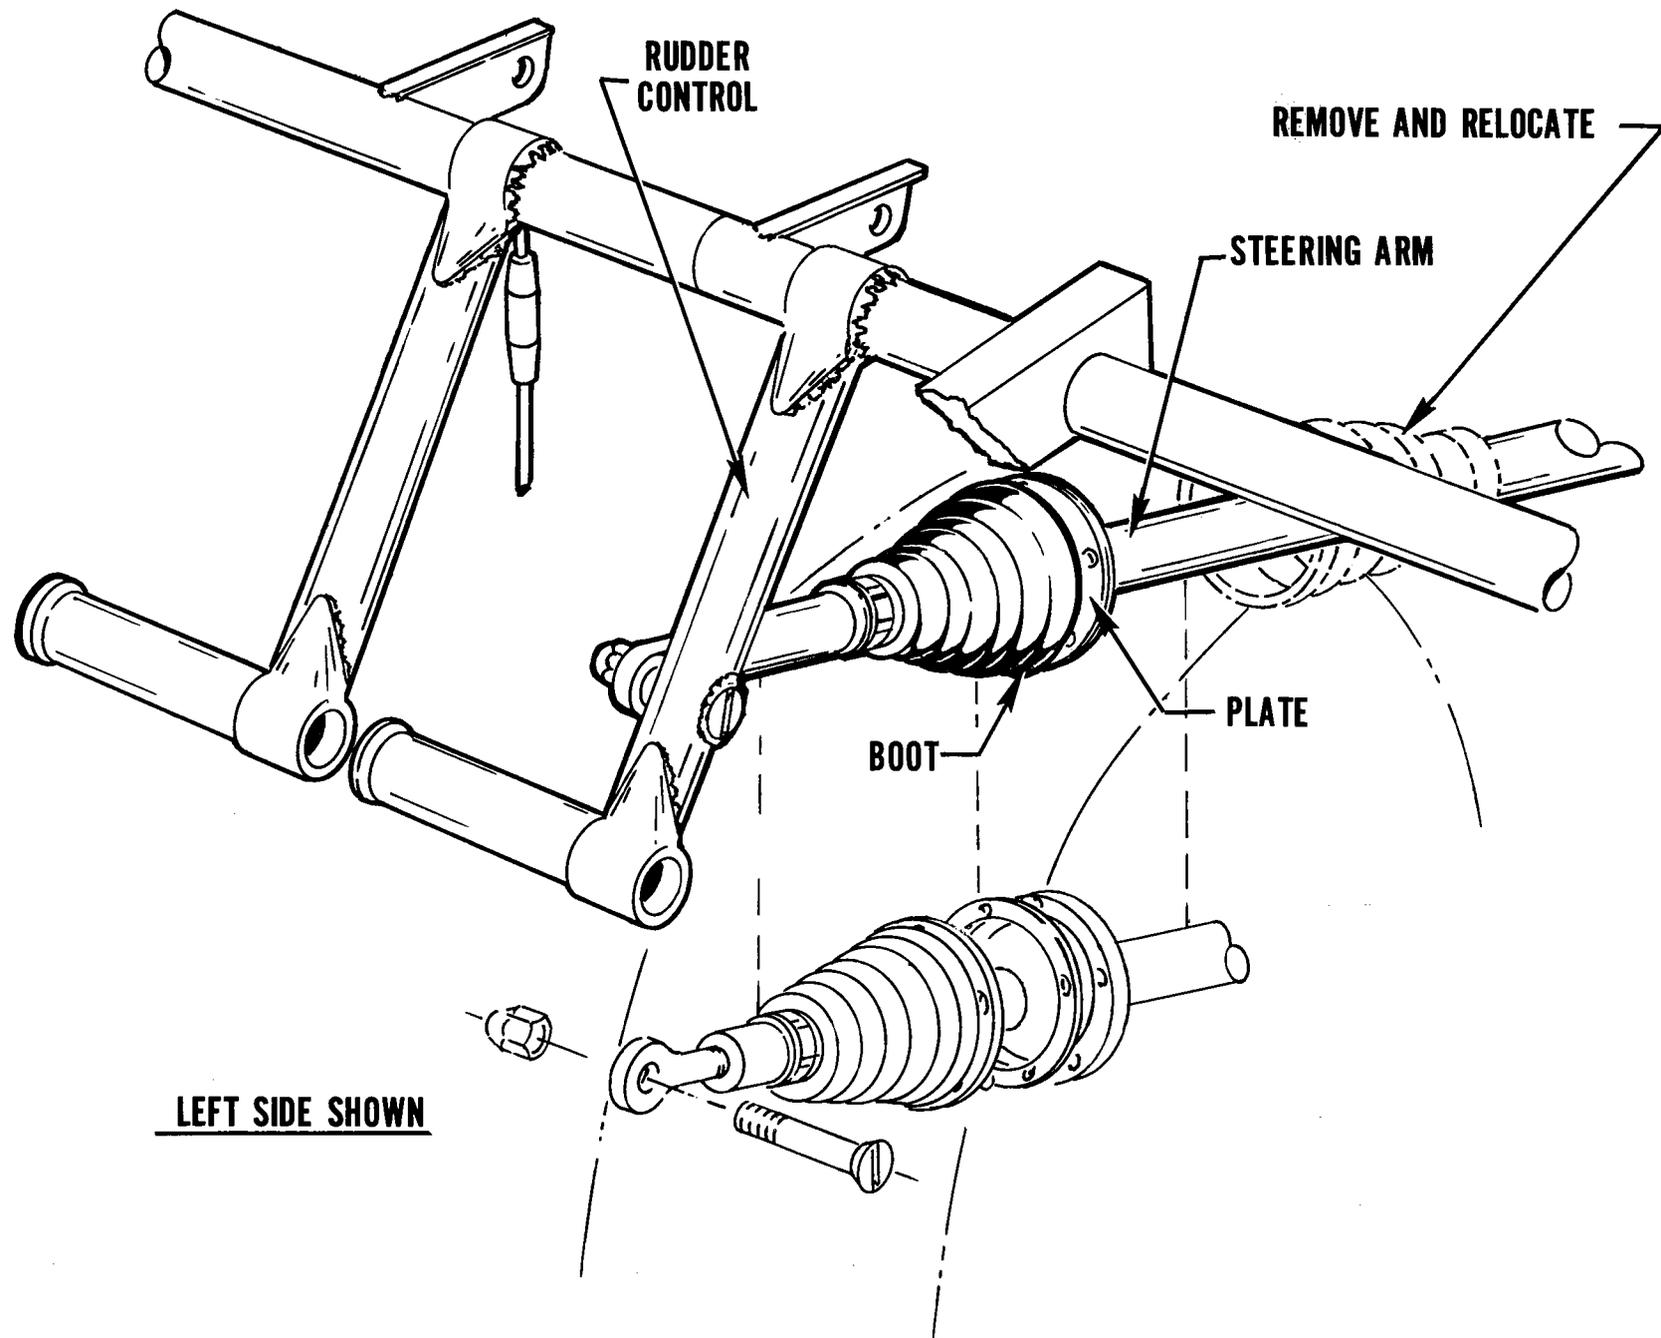
The nose wheel steering tube boot, part number 21996-00, located on the left nose wheel steering tube, is exposed to heat from the muffler and tailpipe necessitating more frequent replacement than the one on the right nose wheel steering tube. In order that the service life of this boot may be extended, it may be removed and installed on the cockpit side of the firewall on the steering tube.

1. Disconnect the steering arm at the rudder control in the cockpit and in the engine compartment.
2. Remove and discard boot assembly, part number 21996-00, from engine side of firewall.
3. On the cockpit side of the firewall remove plate, part number 21042-00, and use as a template to locate the four holes in the flange of the boot assembly. Install the boot on the firewall using the 21042-00 plate, screws and nuts. Reconnect the steering arm to the bellcrank and rudder control, then secure the small end of the boot to the tube with Tinnerman Clamp No. A3122-12-1. Operate rudder control to maximum travel to insure proper clearances are maintained.
4. See sketch on reverse side of this service letter.
