Service Letter No. 339

July 12, 1960

**SUBJECT:** Insulation of Wiring at Starter Solenoid Switch

**MODELS AFFECTED:** PA-24 and PA-24-250 Comanches  
Serial Numbers 24-1 to 24-1881 inclusive, 24-1883 to 24-1919 inclusive, 24-1921 to 24-1932 inclusive, 24-1934 to 24-1962 inclusive, 24-1964 to 24-1981 inclusive, 24-1983 to 24-1987 inclusive, 24-1989 to 24-2001 inclusive, 24-2003 to 24-2006 inclusive, 24-2008 to 24-2010 inclusive, 24-2012 to 24-2021 inclusive, 24-2023 to 24-2026 inclusive, 24-2028 to 24-2030 inclusive, 24-2032, 24-2033, 24-2035, 24-2037 to 24-2040 inclusive, 24-2042 to 24-2044 inclusive, 24-2046 to 24-2069 inclusive, 24-2071 to 24-2078 inclusive, 24-2080 to 24-2085 inclusive, 24-2087 to 24-2092 inclusive, 24-2094 to 24-2105 inclusive, 24-2107 to 24-2109 inclusive, 24-2113 to 24-2118 inclusive, 24-2120, 24-2122, 24-2123, 24-2125, 24-2128 to 24-2132 inclusive, 24-2134, 24-2135.

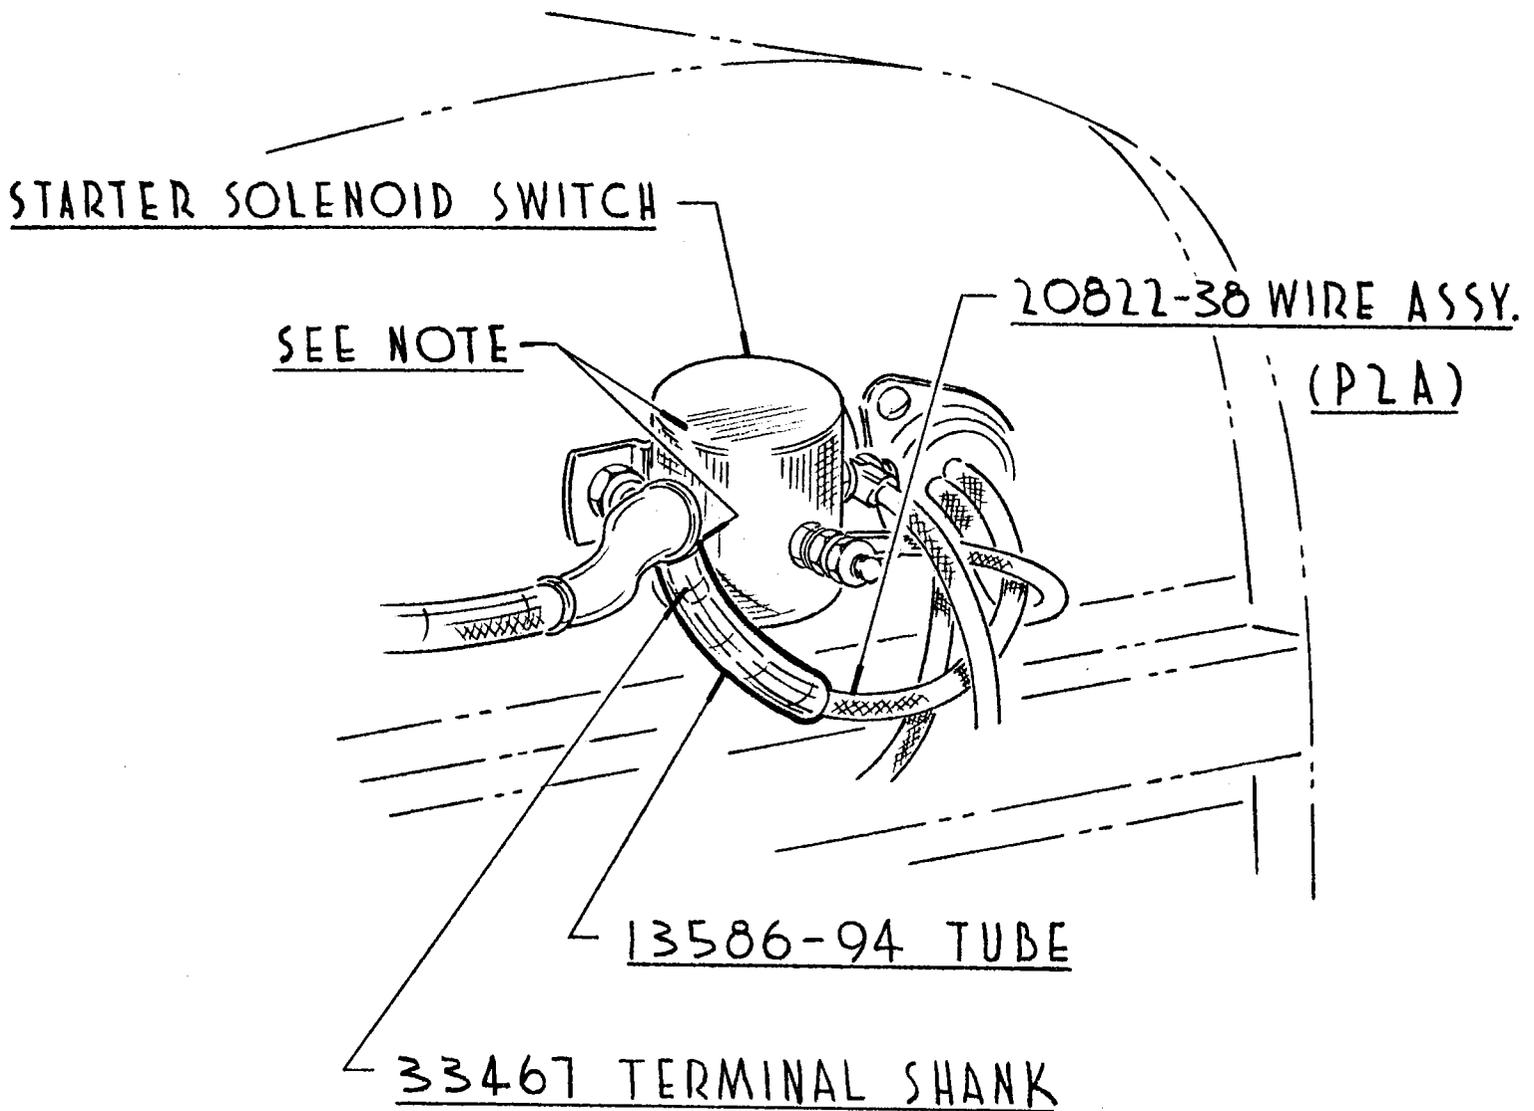
This Service Letter is to advise that a modification has been made to the wiring at the starter solenoid switch. The subject aircraft as indicated by the above serial numbers shall be modified in accordance with the following instructions and enclosed sketch.

1. A piece of plastic insulating tubing, part number 13586-94, two inches long shall be installed over part number 33467, terminal shank, on wire assembly, part number 20822-38.
2. The subject terminal, part number 33467-00, located on the right side of the starter solenoid switch on the forward side of the firewall shall be installed in such a manner as to provide maximum clearance between the terminal shank and the solenoid housing.

NOTE -

INSTALL TERMINAL TO PROVIDE MAX. CLEARANCE  
BETWEEN TERMINAL SHANK & SOLENOID HOUSING
