Service Letter No. 207

SUBJECT: Oil Quick Drain Valve Assembly, Part Number 12956-04

MODELS AFFECTED: All Models incorporating the use of the above valve

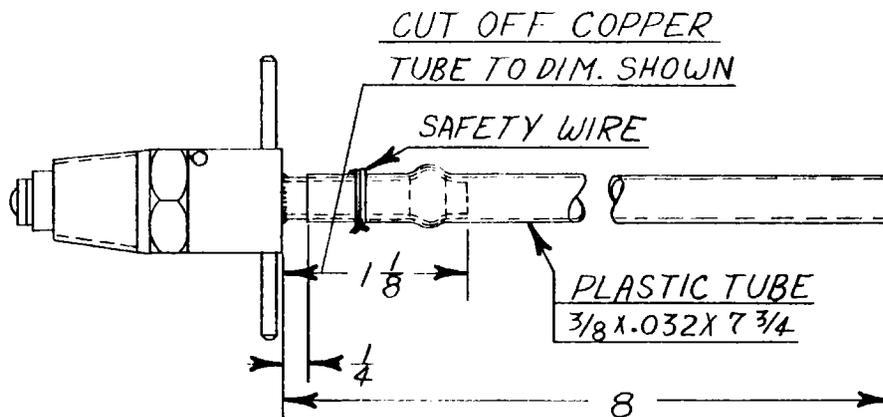
It has been brought to our attention that vibration has caused the quick oil drain valve to break at the rubber washer seal and also at the point where the copper drain tube is soldered.

To eliminate this condition it is recommended that the valve be modified in accordance with the sketch shown below. The plastic tube may be obtained from the Service Department of the Piper Aircraft Corporation on a No Charge basis. This plastic tube will be furnished on a No Charge basis until June 1, 1954.
