SERVICE BULLETIN

No. 354B

Piper Aircraft Corporation

Subject: Fuel Selector Valve Lubrication

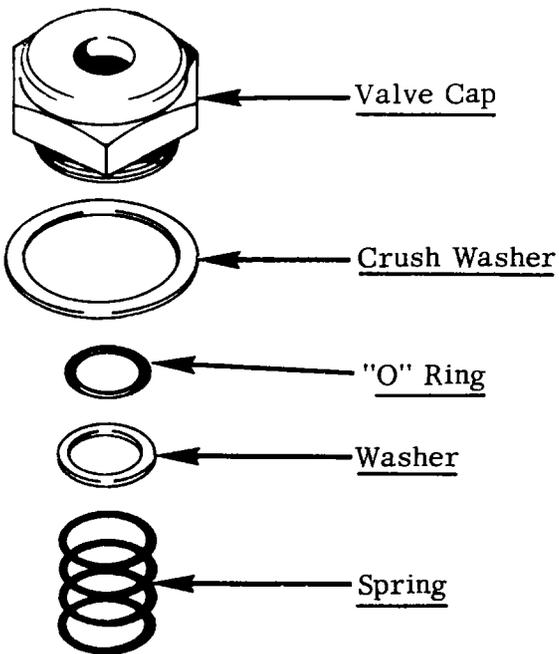
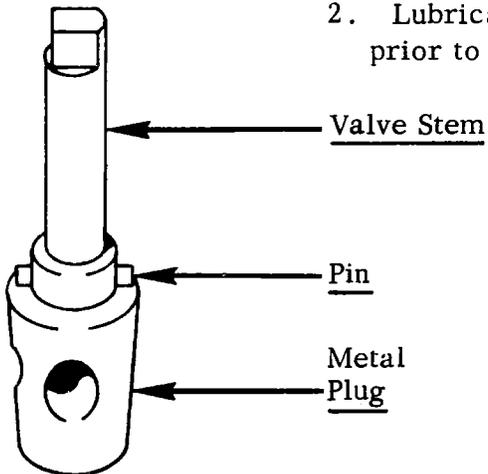
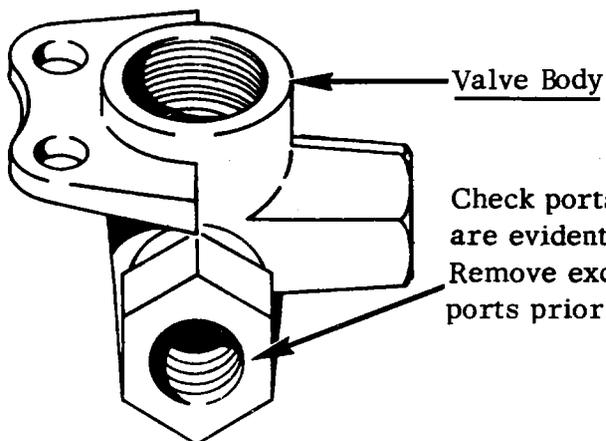
Fuel Selector Valve

Brass Washer - counterbored; to reinstall properly, counterbored surface must face the position washer.

1. Check inside perimeter for indication of extreme wear; if wear is readily apparent, replace position washer.
2. Lubricate with MIL-G-6032 (Type I) prior to reinstallation.

Check ports for cracks; if cracks are evident, replace valve. Remove excess grease from ports prior to reinstallation.

1. With the valve removed from the aircraft, remove the valve cap and interior parts (see attached sketch for an exploded view of valve components).
2. Inspect position washer inner perimeter surface for indications of extreme wear; should this be evident, replace position washer. (See Material Required, below.)

3. Check condition of plug and valve body for scored surfaces. The surfaces, if not badly scored, may be conditioned by lapping with a fine grinding compound. Clean away all compound after lapping. If plug will not seat properly or if scoring remains evident, replace valve with Valve Replacement Kit 764 295.

4. Check condition of valve stem in the area where the "O" ring seats. Should the stem be worn or damaged so that the "O" Ring will not seal, replace valve with Valve Replacement Kit 764 295.

5. With a 10x magnifying glass, inspect valve ports for cracks; if cracks are visible, replace valve with Valve Replacement Kit 764 295.

6. Clean valve of all foreign matter, lubricate plug with a light film of MIL-G-6032 (Type I) grease, turn the plug several times in its seat and wipe off any excess, especially in the valve ports. Also, lubricate position washer with a light film of MIL-G-6032 (Type I) grease. Reassemble valve with a new "O" ring, Piper Part Number 752 822.
