SERVICE LETTER

No. 556A

Piper Aircraft Corporation

Subject: Turbocharger Waste Gate Return Spring

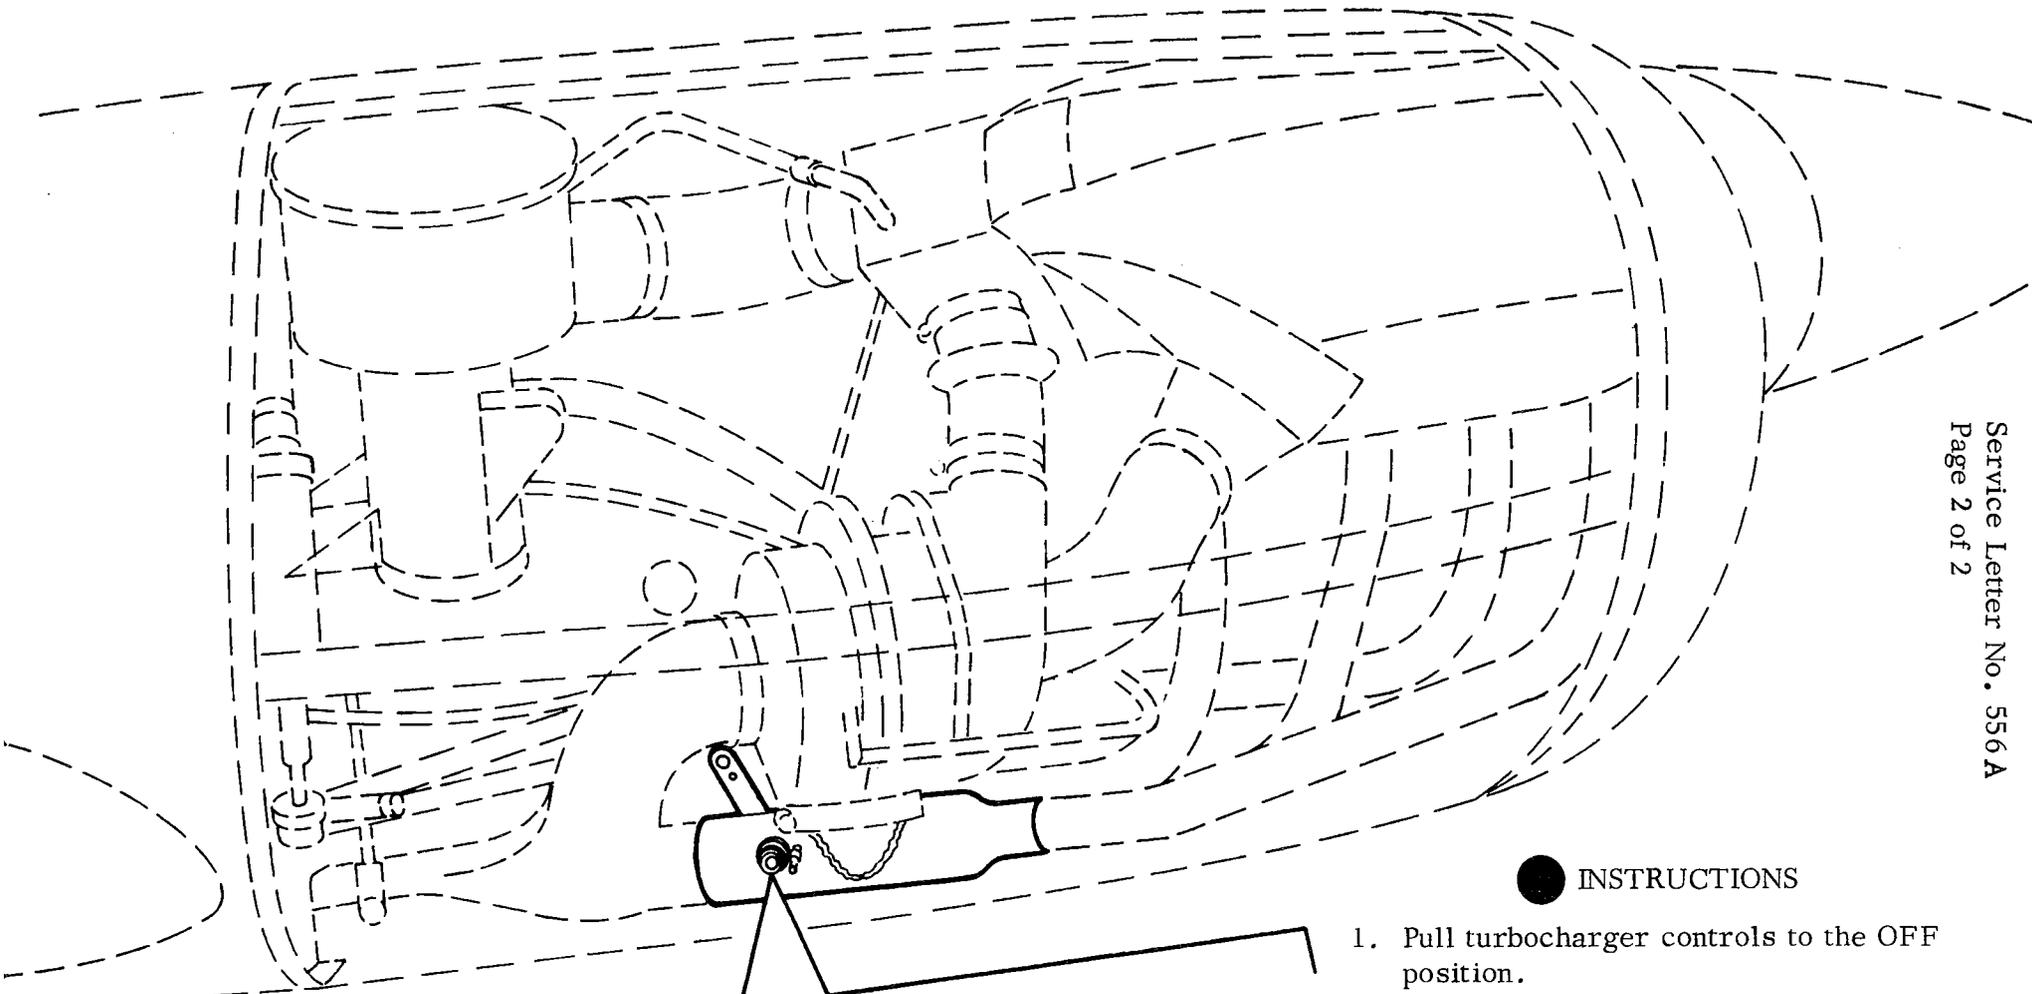
Purpose: To replace the existing turbocharger waste gate return spring with a new heavy duty return spring.

● INSTRUCTIONS

1. Pull turbocharger controls to the OFF position.
2. With side and bottom cowl panels removed, remove the existing turbocharger waste gate spring.
3. Install new turbocharger waste gate spring, RaJay Part Number RJ4120-11, being careful to install center tang in hole 180° to hole from which old spring was removed.
4. Place turbocharger waste gate spring on spring retainer as shown.
5. Actuate turbocharger controls to determine spring winds and unwinds freely.
6. Reinstall cowl.
