Service Letter No. 439

**SUBJECT:** Lycoming Service Bulletin No. 300A (Crankshaft Propeller Flange Inspection)

Service Bulletin No. 300A  
Approved by FAA

SUBJECT: Crankshaft Propeller Flange Inspection

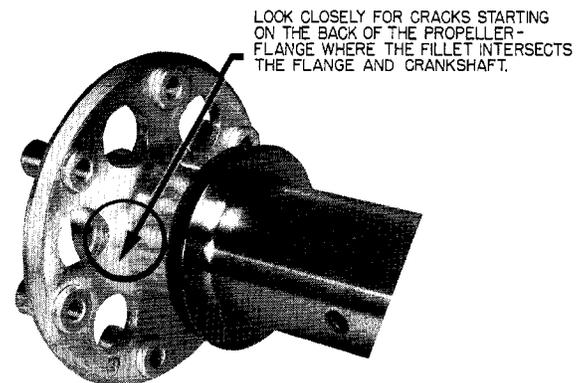
Figure 1. Rear View of Propeller Mounting Flange Showing Area of Lightening Holes.

a. Remove the propeller and starter ring gear from the mounting flange of the engine and examine the entire area of the crankshaft flange from the crankshaft seal forward for evidence of cracks. Use a magnifying glass of approximately 10 power and adequate lighting for this purpose or portable magnetic particle test equipment. Pay particular attention to the flange area and fillet radius on rear face of propeller flange. See accompanying illustrations for possible location of where cracks might appear and type of structural damage which can occur. Because of machining marks, the factory does not recommend using dye penetrant for this inspection. Further flight with a cracked propeller flange is not permissible.
