Piper Aircraft Corporation
Lock Haven, Pennsylvania, U.S.A.

SERVICE No. 222A BULLETIN

SUBJECT: Removal of Restriction to Air Speed Limits
(Replacement of Stabilator Torque Tube)

MODELS AFFECTED: PA-30 Twin Comanches, Serials 30-1 to 30-482 incl., 30-484 to 30-491 incl., 30-493, 30-494, 30-496 to 30-502 incl., 30-504, 30-505, 30-507 to 30-565 incl.

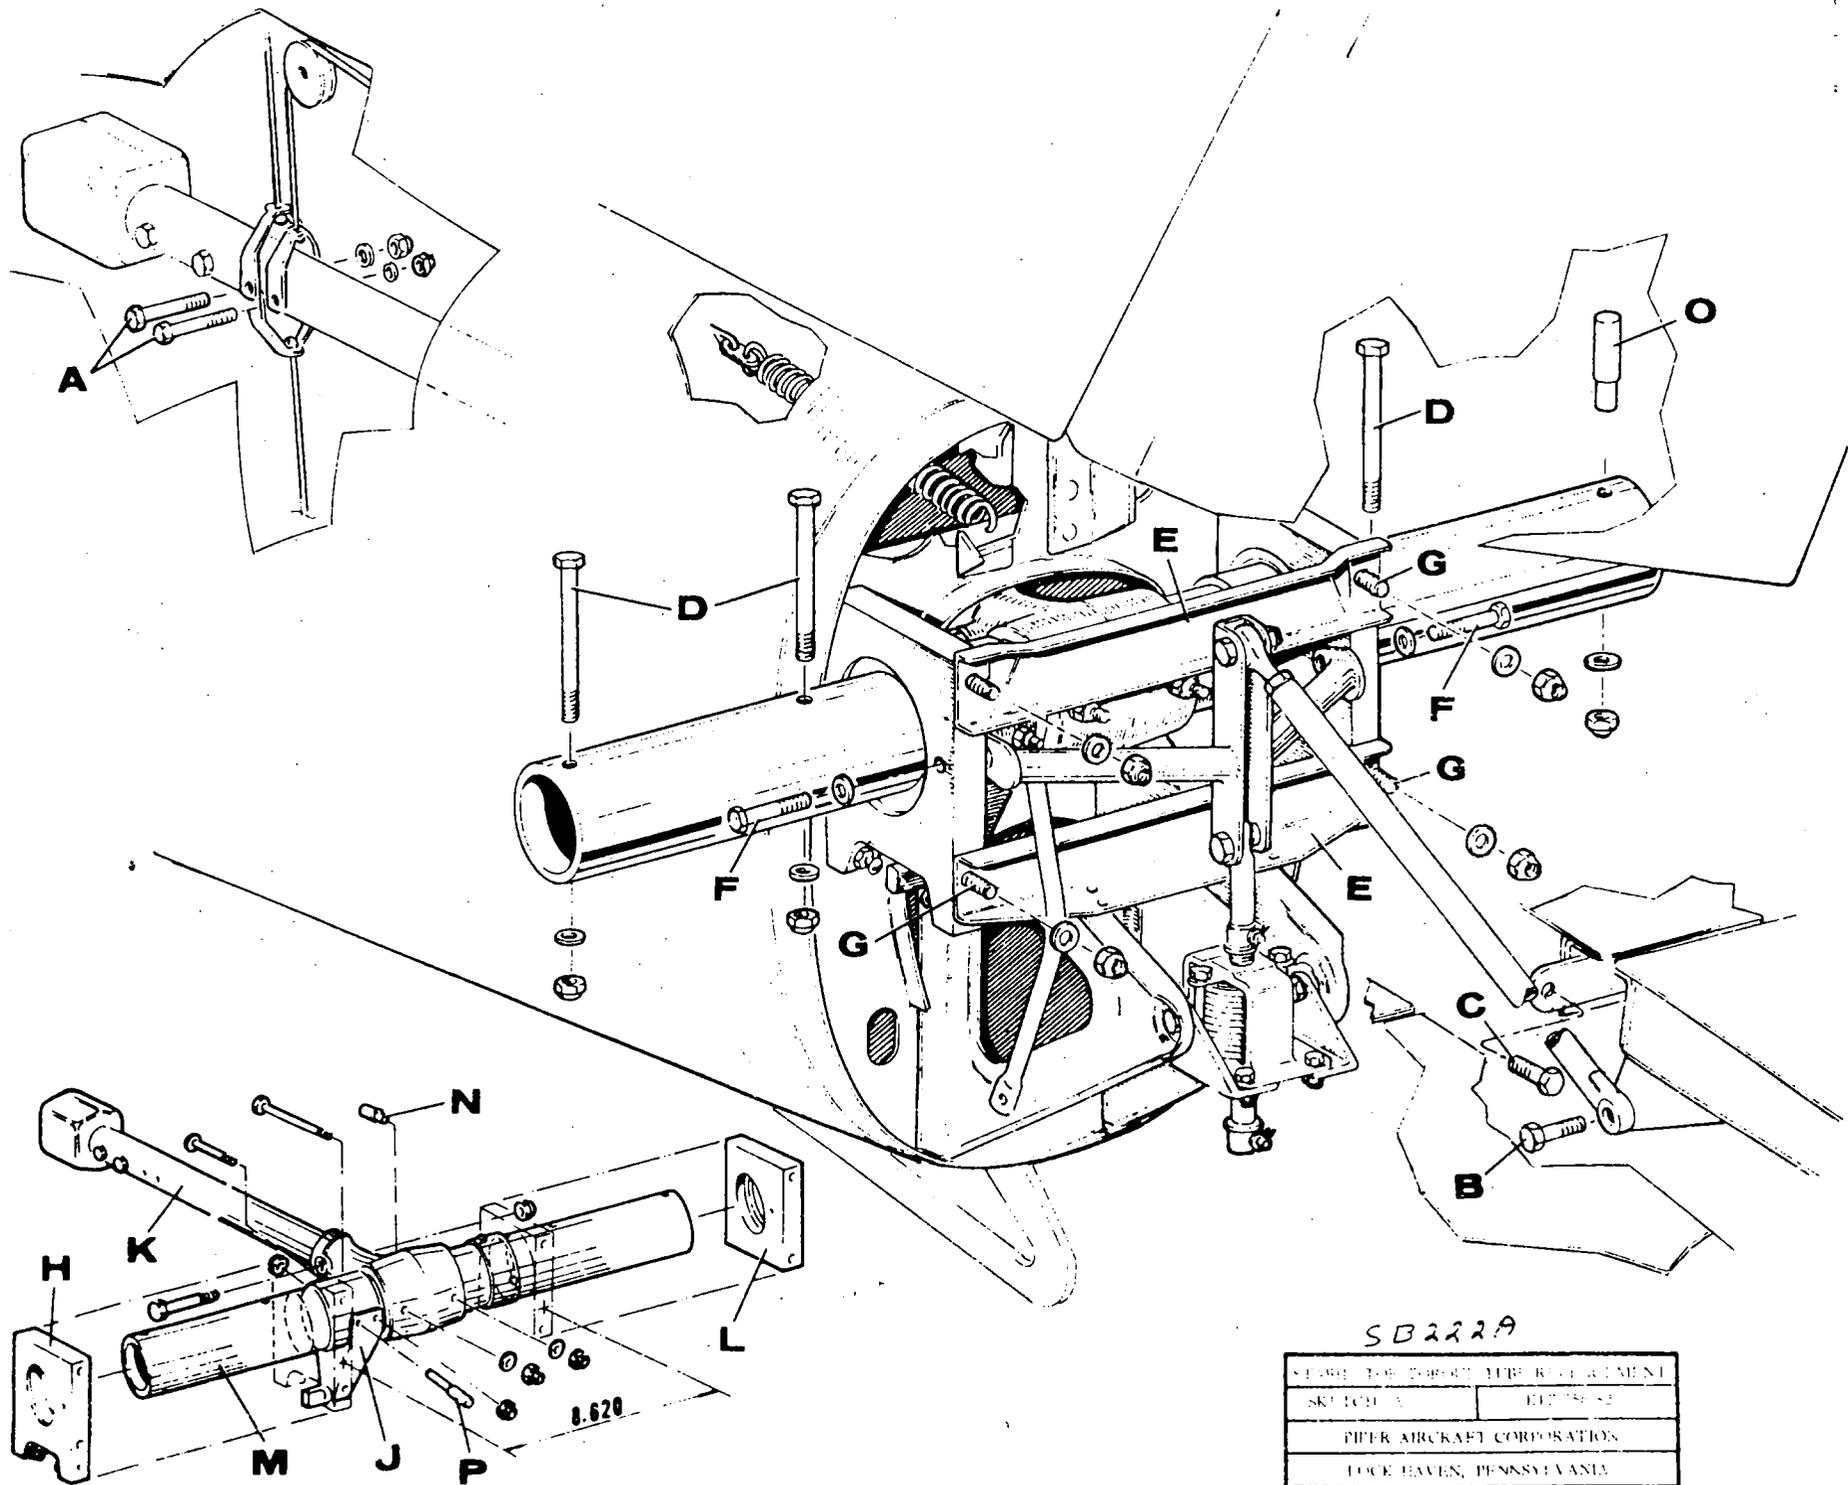
SB222A

Owners and operators of the subject aircraft were advised recently that because vibration at approximately the red line not-to-exceed limit had been observed, it was necessary to restrict the air speed.

It has been determined that a stabilator torque tube, part number 22655-07, of heavier wall thickness will eliminate this vibration.

1. Remove fuselage access cover plate.
2. Disconnect stabilator control cables on balance weight arm. Item A.
3. Remove bolt from stabilator trim tab born. Item B.

4. Remove bolt from stabilator rear spar. Item C.
5. Remove four bolts attaching stabilator to stabilator torque tube and remove stabilators. Item D.
6. Remove top and bottom fuselage tail fairings.

7. Remove stabilator bearing block reinforcement channels. Item E.
8. Remove two bolts holding stabilator tab control bellcrank assembly to stabilator bearing blocks. (It is not necessary to further disassemble this unit.) Item F.

9. Remove the bolts from the right stabilator bearing block and the bottom bolt in the left bearing block. DO NOT REMOVE the top bolt in the left bearing block. Item G.
(Caution - Mark top for proper reassembly.)

10. By pulling rearward and rotating the right end of the stabilator torque tube downward to pass the rudder arm, the entire torque tube and counterbalance assembly can be removed from the aircraft. The top left bearing block bolt should stay in place.

11. During disassembly of the torque tube assembly note the position of parts so that it can be properly reassembled.
12. Remove left bearing block by tapping with a soft mallet. Note shims, part number 81262-72 if installed. Item H.

13. Remove stop assembly. Item J.
14. Remove counterbalance arm assembly. Item K.
15. Remove right bearing block assembly. Note shims (81262-72) if installed. Item L.

16. Install counterbalance arm assembly on new stabilator torque tube, part number 22655-07. Note position in View B. Item M.

Ream the other hole in the tube to .3120 to .3130. Insert bolt in reamed hole before removing locating pin to ream the second hole.

Ream the other hole in the tube to .2465 to .2475. Insert bolt in reamed hole before removing locating pin to ream the second hole.

Shims, part no. 81262-72, should be installed with bearing blocks in same position as when removed to maintain a dimension of 8.620 shown in View C.

19. Reinstall torque tube assembly on aircraft in reverse order of disassembly.
20. Install stabilators and bolt the rear spar. Insert locating pin in same manner as previously used in one hole on either stabilator. Ream the other hole to .3120 to .3130 and install bolt. Item O.
