SERVICE BULLETIN

No. 751

Piper Aircraft Corporation

Subject: Spar Cap Chafing Inspection

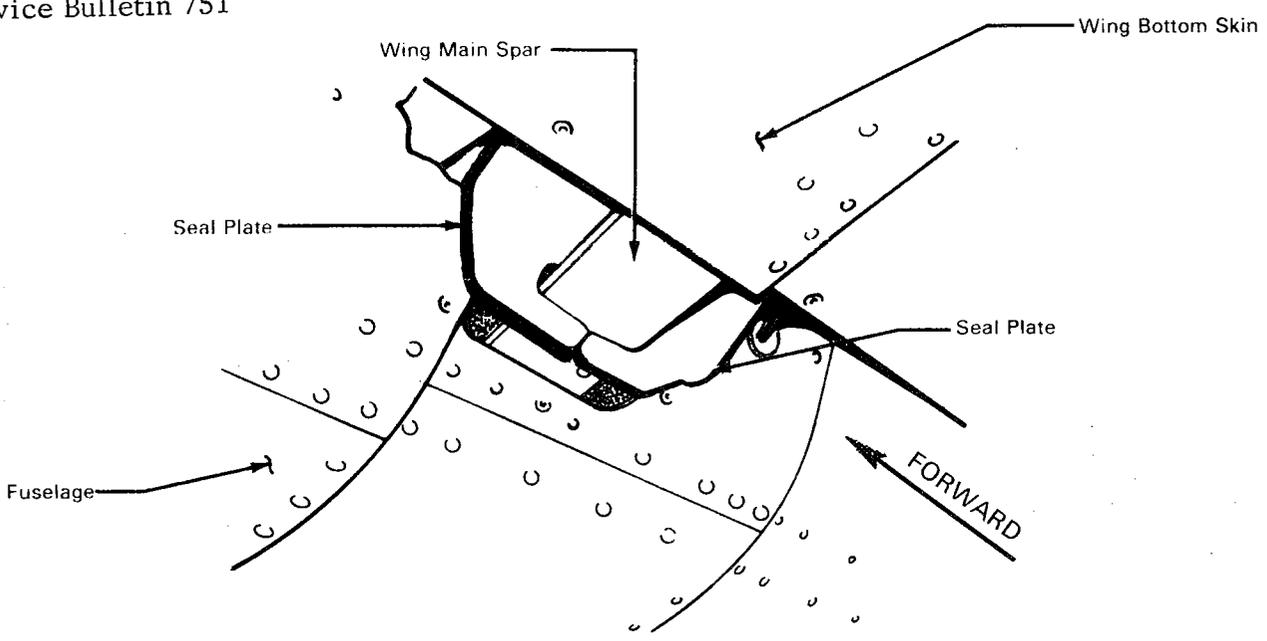
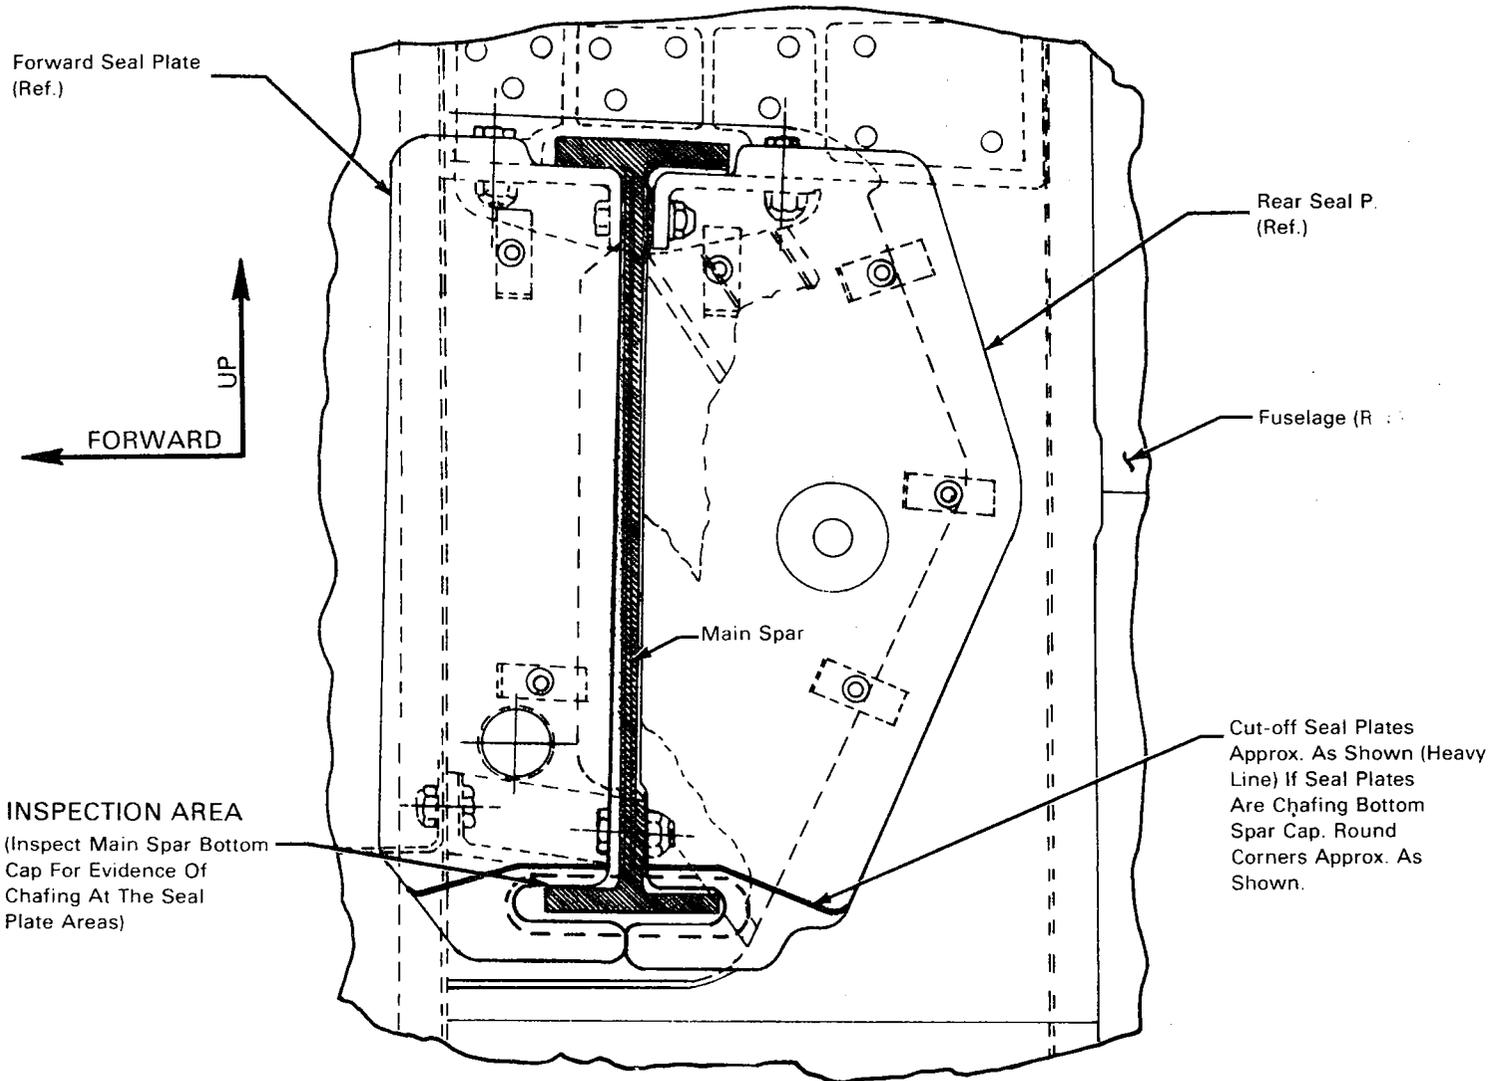
Service Bulletin 751

Several cases have been reported of chafing of the wing main spar lower cap where the spar enters the fuselage. This is caused either by deterioration of the rubber baffle material attached to the front and rear seal plates or by improper re-installation of the subject plates. Either situation may allow the seal plates to contact and chafe the lower spar cap.

1. Obtain access to the affected area of the lower spar cap by removing the lower wing root fairing.
2. With reference to the attached sketch, trim off the lower portion of each seal plate using a pair of aviation sheet metal shears.
3. Visually inspect both the upper and lower surfaces of the bottom spar cap where it passes through the seal plates. A mirror and flashlight will be necessary to properly inspect the upper surface. If no chafing is found, no further action is required.
4. If chafing is evident, perform a dye penetrant check of the chafed area. Provided no cracks are found, the chafed area should be polished to a smooth contour with progressively finer grades of "wet or dry type" emery paper. Final polishing should be accomplished with a 400 or 600 grade paper. The depth of the contoured area after smoothing and polishing
