Service Letter No. 404

SUBJECT: Inspection of Altimatic and Altimatic II Pitch Servo Assembly Chain Adjustment Screw

MODELS AFFECTED: PA-23 Apaches, Serials 23-1502 to 23-2046 inclusive
PA-23-250 Aztecs, Serials 27-1 to 27-504 inclusive
PA-23-235 Apaches, Serials 27-505 to 27-572 inclusive
PA-23-250 (6 place) Aztecs, Serials 27-2000 to 27-2388 inclusive
PA-24 and PA-24 "250" Comanches, Serials 24-2003, 24-2203, 24-2299 to 24-3557 inclusive

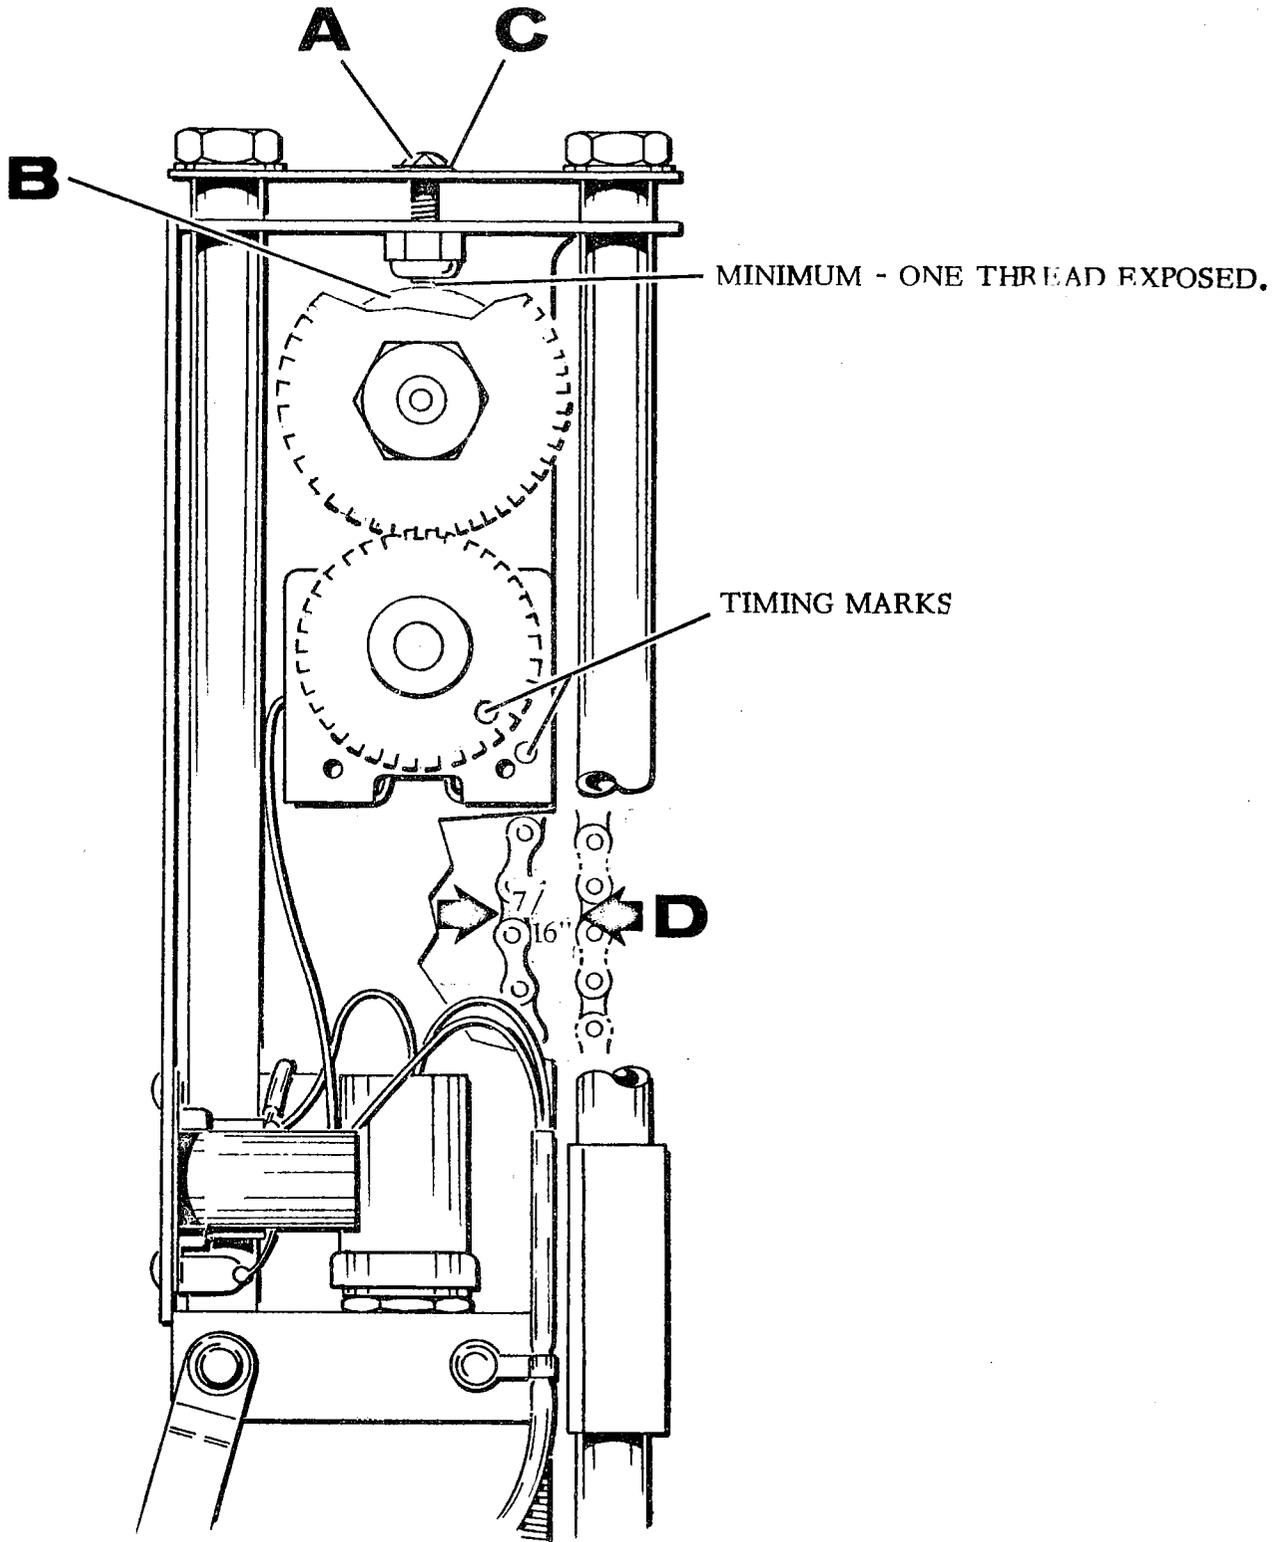
SERVICE LETTER NO 404

In order to provide a positive lock of the screw, at least one or more threads must protrude through the nut. If this cannot be accomplished without maladjustment of the pitch servo chain tension, (See pitch servo chain adjustment procedure on the following page.) it will be necessary to remove the screw and replace it with a "long-lok" type screw (Mitchell part number 3S275). Standard AN 1/32" thickness washers may be used as required under the head of the screw to prevent driving the screw end against the adjacent sprocket mounting.

IF LONG-LOK SCREW (A) CONTACTS SPROCKET MOUNTING (B), REMOVE SCREW AND INSTALL PACK WASHERS (C), UNDER HEAD OF SCREW AS REQUIRED TO MAINTAIN CHAIN TENSION OF 7/16" SLACK (D).
