# SERVICE LETTER

**No.** 445

Piper Aircraft Corporation

**SUBJECT:** Installation of Nose Gear Drag Link Clevis Reinforcement Bracket

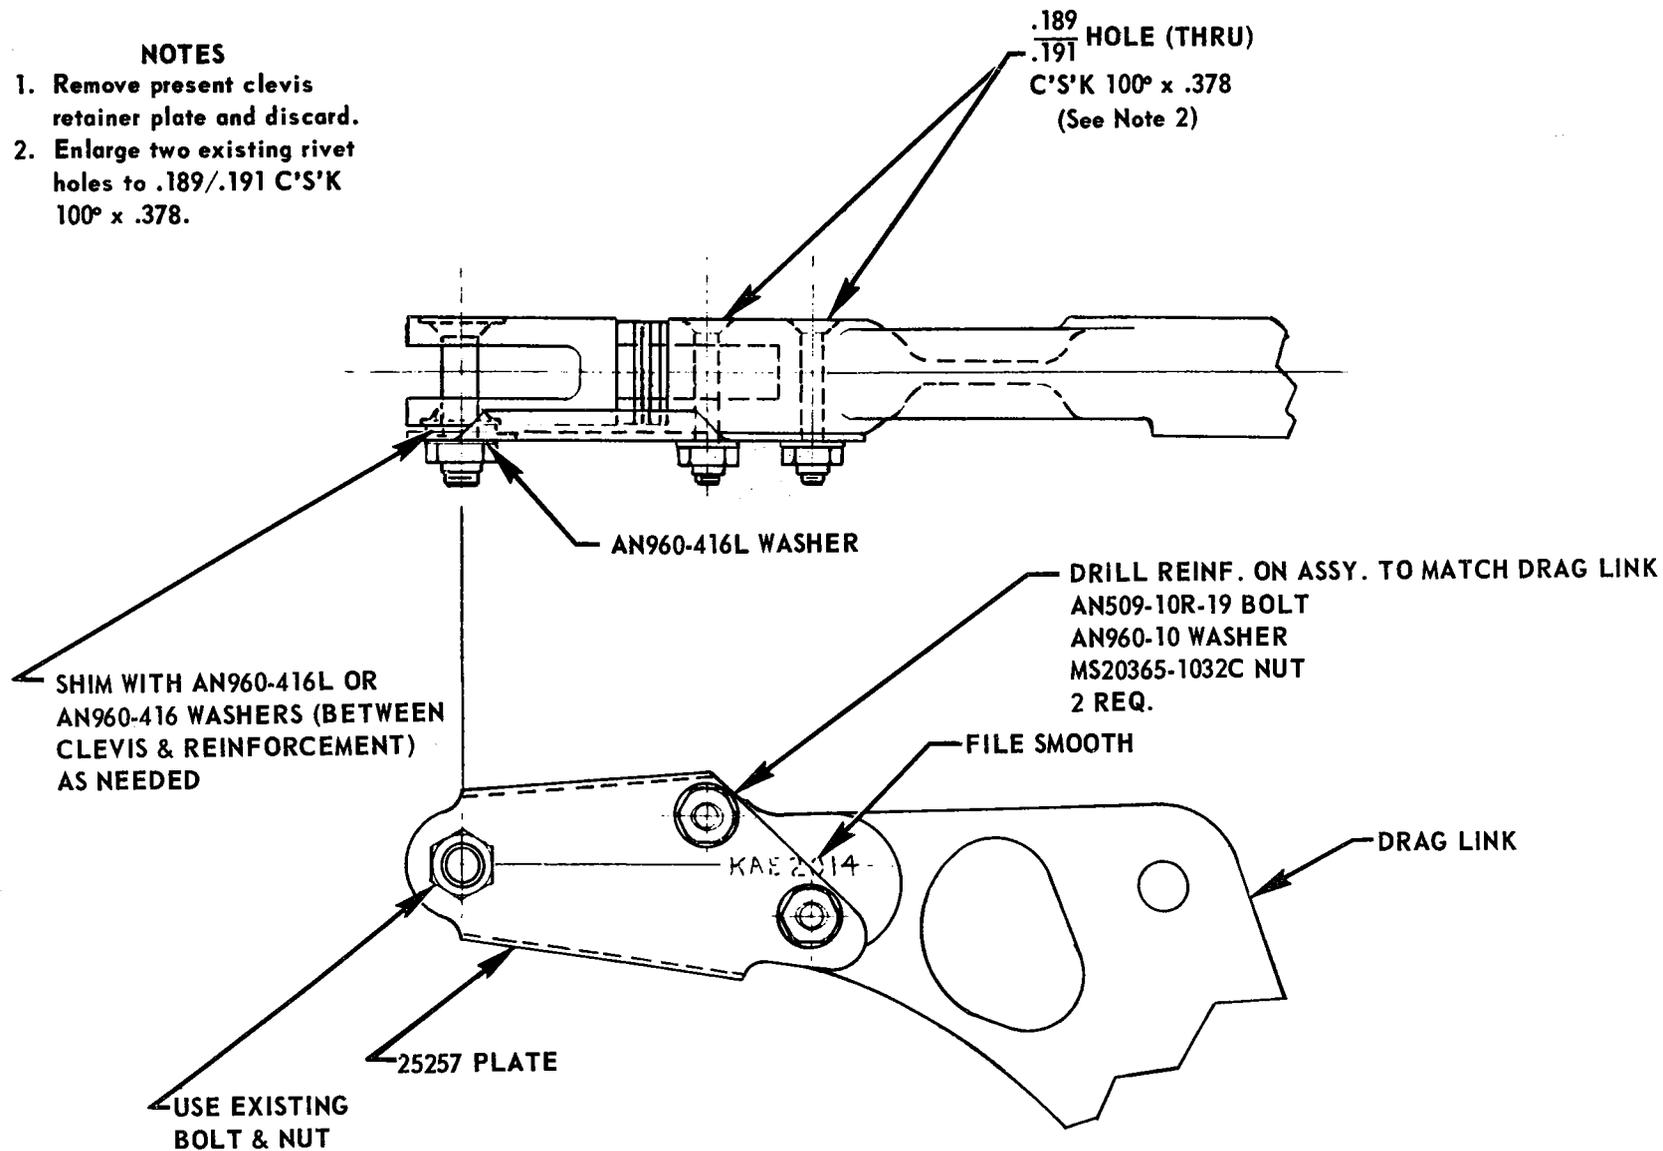
It is requested that the reinforcement bracket, which is applicable to clevises, part numbers 20859-03 (HT), 20859-02, or 20859-00, be installed to derive the benefit of the additional support. See sketch on the reverse side of this Service Letter.

1. Remove present clevis retainer plate and discard.
2. Enlarge two existing rivet holes to  $.189/.191$  C'S'K  $100^\circ \times .378$ .
