SERVICE BULLETIN

No. 478A

Piper Aircraft Corporation

Subject: Installation of Airspeed Limitation Placard.

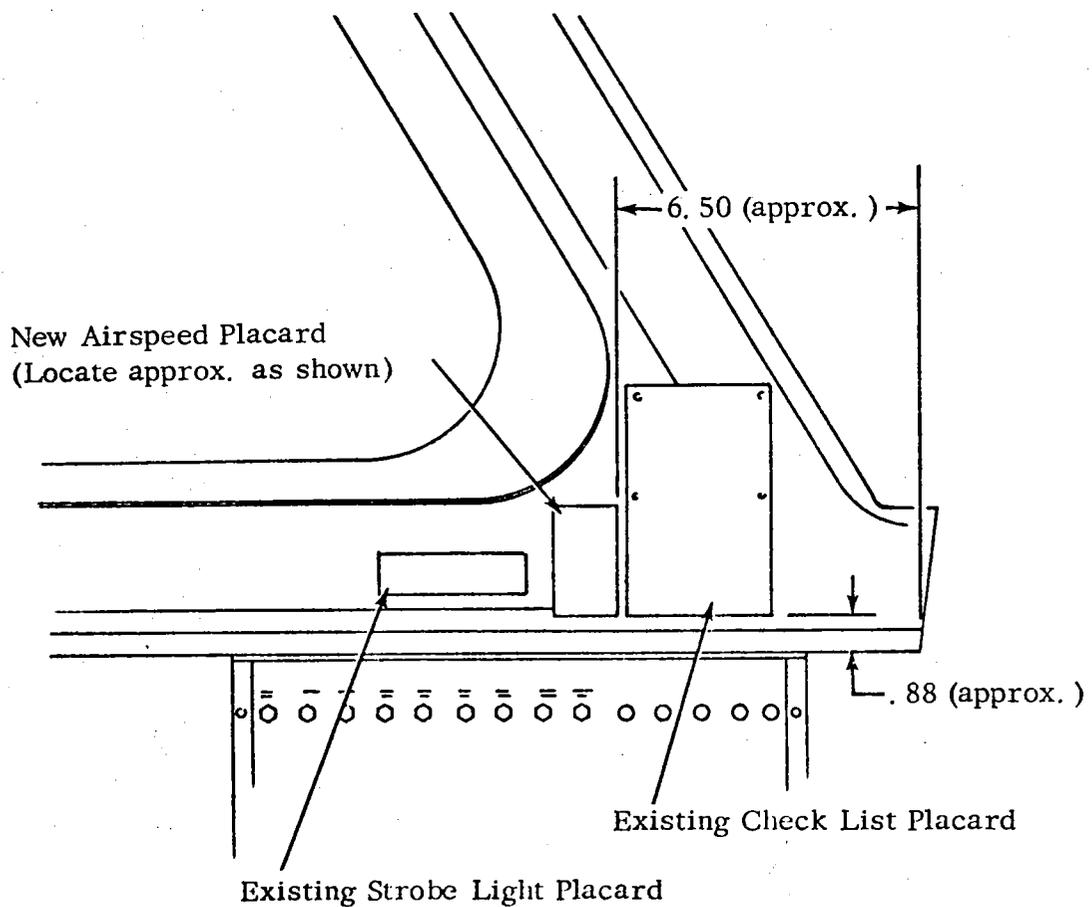
To provide material and instructions to install an airspeed limitation placard in ready view of the operator (see sketch on reverse side) in order to supplement airspeed limitation data contained in the Pilot's Operating Manual and on the airspeed indicator.

The placard contains airspeed limitation data specified in miles per hour for various altitude levels.

1. Contained in Piper Kit Number 761 075, Airspeed Placard Installation.
2. Subsequent to installation, make proper log book entry.
