SERVICE LETTER

No. 716

Subject: Cross Shaft Support Tube Moisture Seal -- reference attached Avco Lycoming Service Bulletin No. 375A, dated May 10, 1974.

Service Bulletin No. 375A
(Supersedes Service Bulletin No. 375)
Engineering Aspects are
FAA (DEER) Approved

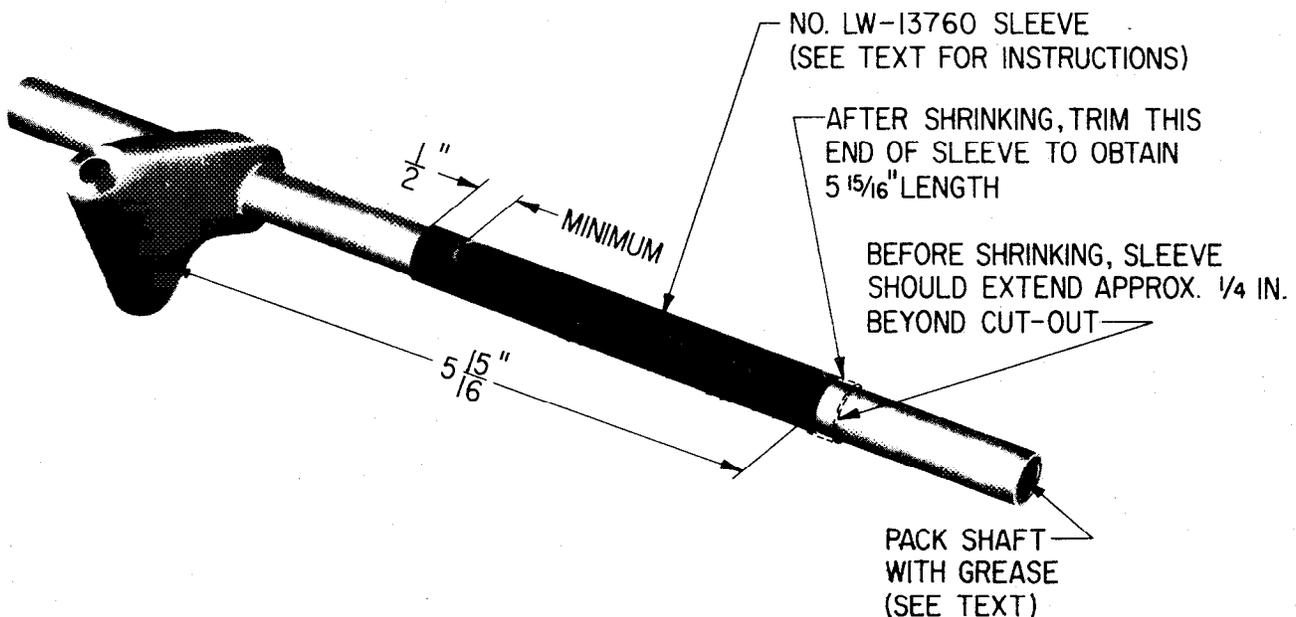
The cut-away portion of the cross shaft control support tube allows moisture to accumulate in the tube causing the fuel injector linkage shaft to freeze inside the cross shaft control support tube. To remedy this situation a heat shrinkable sleeve may be installed over the cut-away portion of the cross shaft control support tube in the following manner.

Cross Shaft Support Tube Showing Heat Shrinkable Sleeve Installed

6. Remove throttle cross shaft control lever from fuel injector linkage shaft, by driving out the roll pin.
7. Remove fuel injector linkage shaft from cross shaft control support tube.
8. Remove cross shaft (right) support from cross shaft control support tube.
9. Clean cross shaft support tube thoroughly with Varsol or like solvent and blow dry with compressor air.
10. Slip heat shrinkable sleeve LW-13760 over cross shaft control support tube and position over cut-away portion allowing approximately 1/4 inch of the sleeve to extend beyond the slot as shown in the illustration.
11. Using an adequate heat lamp (approximately 375 watts) shrink the tubing on the cross shaft control support tube (using an even heat and rotating motion) until the tubing is tight.

12. Allow the heat shrinkable sleeve to cool on the cross shaft control support tube and trim as shown in figure and assemble cover shaft (right) support.
